# Demining Programme Office in the Falkland Islands - Technical Support 2013

## Demining Programme Office in the Falkland Islands – Technical Support 2013

**Submitted by:** Fenix Insight Ltd

EXPLOITATION OF ITEMS RECOVERED DURING DEMINING OPERATIONS: 2012/13

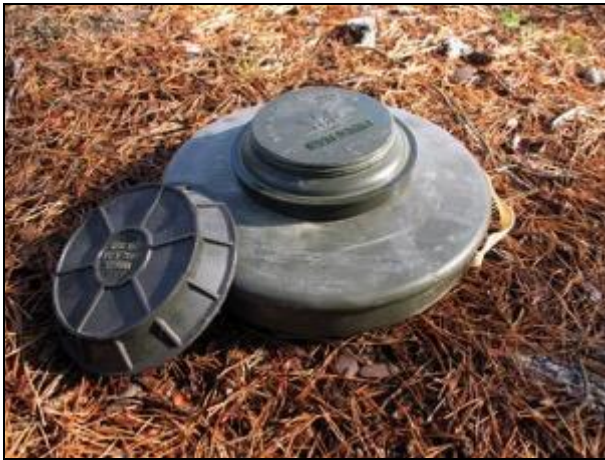
**Figure 1**

*The Spanish C3B anti-tank mine*

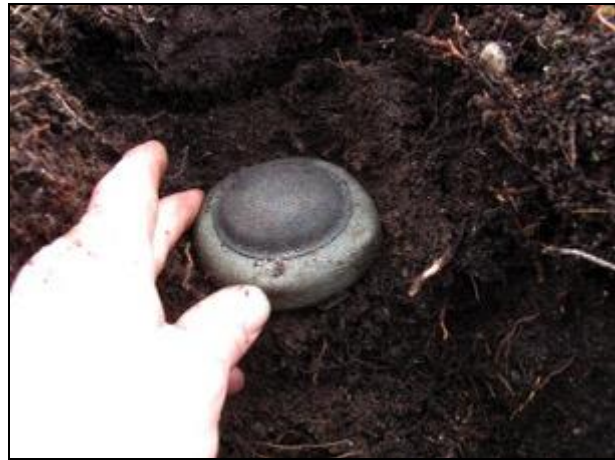
**Figure 2**

*The Italian SB-33 anti-personnel mine*

9. A solitary SB-33 anti-personnel mine was discovered in SA064, but located approximately 70 m from the nearest mine row.
10. The mine had sustained external damage to the casing and the detonator plug, but it's internal condition was unknown.
11. The mine was set aside in the hope that exploitation might offer some explanation for its location and condition.
12. Findings from the exploitation of the SB-33 mine are at **Annex B**.

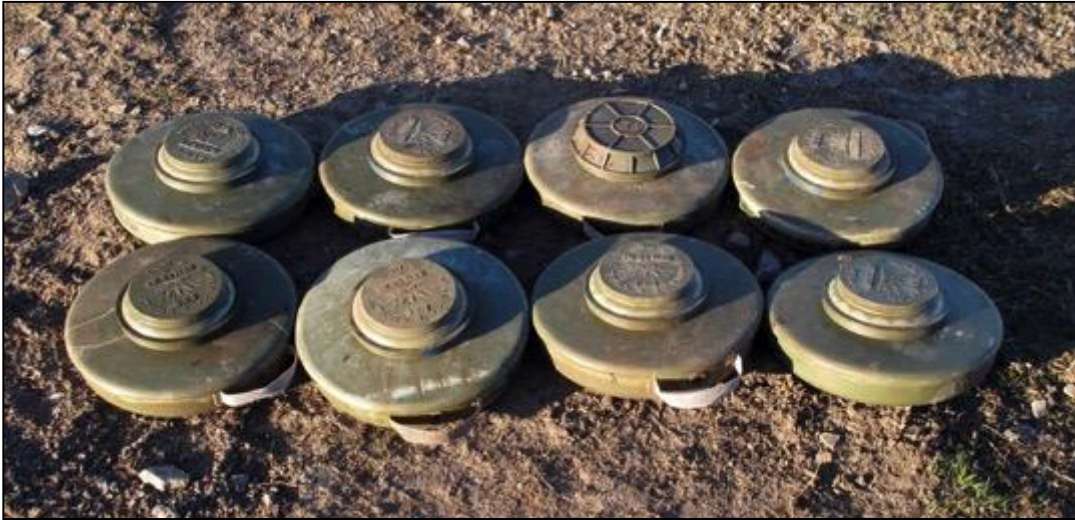
**Figure 3**  
*Inert mines  
for use as  
training aids  
and detection  
samples*

16. Most of the inert mines contain the original metal content and can therefore be used for detection trials. The two mines with metal content removed were clearly marked and were retained for display purposes only.

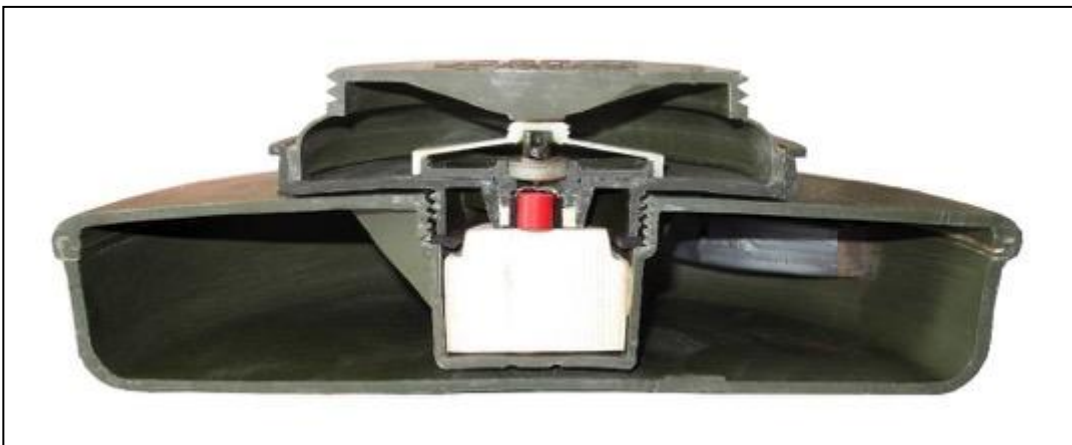
**Figure 4**  
*One of the  
C3B mines  
was sectioned  
to produce  
this training  
aid*

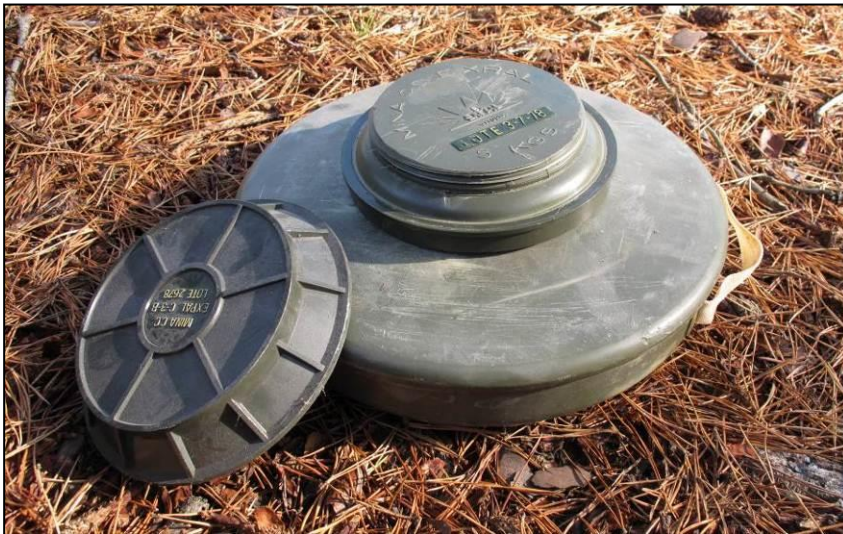
**Figure A1**  
The Spanish C3B anti-tank mine, shown here armed, with fuze fitted and safety cap to the left

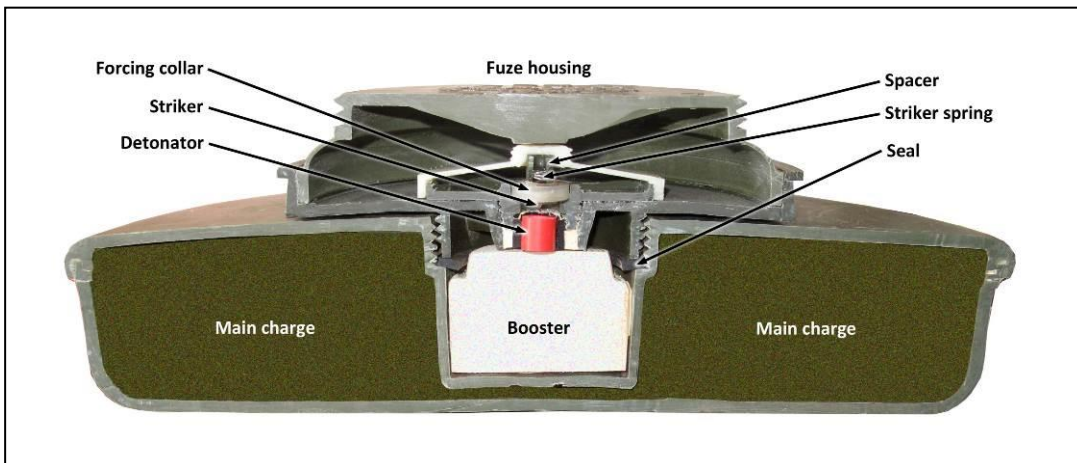
2. The C3B uses a fuze mechanism very similar to that of the P4B anti-personnel mine, protected by an additional plastic assembly to bring the operating pressure up to an acceptable level. Most of the components of the C3B are based on polystyrene plastic and are solvent-bonded together; this makes disassembly difficult and potentially dangerous. Components of the C3B are shown in **Figure A2**.

**Figure A2**  
Components of the C3B

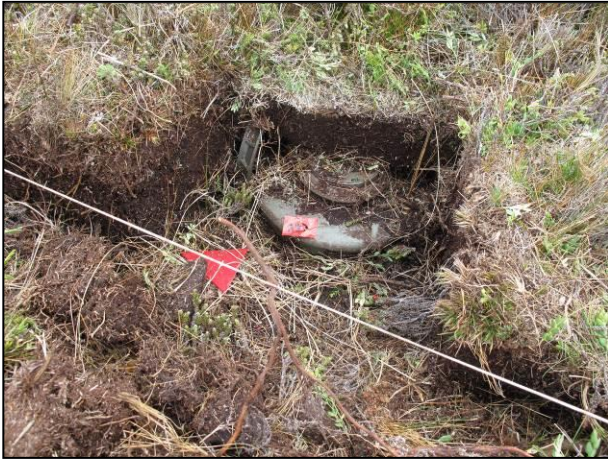
4. Each of the 32 C3B mines located in SA064 was photographed in position and allocated a unique serial number. The mines were extracted from the ground and defuzed in the minefield. A sample of 14 mines were then selected and disassembled for examination.
5. All of the mines had been buried beneath peaty soil and vegetation, with depths typically around 100 mm. Mines from a variety of conditions were represented within the 14 chosen; some were extracted from firm ground while others were partially or completely submerged (see **Figures A3 and A4**).

**Figure A3**  
*C3B in firm ground*

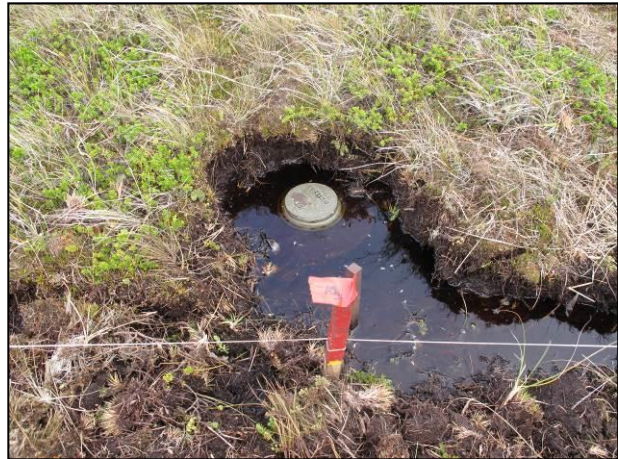
**Figure A4**  
*Some mines were submerged*

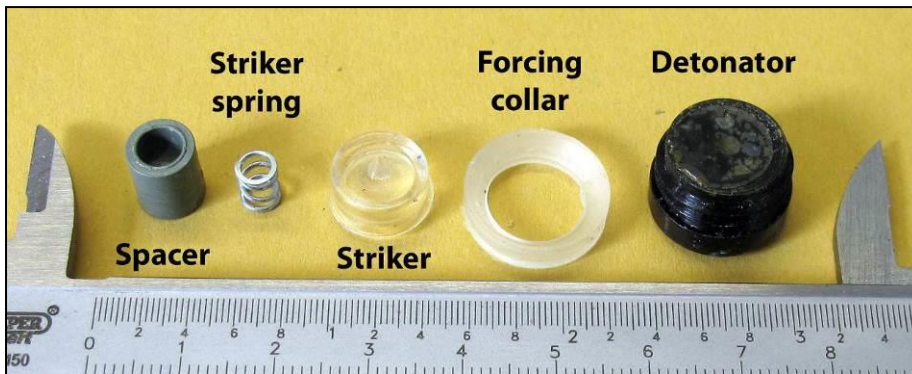
**Figure A8**  
Components of the C3B fuze mechanism. Pressure applied to the top of the fuze forces the striker through a flexible 'forcing collar', which accelerates the striker into the detonator. The spring makes relatively little contribution to this effect

17. All fuze mechanisms appeared to be operational, despite the corrosion of some striker springs. Fuzes are likely to remain functional despite the deterioration of the striker spring.

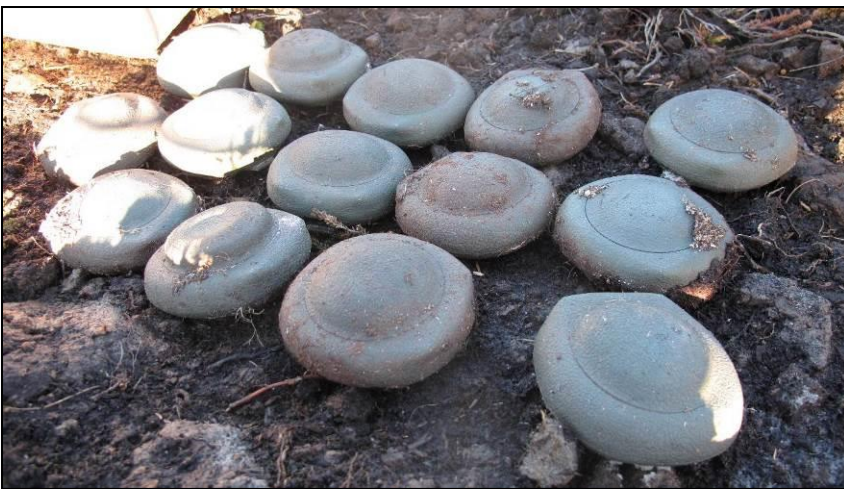
**Figure B1**  
SB-33 mines recovered from mine rows in SA064

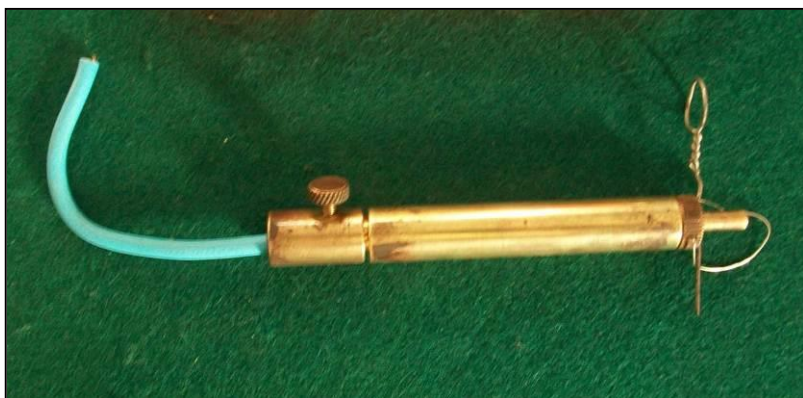
**Figure C1**

*The firing device typically used with Argentinian booby traps. The tube contains a spring-loaded striker retained by both a pin and a shear wire; this allows for optional pull or pressure actuation. The striker initiates a percussion cap, which ignites a safety fuze link to the detonator in the main charge. The safety fuze is retained in the fuze holder by the screw on the side*

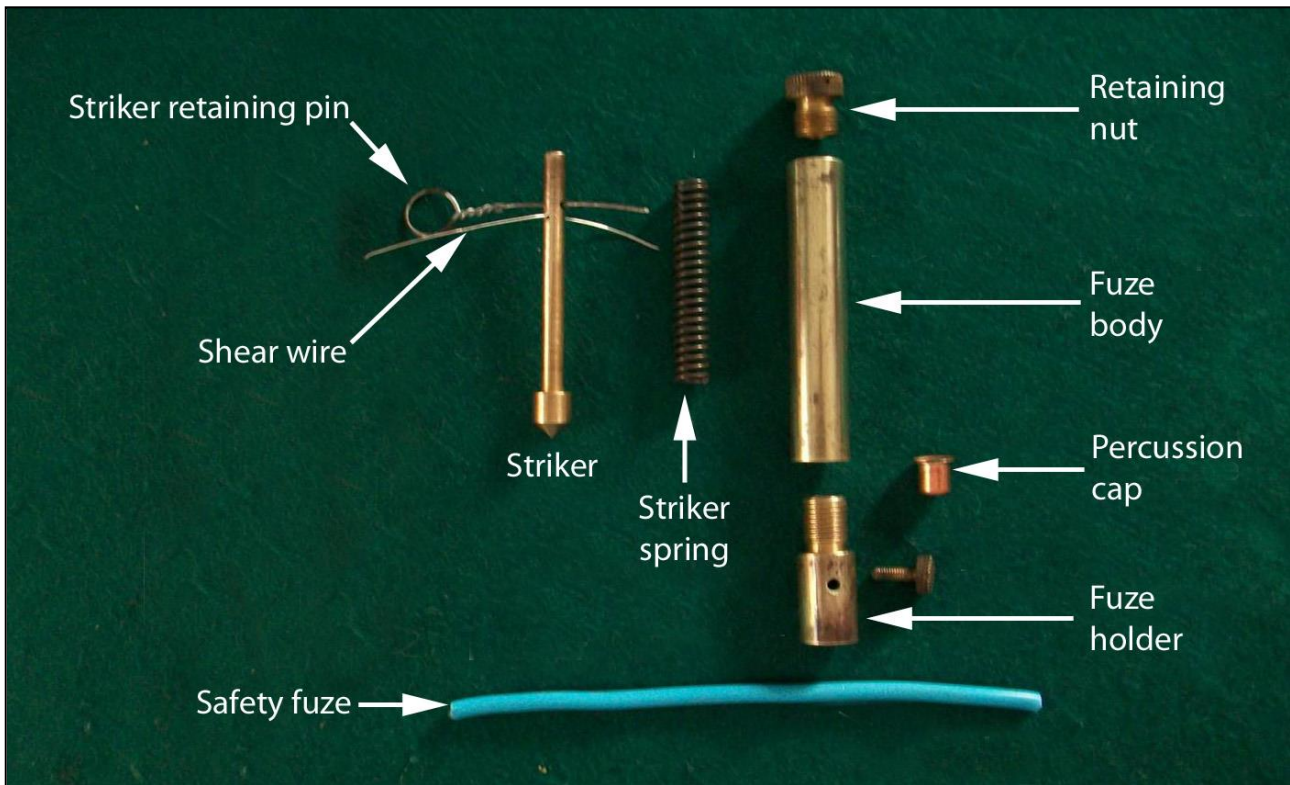
**Figure C3**  
Components of the Argentinian firing device
