# Demining Programme Office in the Falkland Islands - Exploitation 2017

CPG/1107/2016

## Demining Programme Office in the Falkland Islands – Exploitation 2017

## FALKLANDS ORDNANCE EXPLOITATION – JANUARY 2017

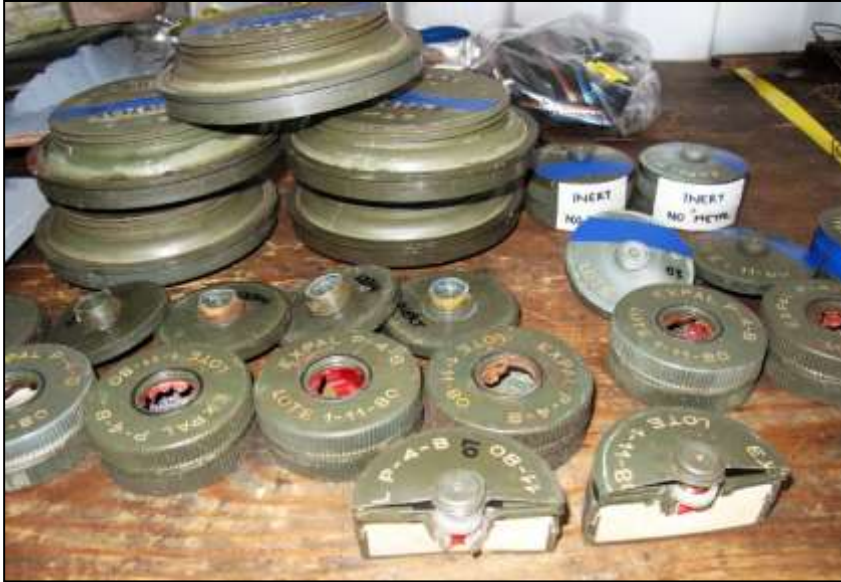
A number of P4B and C3B mines were rendered inert, including the extraction of initiation compositions and primary explosive from the detonators. This allowed the construction of inert versions of the detectable P4B mines for the use of the LRC and DPO.

*A number of inert training aids were produced, including sectioned P4B mines and inert mines, reconstructed with detectable detonator capsules*

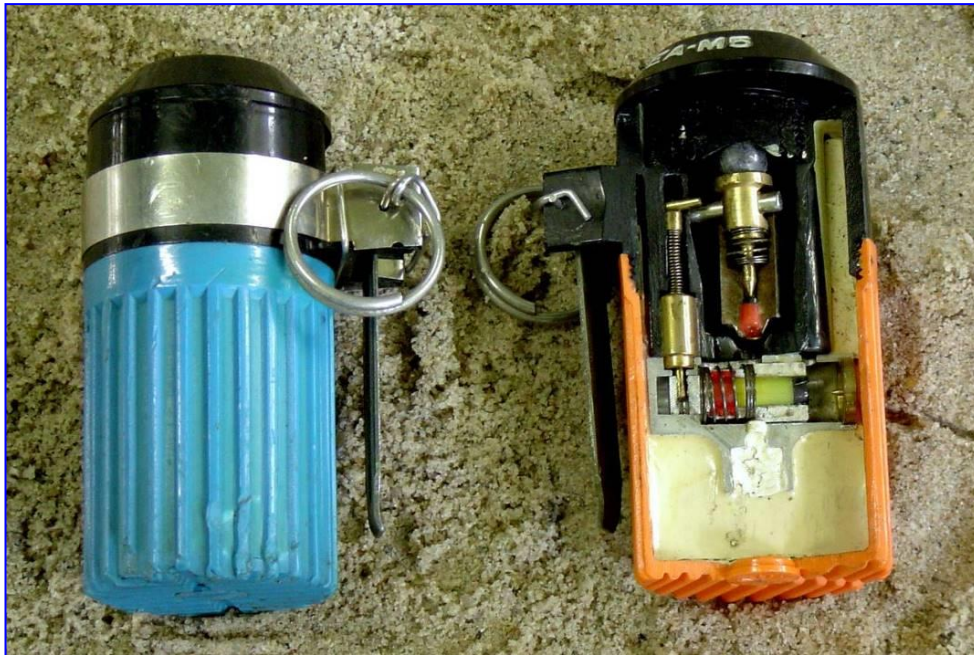
The M5 is an unusually complex grenade manufactured by the same Spanish company (Explosivos Alavese 'EXPAL' SA) that produced the P4B and C3B mines. Once the safety pin has been withdrawn, release of the fly-off lever initiates a firing delay, but can also be set to arm an impact fuze. The impact fuze uses an 'all-ways acting' mechanism, so called because it functions no matter what the direction of impact. This makes it inherently dangerous, and therefore of concern during disposal.

*The Spanish M5 grenade. The lower casing of the live grenade is black*

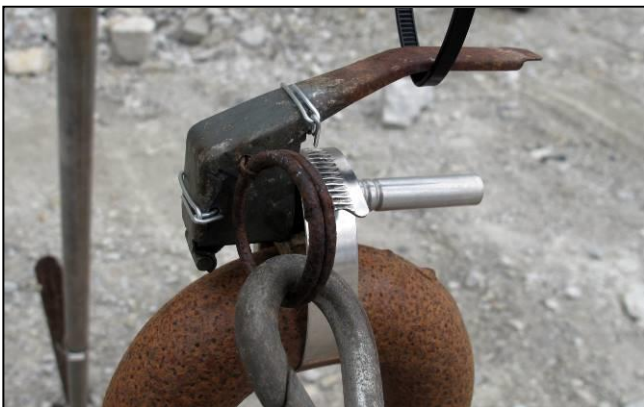
Removal of the initiation set (the assembly comprising the fuze, detonator, fly-off lever and safety pin) required a substantial amount of force, but the tight fit and presence of a sealing O-ring had prevented water from entering the grenade body. This meant that the detonator and main charge were in excellent condition.

In order to establish the functionality of the fuze, it was mounted onto the explosive test rig so that the safety pin could be pulled out, using a line, from a safe distance.

*Preparing to test the M67 fuze*

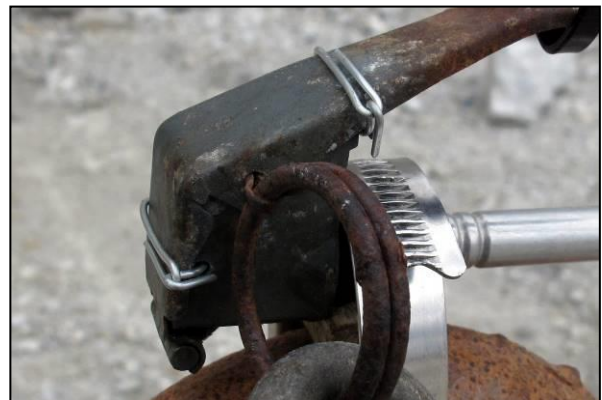
*Safety wiring with the fly-off lever in place*

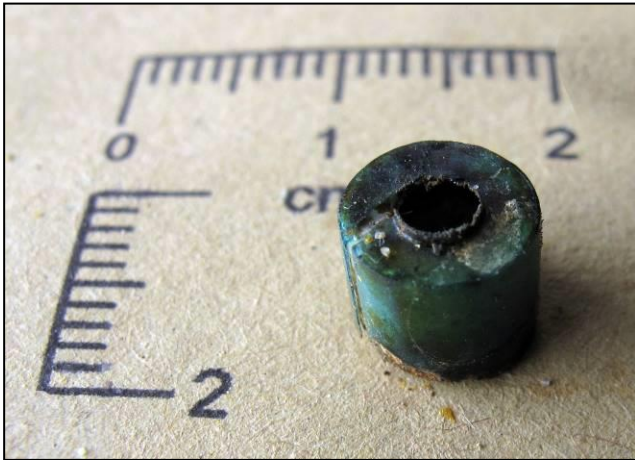
A number of detonator capsules were extracted from mines belonging to lot 1-11-80, and all of the energetic material removed. Each capsule is approximately 7mm in diameter and 6 mm high, made from aluminium alloy and weighing approximately 0.1 g. The capsules were then tested, with the Minelab metal detector used by the LRC, to establish the distance at which they could be detected.

*The detonator capsule from a lot 1-11-80 P4B*

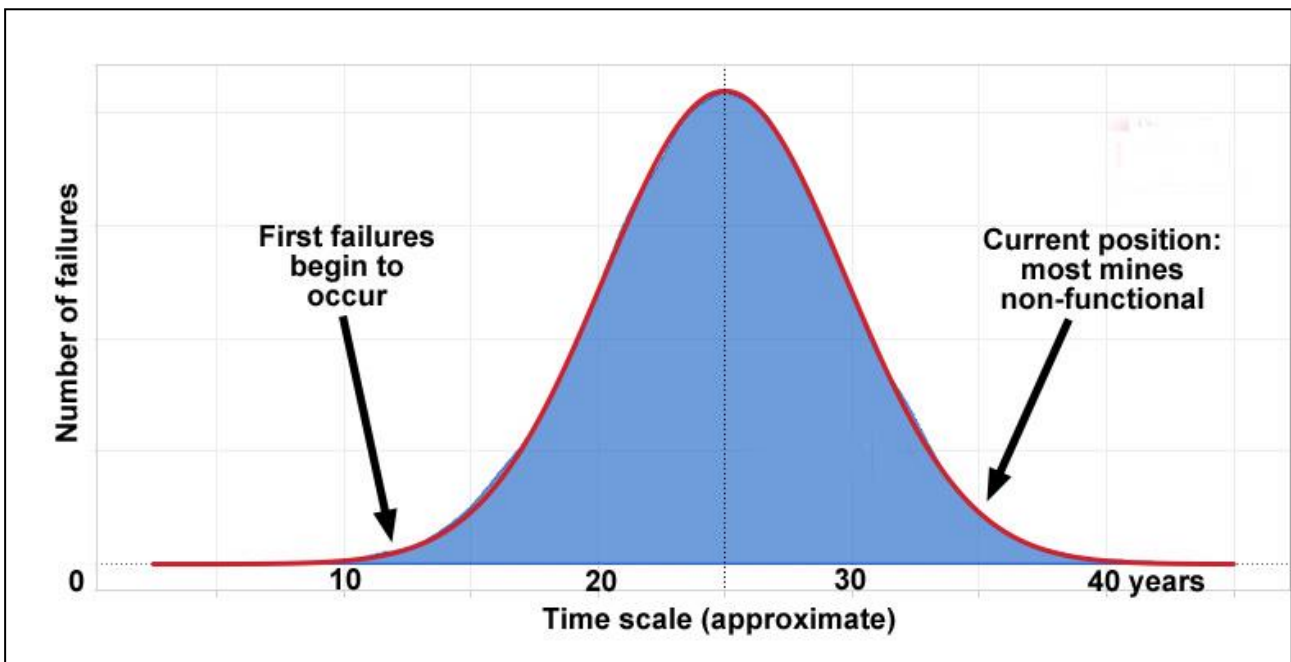
**Functionality.** The findings from the functionality testing build on the evidence of previous phases, confirming that the majority of P4B mines are no longer capable of functioning as designed. The sample sizes are too small to have real statistical significance and other factors, such as location and immediate environment, may be influential. However, exploitation and testing appears to indicate that the proportion of mines remaining functional is decreasing noticeably, year on year.

This would support the expectation that the rate of failure among mines is following a normal distribution curve, and that the current position is well towards the end of that curve, as shown in the illustration below.

*The decline in mine functionality is expected to follow a normal distribution curve. Testing indicates that most P4B and C3B mines have already reach the end of their functional life*
