Evaluation of Floorpan Tearing and Cable Splices for Cable Barrier Systems

*Midwest States Pooled Fund Research Program
Fiscal Years 2014-2015 (Years 24 and 25)
Research Project Number TPF-5(193) Supplement #64 and #79
NDOR Sponsoring Agency Code RFPF-14-CABLE-1 and RFPF-15-CABLE-1*

EVALUATION OF FLOORPAN TEARING AND CABLE SPLICES FOR CABLE BARRIER SYSTEMS

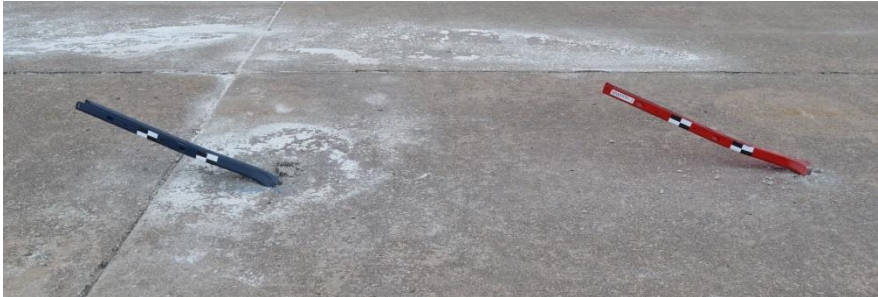
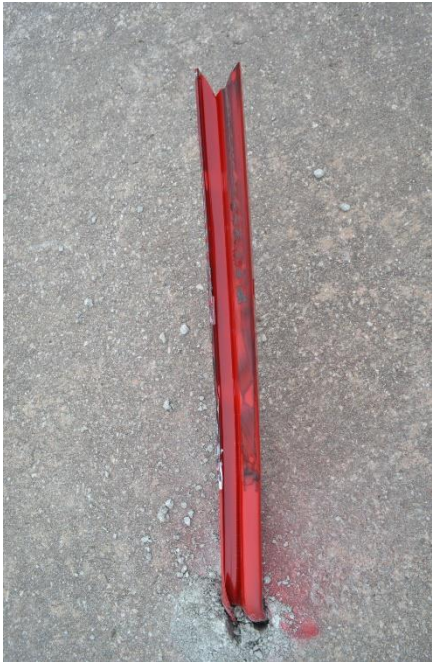
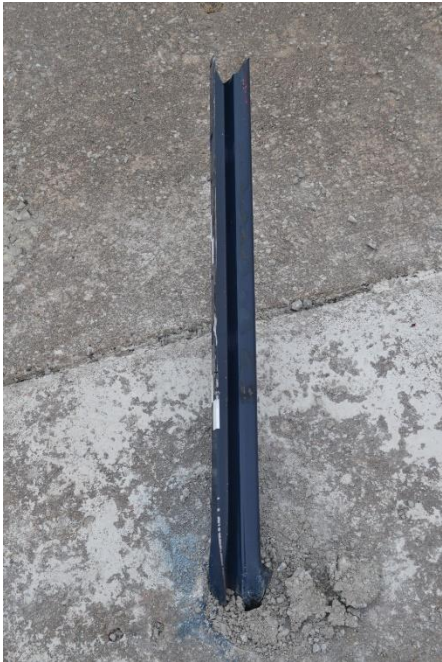
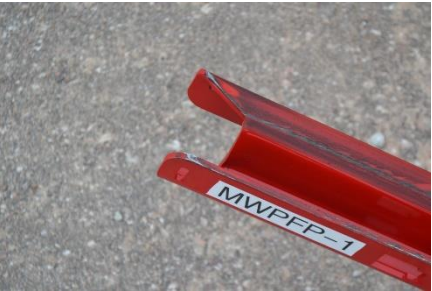
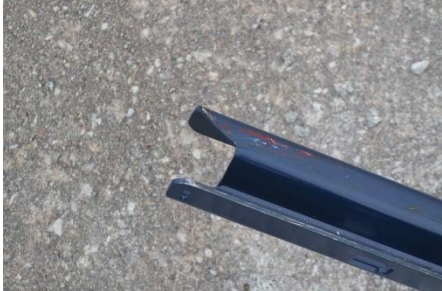
Figure 24. Time-Sequential and Post Damage Photographs, Test No. MWPFP-1

Unfortunately, the crossbeams located at the front and mid-span of the simulated floorpan had not been installed for test no. MWPF1-1. Thus, the front edge of the sheet steel was exposed to contact, and the posts snagged on the simulated floorpan. The simulated floorpan was torn from the front of the undercarriage frame, as shown in Figure 25. This result allowed a broader area of the simulated floorpan to deform and reduced the severity of the localized gouging and tearing. Therefore, modifications to the test setup were required to accurately replicate the floorpan of a Kia Rio. Subsequently, crossbeams were added to eliminate this problem for subsequent tests and to simulate undercarriage support members.

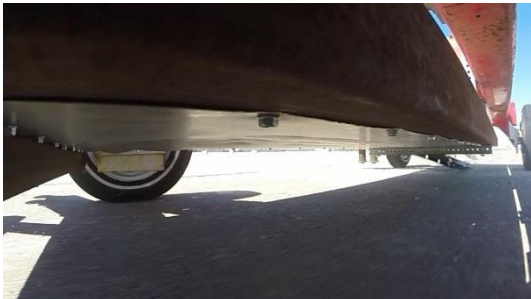
Figure 27. Time-Sequential Photographs Underneath Bogie, Test No. MWFPF-2

Test no. MWFPF-2 was conducted on MWPs installed in 8-in. (203-mm) diameter concrete sleeves with a 0-degree orientation angle, thus creating an impact about the post's weak-axis of bending. During the test, the bogie impacted the first post with a speed of 25.8 mph (41.5 km/h). Upon impact, a plastic hinge formed in the post near the groundline, and the post bent over until the bogie overrode it. As the crossbeams passed over the post, elastic restoration caused the top of the post to rebound upward and contact the simulated floorpan. The first post impacted the front and rear bays of the simulated floorpans 0.158 seconds and 0.298 seconds after impact, respectively. The bogie impacted the second post at 0.224 seconds and caused similar deformation and spring-back characteristics as observed in the first post. The second post impacted the front and rear bays of the simulated floorpans at 0.396 seconds and 0.540 seconds, respectively. The elastic spring-back of the posts and the contact with the simulated floorpan were captured via digital video taken underneath the bogie vehicle, as shown in Figure 27.

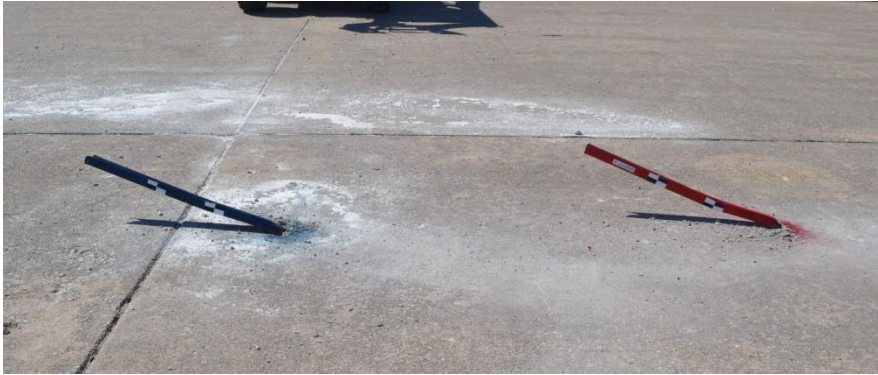
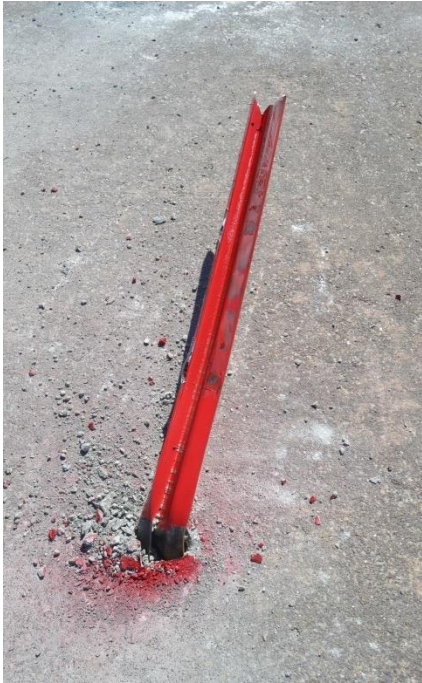
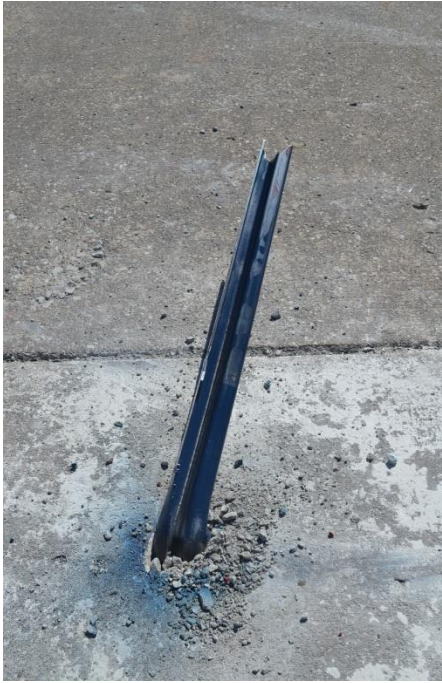
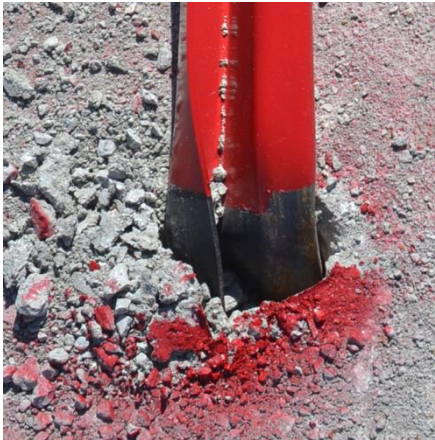
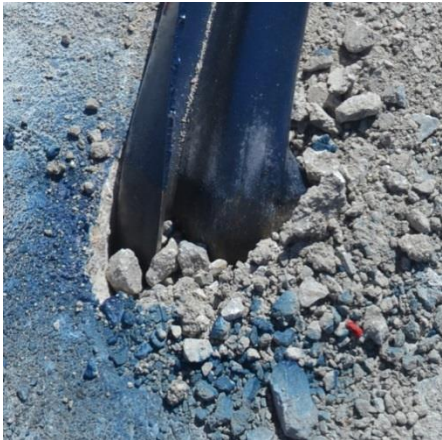
Figure 28. Time-Sequential and Post Damage Photographs, Test No. MWFPF-2

The posts were bent plastically near the groundline, and contact marks were found on the top half of the post along the free edge and impact side face of the post, as shown in Figure 28. Damage to the simulated floorpan included creasing and tearing due to contact from the top corners of both posts, as shown in Figure 29. Two tears were found in both the front and rear bays of the simulated floorpan. These tears corresponded to the location of initial contact between the free edges of the posts and the floorpan as the posts passed the crossbeams and rebounded upward. The largest tear was 5 in. (127 mm) long and had a maximum width of ½ in. (13 mm). Creases in the simulated floorpan were found extending from the tears toward the rear of the bogie. Approximately 3 in. (76 mm) to the right of the tears and creases caused by the free edges, additional creases caused by the continuous edges of the posts were present on the floorpan. All tears and creases observed on the simulated floorpan were measured and are summarized in Table 5.

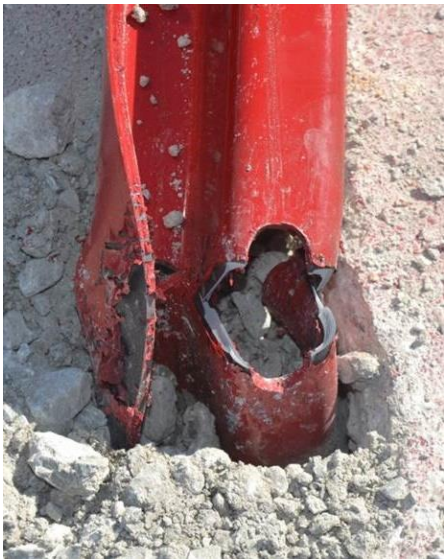
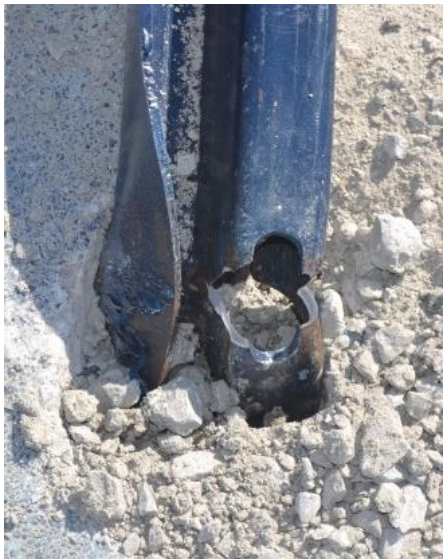
Figure 32. Time-Sequential and Post Damage Photographs, Test No. MWPPF-3

The posts were bent plastically near the groundline, and tearing was found in both posts, as shown in Figure 32. The tears initiated from the weakening holes on the impact side of the posts and extended into the webs and adjacent flanges. Contact marks were found on the top half of the post along the free edge and impact side face of the post. Damage to the simulated floorpan included scrapes and creases but no tearing. Four creases were found in both the front and rear bays of the simulated floorpan, as shown in Figure 33. The creases resulting from contact with the free edges of the posts extended nearly the entire length of the bogie vehicle, while the creases resulting from contact with the continuous edges of the posts were limited in length. All creases observed on the simulated floorpan were measured and are summarized in Table 6.

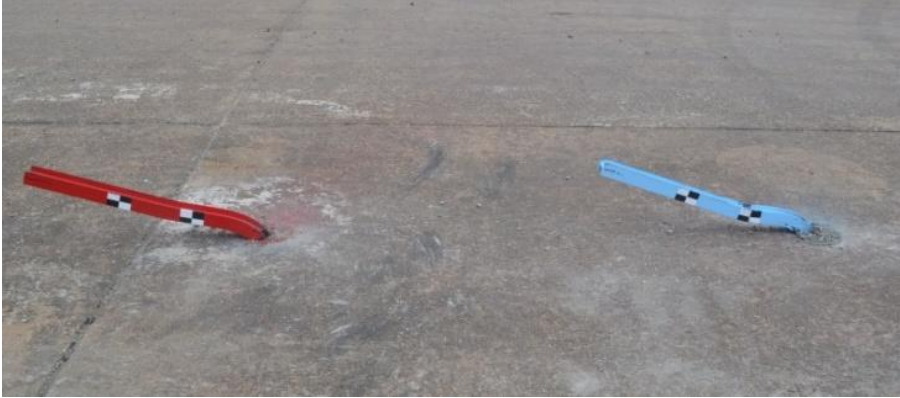
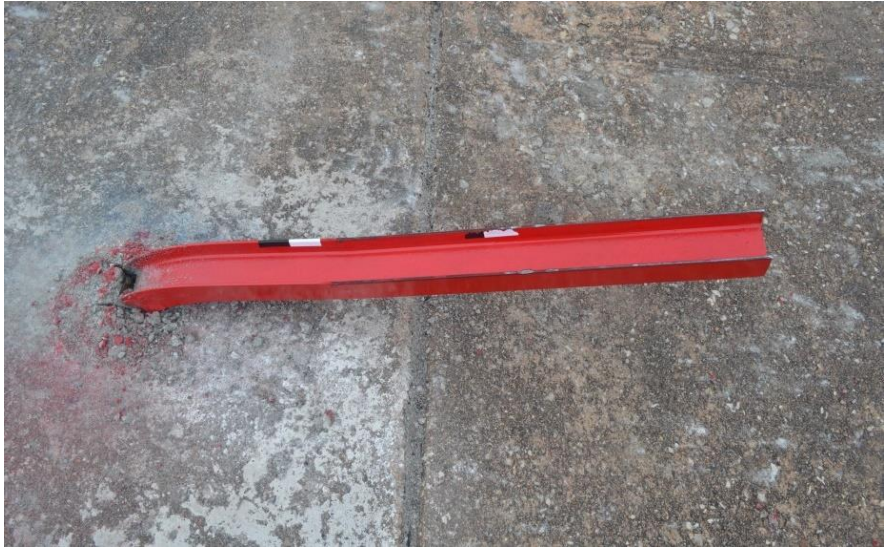
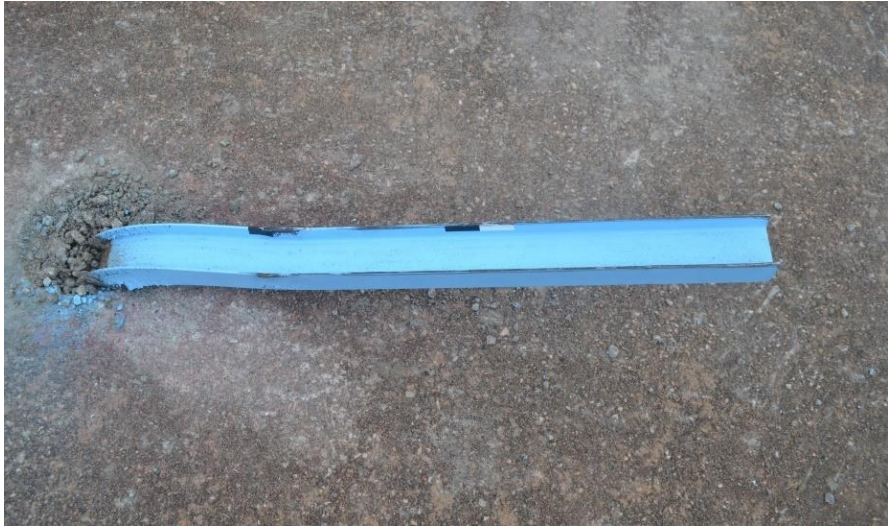
Figure 35. Time-Sequential and Post Damage Photographs, Test No. MWPPF-4

The posts were bent plastically near the groundline, and contact marks were present on both edges of the posts, as shown in Figure 35. Damage to the simulated floorpan included tearing and creasing due to contact with the top corners of both posts, as shown in Figure 36. Four tears were found in both the front and rear bays of the simulated floorpan. These tears corresponded to the location of initial contact between the free edges of the posts and the floorpan as the posts passed the crossbeams and rebounded upward. The largest tear was 6³/₄ in. (171 mm) long and had a maximum width of ⁵/₁₆ in. (8 mm). Creases in the simulated floorpan were found following all four tears and extending toward the rear of the bogie. All of the tears and creases observed on the simulated floorpan were measured and summarized in Table 7.

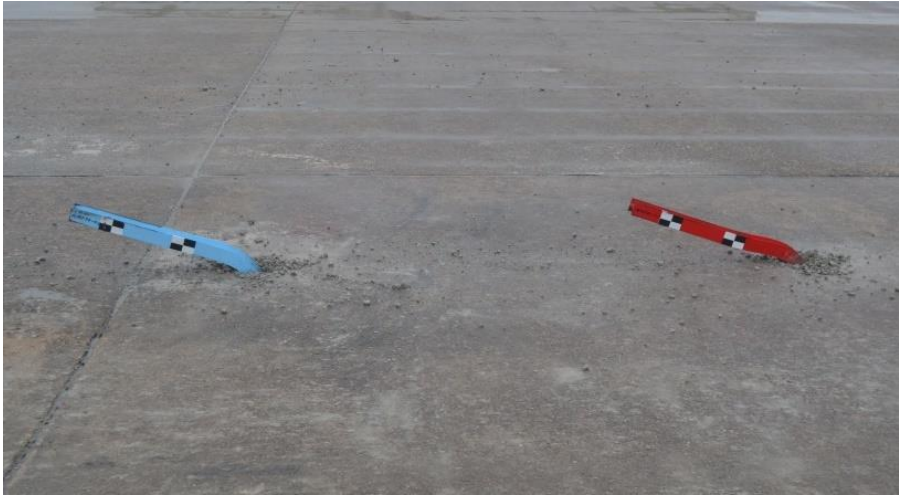
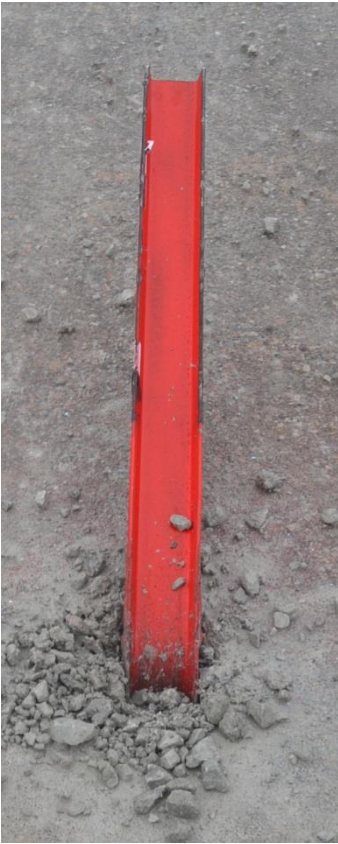
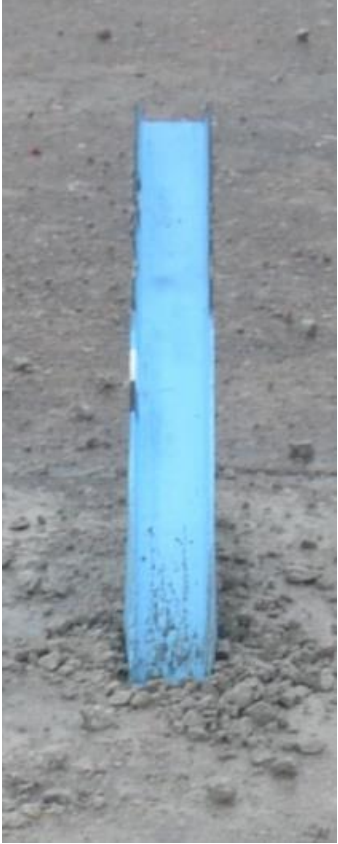
Figure 38. Time-Sequential and Post Damage Photographs, Test No. MWFPF-5

The posts were bent plastically near the groundline, and contact marks were present on both edges of the posts, as shown in Figure 38. Damage to the simulated floorpan included tearing and creasing due to contact with the top corners of both posts, as shown in Figure 39. Four tears were found in both the front and rear bays of the simulated floorpan corresponding to the location of initial contact between the posts and the floorpan as the posts passed the crossbeams and rebounded upward. The largest of these initial tears was 6½ in. (165 mm) long and had a maximum width of ¼ in. (6 mm). Continued contact with one of the posts resulted in two additional tears in the front bay measuring 16 in. (406 mm) and 13 in. (330 mm) in length. The shorter height of the posts appeared to cause higher restoration forces, which led to these additional tears. Creases were also found in the simulated floorpan extending from the initial tears toward the rear of the bogie. All of the tears and creases observed on the simulated floorpan were measured and are summarized in Table 8.

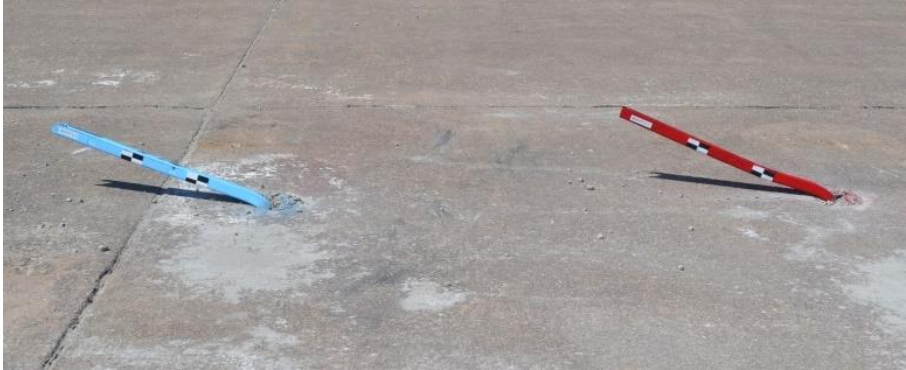
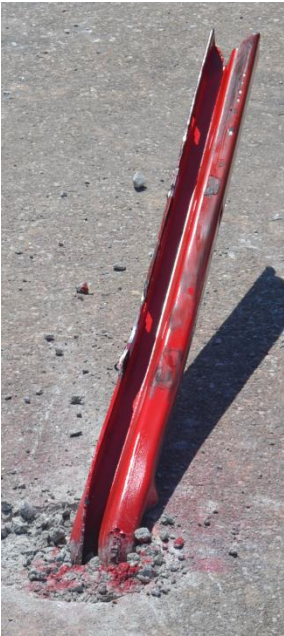
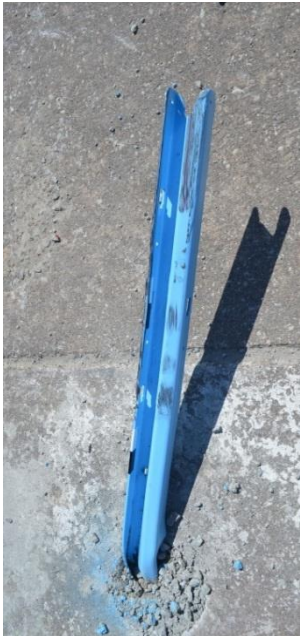
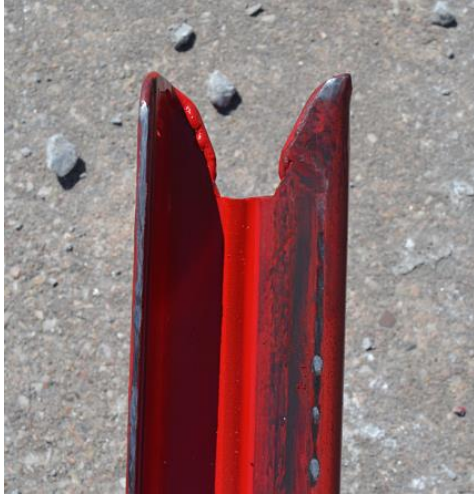
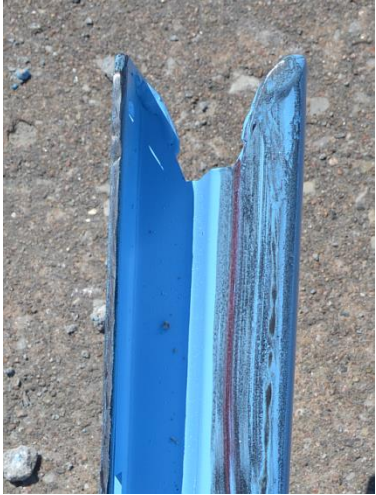
Figure 42. Time-Sequential and Post Damage Photographs, Test No. MWPPF-6

The posts were bent plastically near the groundline, and contact marks were found on the top half of the post along the free edge and impact side face of the post, as shown in Figure 42. Damage to the simulated floorpan included creasing and tearing due to contact from the top corners of both posts, as shown in Figure 43. Two tears were found in both the front and rear bays of the simulated floorpan. These tears corresponded to the location of initial contact between the free edges of the posts and the floorpan as the posts passed the crossbeams and rebounded upward. The largest tear was 12¾ in. (324 mm) long and had a maximum width of ½ in. (13 mm). Creases in the simulated floorpan were found extending from the tears toward the rear of the bogie. Additional creases caused by the continuous edges of the posts were present in the floorpan, approximately 3 in. (76 mm) to the right of the tears and creases caused by the free edges of the post. All tears and creases observed on the simulated floorpan were measured and are summarized in Table 9.

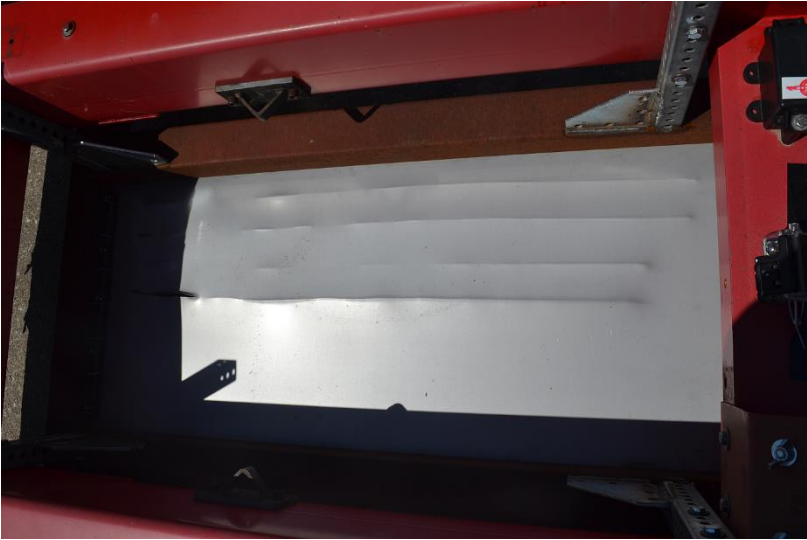
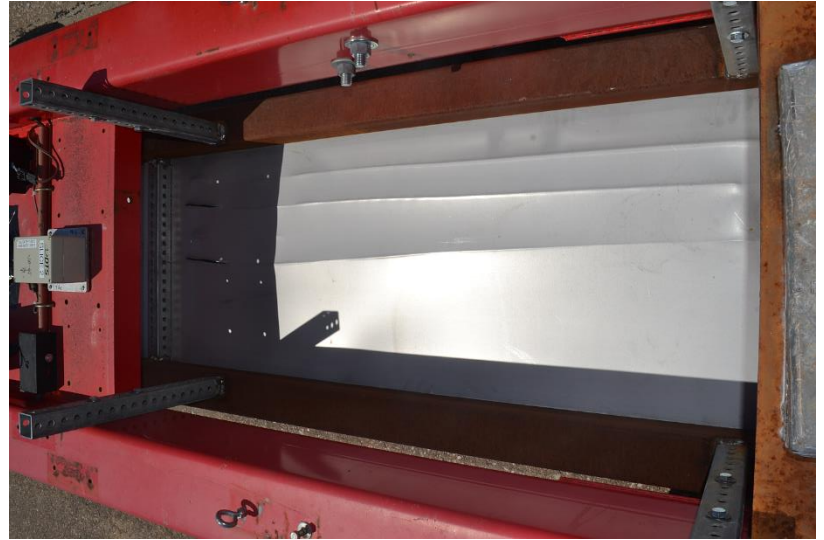
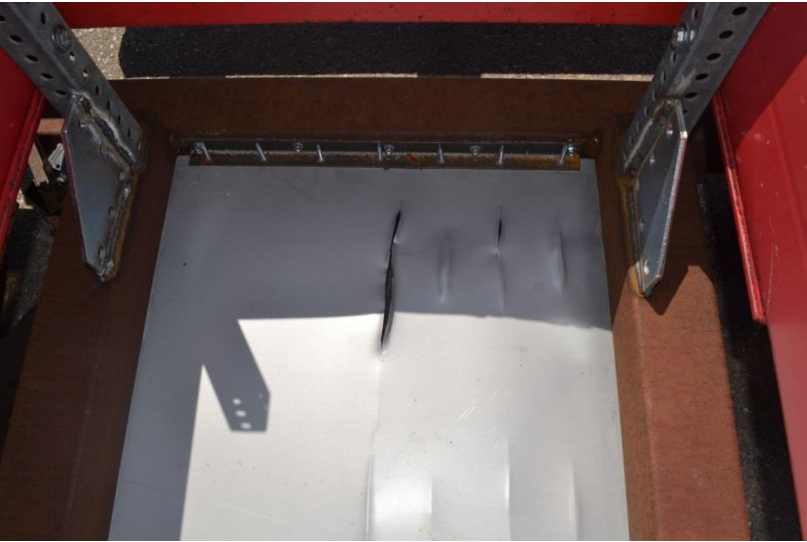
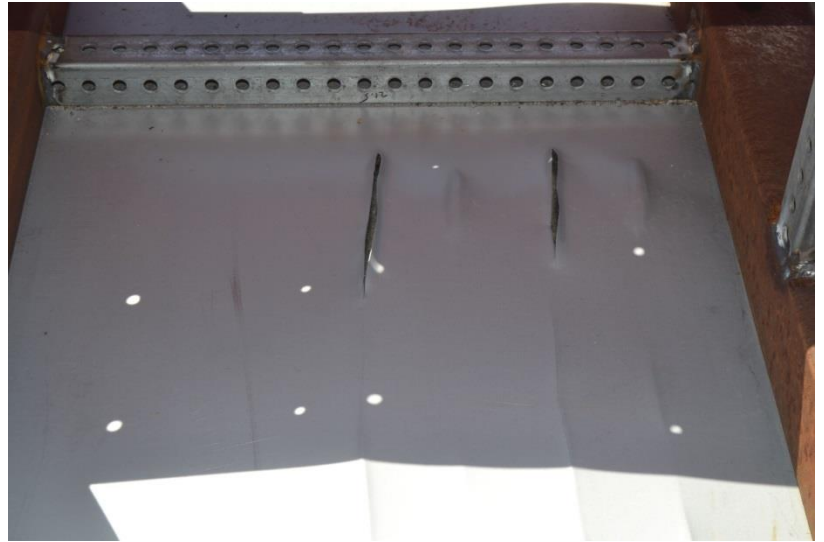
Figure 43. Simulated Floorpan Damage, Test No. MWPF6-6

MWFPF-6 Floorpan Damage					
Location	Description	1st Post		2nd Post	
		Free Edge in. (mm)	Continuous Edge in. (mm)	Free Edge in. (mm)	Continuous Edge in. (mm)
Front Bay	Tear Length	12¾ (324)	-	2 (51)	-
	Max. Tear Width	½ (13)	-	¼ (6)	-
	Crease Length	40½ (1,029)	34 (864)	40 (1,016)	44 (1,118)
Rear Bay	Tear Length	7 (178)	-	5 (127)	-
	Max. Tear Width	½ (13)	-	¼ (6)	-
	Crease Length	52 (1,321)	4 (102)	56 (1,422)	58½ (1,486)

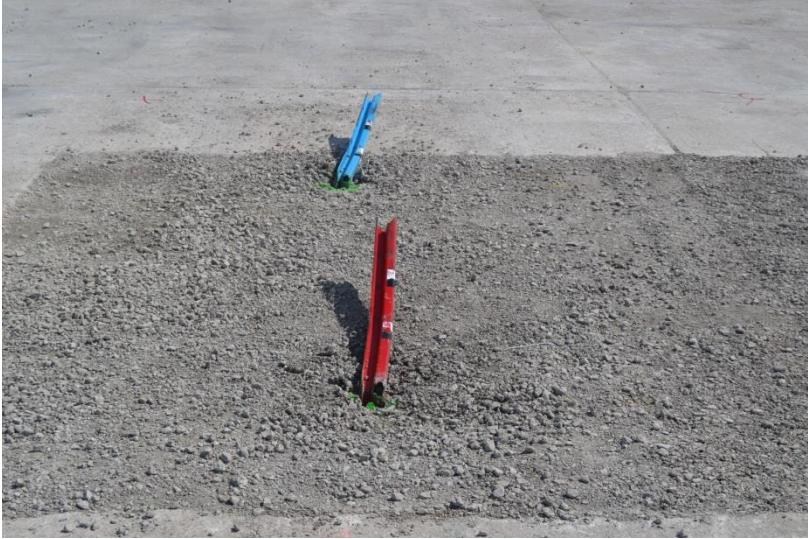
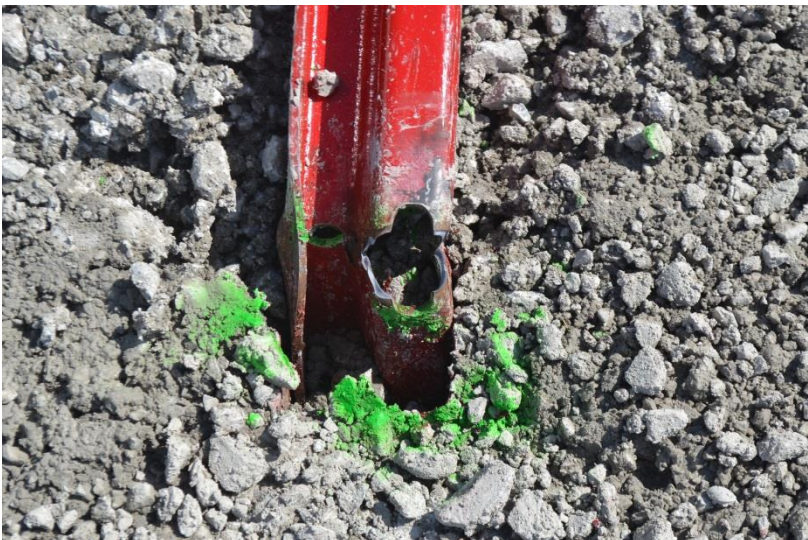
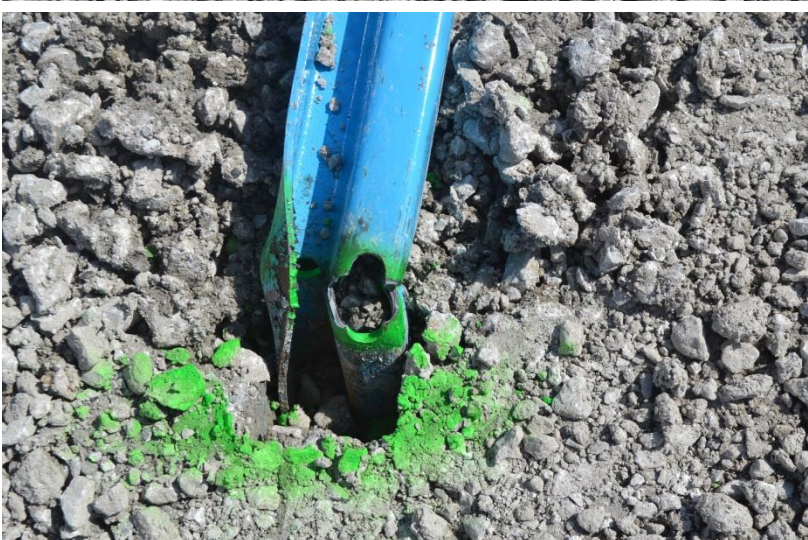
Figure 45. Time-Sequential and Post Damage Photographs, Test No. MWFPF-7

The posts were bent plastically near the groundline, and tearing was present in both posts, as shown in Figure 45. The tears initiated from the weakening holes on the impact side of the posts and extended into the webs and adjacent flanges. The posts displaced approximately 1 in. (25 mm) through the soil at the groundline. Contact marks were found on the top half of the post along the free edge and impact side face of the post. Damage to the simulated floorpan included scrapes and creases, but no tearing. Four creases were found in both the front and rear bays of the simulated floorpan, as shown in Figure 46. The two creases in each bay resulted from contact with the free edges of the posts and extended nearly the entire length of the bogie vehicle. The creases resulting from contact with the continuous edges of the posts were limited to less than 6 in. (152 mm). All creases observed on the simulated floorpan were measured and summarized in Table 10.

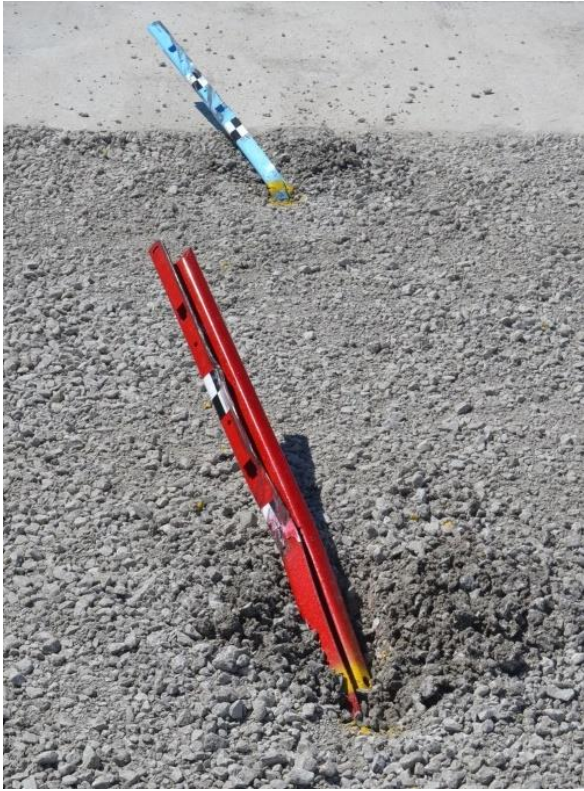
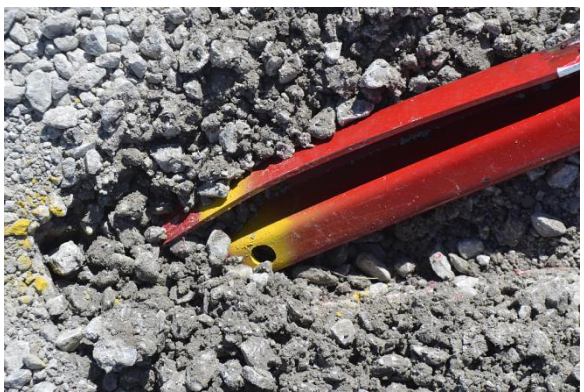
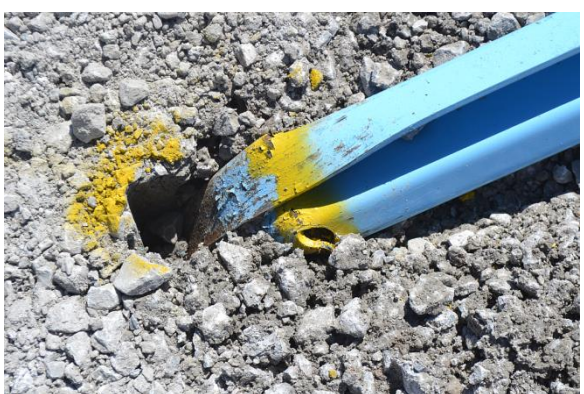
Figure 48. Time-Sequential and Post Damage Photographs, Test No. MWPPF-8

The posts were bent plastically near groundline, and contact marks were found along the top half of the post, as shown in Figure 48. No tearing was observed in the post around the weakening holes. The posts displaced 2 to 3 in. (51 to 76 mm) through the soil at the groundline. Damage to the simulated floorpan included tears and creases, as shown in Figure 49. Tears were found in the front and rear bays corresponding to contact from the free edge of the first post. Each bay had an initial tear near the crossbeam, the largest of which was 10¾ in. (273 mm) long with a maximum opening width of ⅝ in. (16 mm). Creasing followed these tears and eventually led to secondary tears measuring 25 in. (635 mm) and 18½ in. (470 mm). The free edge of the second post left a prominent crease along the front bay of the simulated floorpan and a short crease on the rear bay before sliding to the side of the bogie and losing contact with the floorpan. Due to the orientation angle of the post, the continuous edges left only minor creases in the floorpan. All tears and creases observed on the simulated floorpan were measured and are summarized in Table 11.

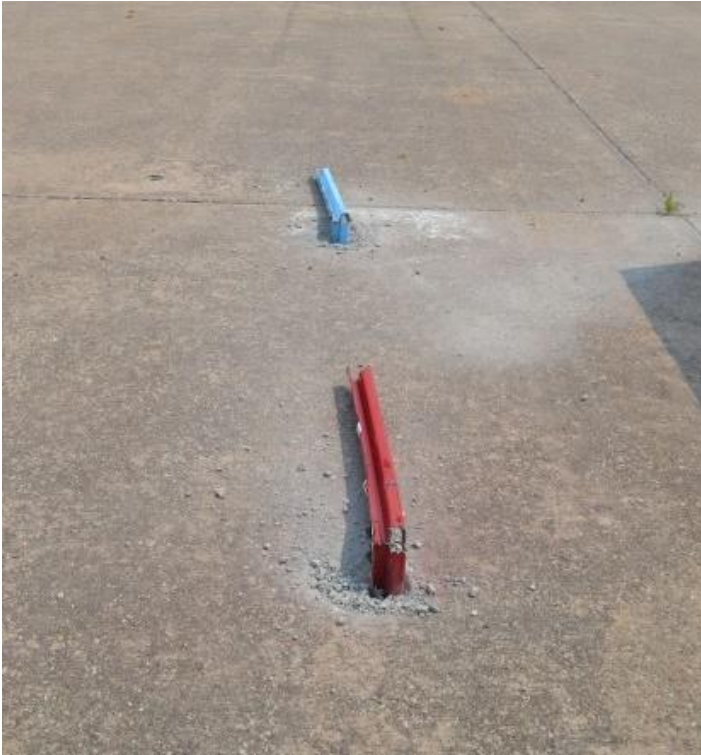
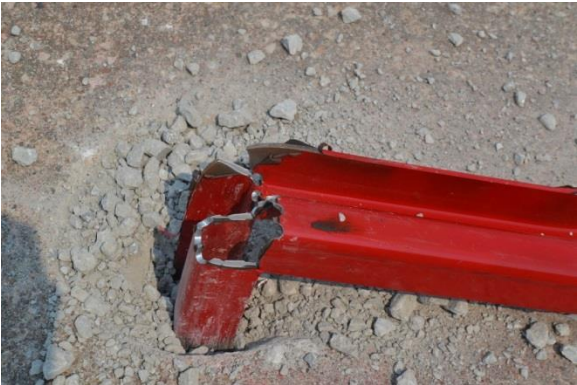
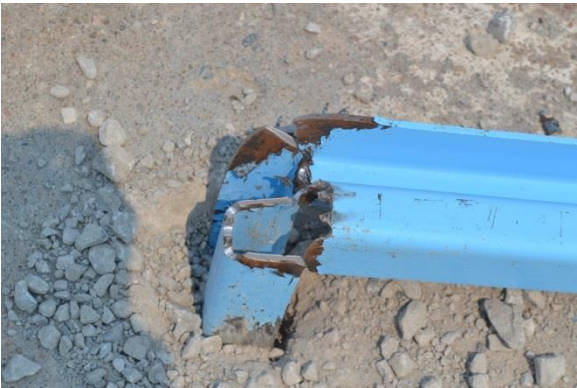
Figure 52. Time-Sequential and Post Damage Photographs, Test No. MWPPF-11

The posts were completely bent over, and tearing was present in both posts, as shown in Figure 52. The tears initiated from the weakening holes on the impact side of the posts and extended into the webs and adjacent flanges. Additional tears occurred in the free edges of the posts leaving only the backside face of the posts to hold the posts together. After the tears formed in the posts, the angular momentum of the top of the posts rotated backward and then impacted the ground causing the bottom of the posts to pull out of the ground vertically a few inches. The simulated floorpan was undamaged as the posts never contacted the undercarriage of the bogie vehicle.

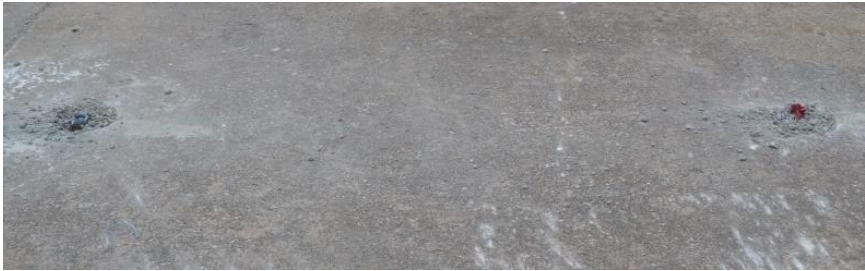
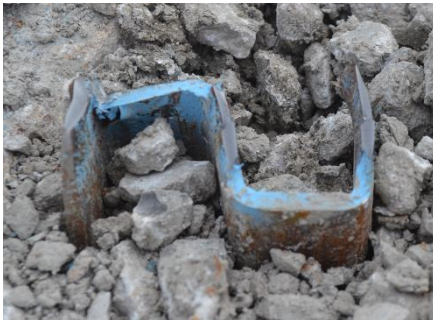
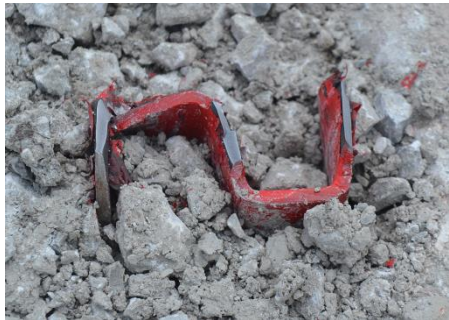
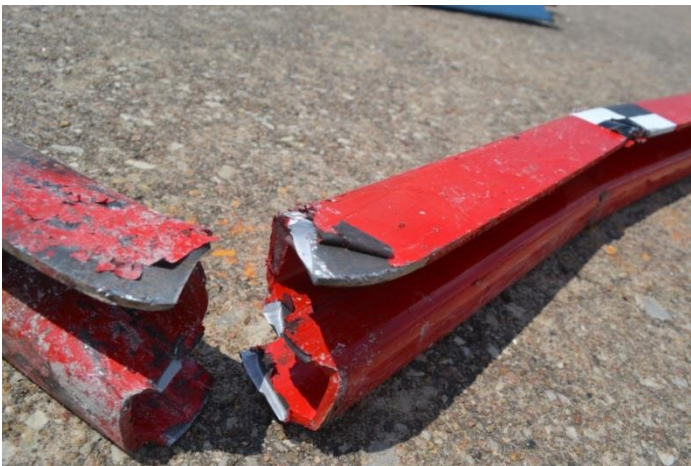
Figure 55. Time-Sequential and Post Damage Photographs, Test No. MWPPF-12

Both posts had ruptured at the groundline, as shown in Figure 55. Tearing was initiated around the weakening slots on the impact side of the posts and continued through the entire cross section. The simulated floorpan was undamaged as the posts never contacted the undercarriage of the bogie vehicle.

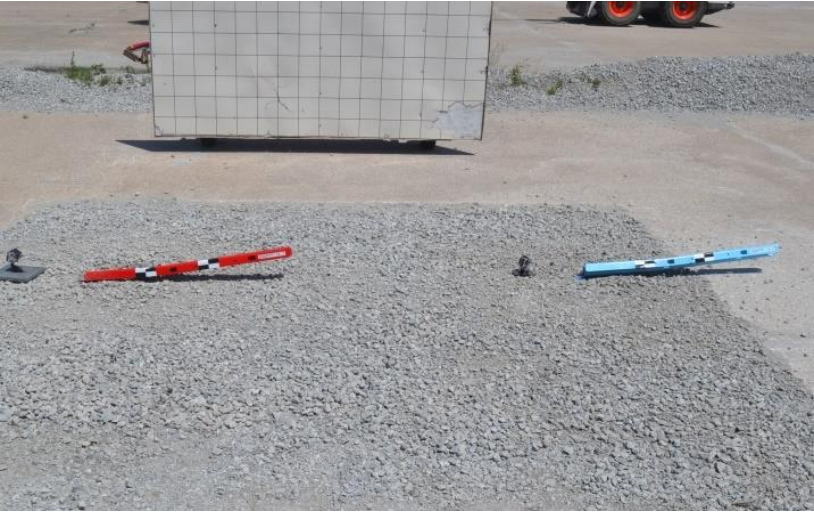
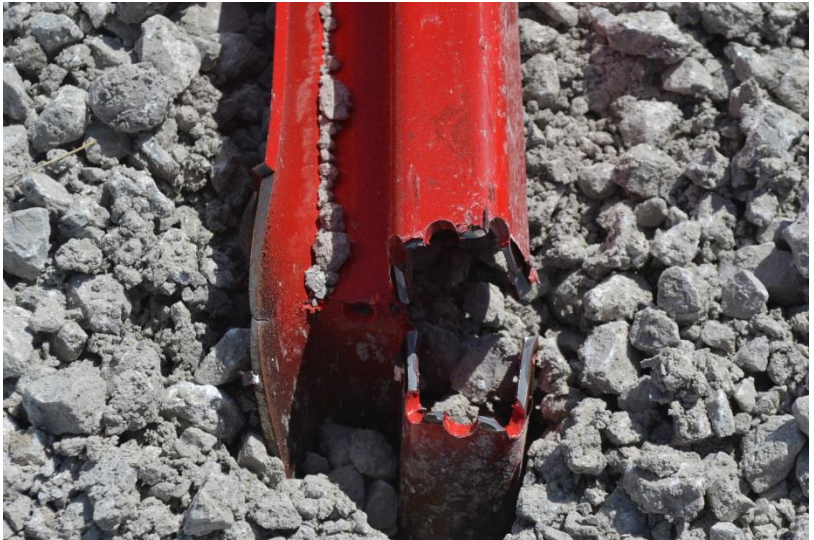
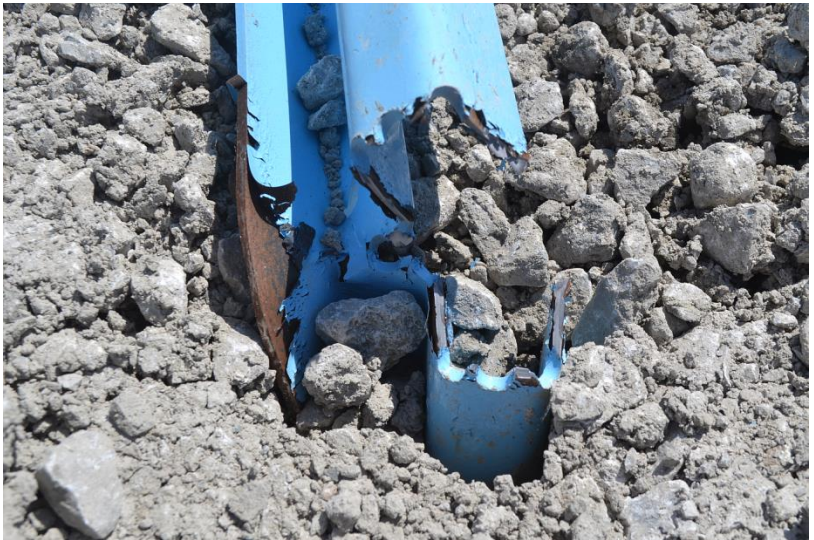
Figure 62. Time-Sequential and Post Damage Photographs, Test No. MWFPF-14

The posts were completely bent over, and tearing was present in both posts, as shown in Figure 62. The tears initiated from the weakening holes on the impact side of the posts and extended through the adjacent flanges and the webs. Only the opposite-side flanges and the backside faces of the posts were still intact and held the posts together. The posts displaced approximately 1½ in. (38 mm) through the soil at the groundline. The simulated floorpan was undamaged as the posts never contacted the undercarriage of the bogie vehicle.

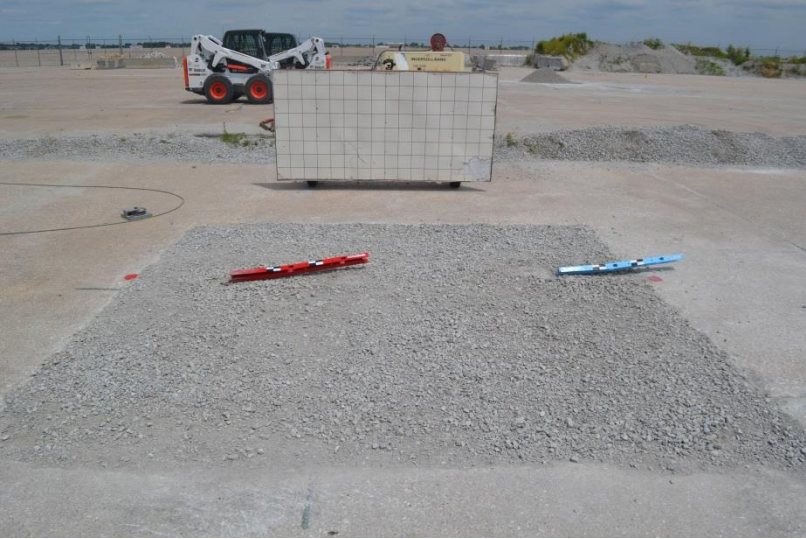
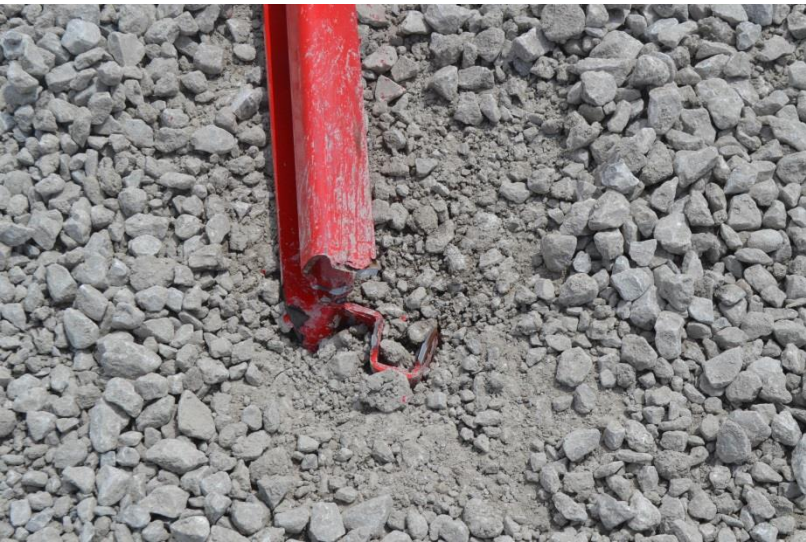
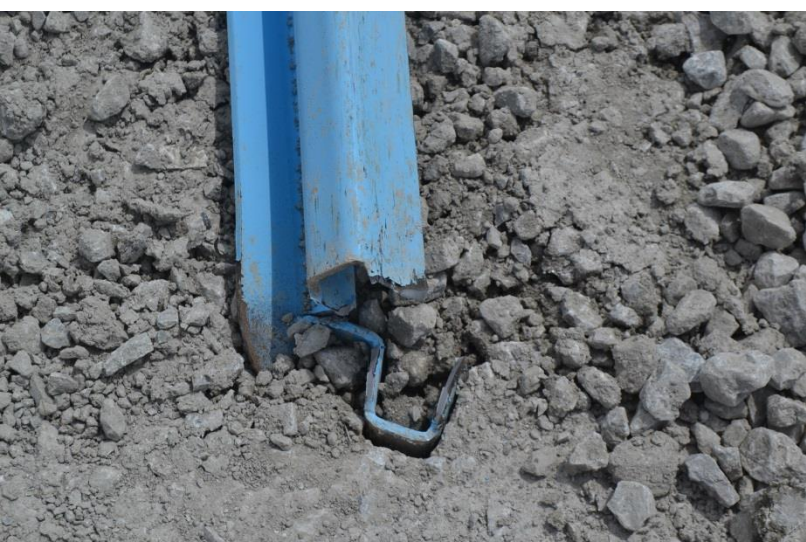
Figure 64. Time-Sequential and Post Damage Photographs, Test No. MWFPF-15

The posts were completely bent over, and tearing was present in both posts, as shown in Figure 64. The tears initiated from the weakening slots on the impact side of the posts and extended through the adjacent flanges and the webs. Only the opposite-side flanges of the posts were still intact and held the posts together. The posts displaced approximately $\frac{1}{2}$ in. (13 mm) through the soil at groundline. The simulated floorpan was undamaged as the posts never contacted the undercarriage of the bogie vehicle.

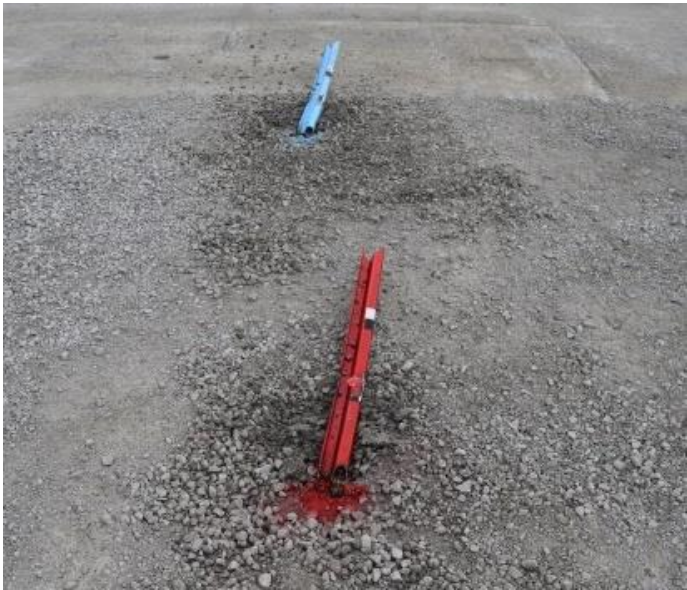
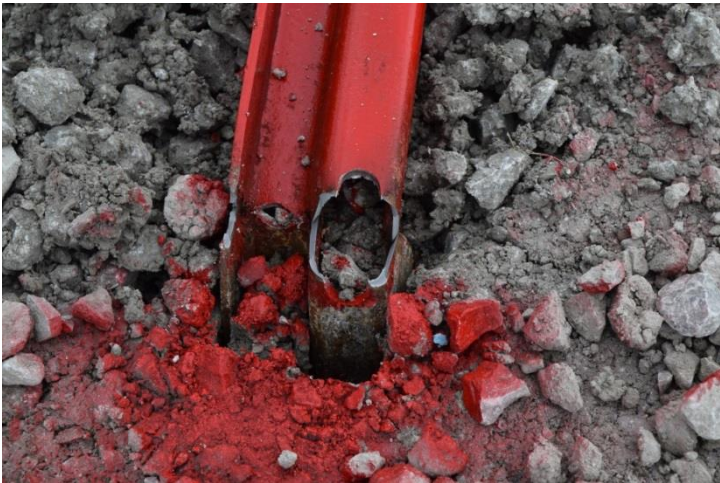
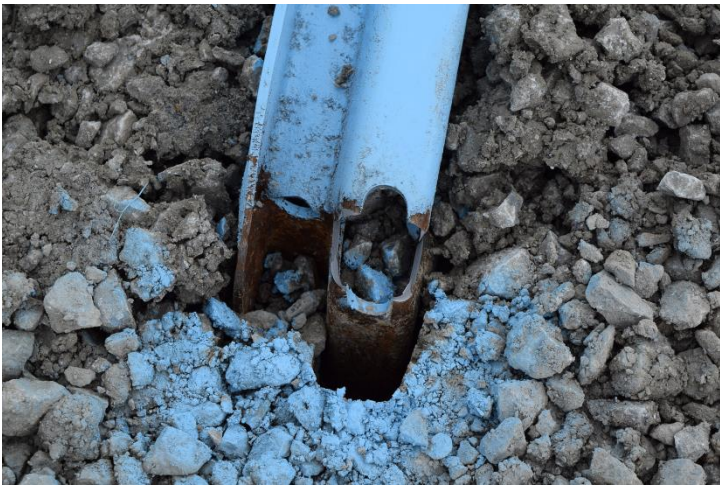
Figure 66. Time-Sequential and Post Damage Photographs, Test No. MWFPF-18

The posts were bent plastically near the groundline, and tearing was present in both posts, as shown in Figure 66. The tears initiated from the weakening holes on the impact side of the posts and extended into the webs and adjacent flanges. Additional tearing was found on the opposite side flange of the first post. The posts displaced approximately 1 1/2 in. (38 mm) through the soil at the groundline. Damage to the simulated floorpan included scrapes and creases, but no tearing. Two creases were found in both the front and rear bays of the simulated floorpan, as shown in Figure 67. Only one of the creases extended past the region of initial contact. All creases observed on the simulated floorpan were measured and are summarized in Table 13.

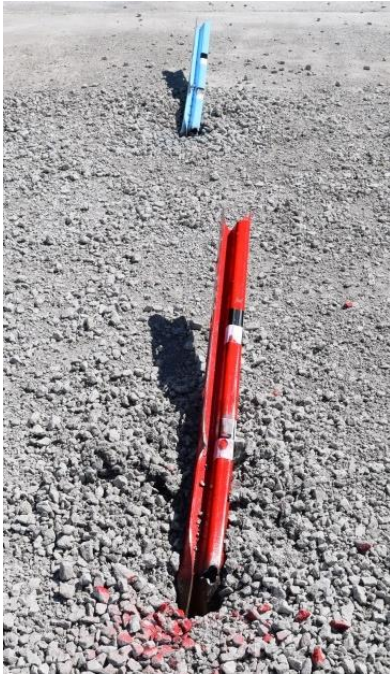
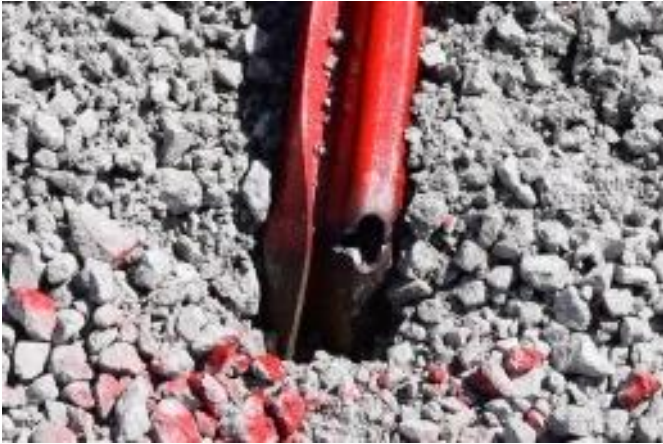
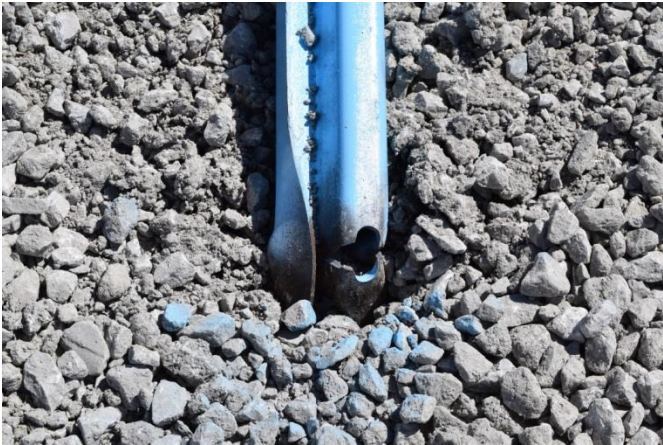
Figure 69. Time-Sequential and Post Damage Photographs, Test No. MWFPF-21

The posts were bent plastically near the groundline, and tearing was present in both posts, as shown in Figure 69. The tears initiated from the weakening holes on the impact side of the posts and extended into the webs and adjacent flanges. The posts displaced approximately 1½ in. (38 mm) through the soil at the groundline. Damage to the simulated floorpan included scrapes and creases, but no tearing. Three creases were found in both the front and rear bays of the simulated floorpan, as shown in Figure 70. Creases resulting from contact with free edges extended along the length of the simulated floorpan. Creases formed from contact with continuous edges were limited to only the area of initial contact. All creases observed on the simulated floorpan were measured and are summarized in Table 14.

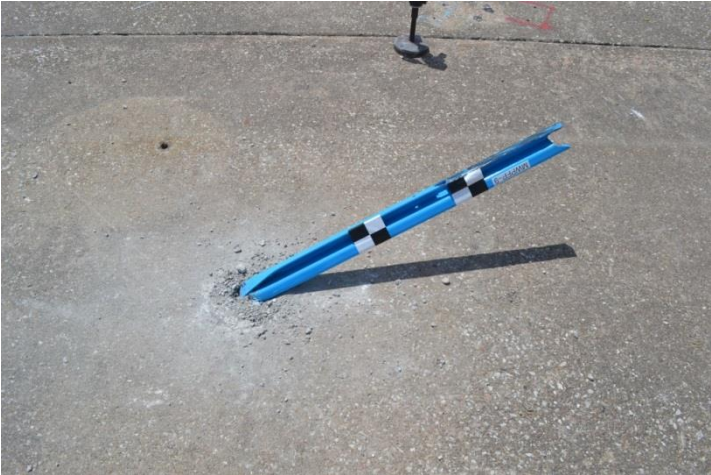
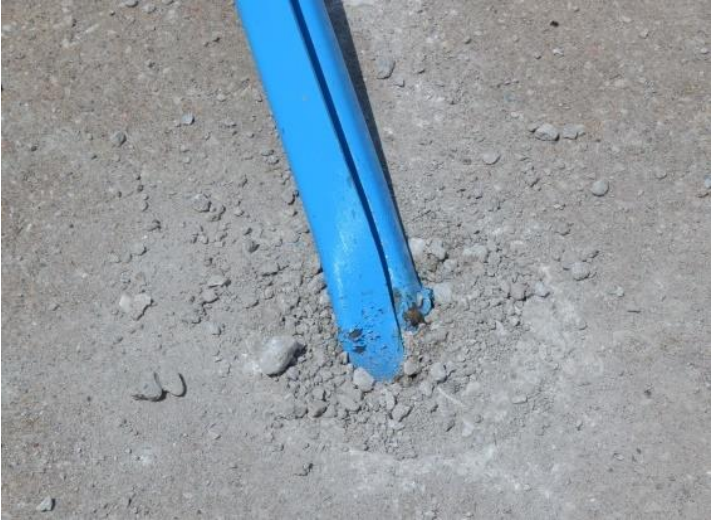
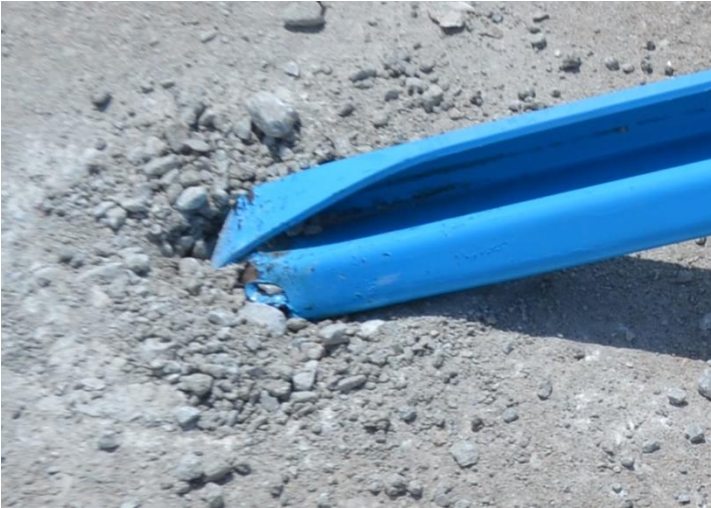
Figure 80. Time-Sequential and Post-Impact Photographs, Test No. MWFPF-9

Sequential and post damage photographs are shown in Figure 80. Contact marks were present along the top portion of the impact-side flange. A plastic hinge was observed around the weakening holes near groundline, and the post flanges collapsed inward toward the web. The weakening holes were deformed, but the post did not tear.
