Evaluation of Floorpan Tearing and Cable Splices for Cable Barrier Systems

*Midwest States Pooled Fund Research Program
Fiscal Years 2014-2015 (Years 24 and 25)
Research Project Number TPF-5(193) Supplement #64 and #79
NDOR Sponsoring Agency Code RFPF-14-CABLE-1 and RFPF-15-CABLE-1*

EVALUATION OF FLOORPAN TEARING AND CABLE SPLICES FOR CABLE BARRIER SYSTEMS

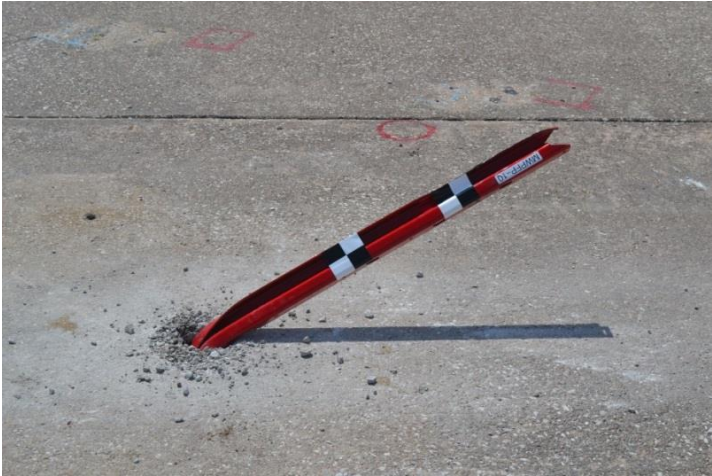
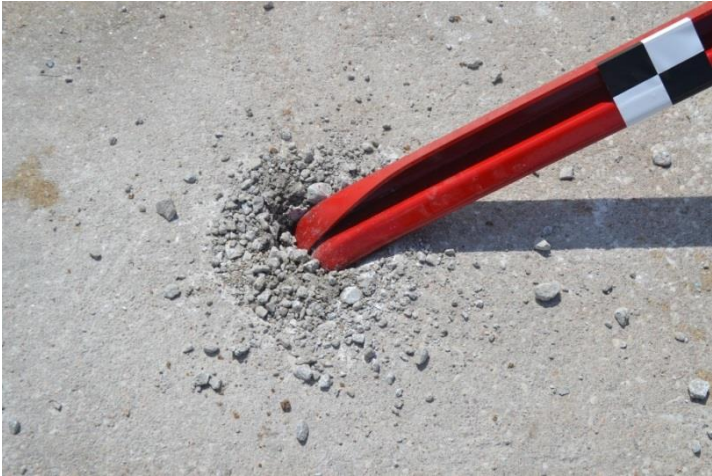
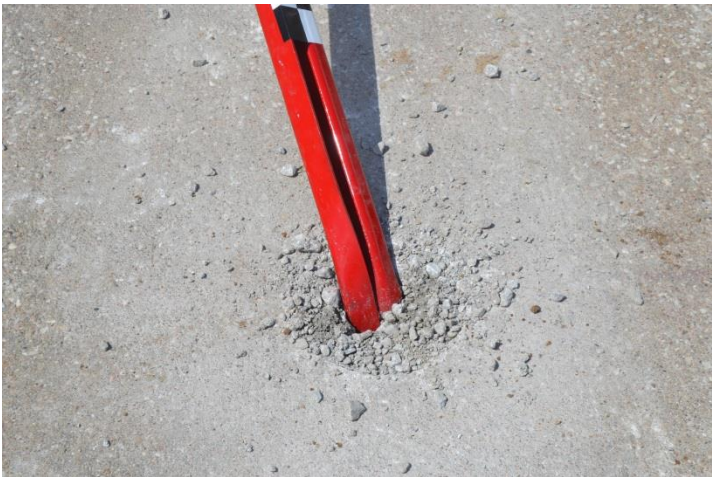
Figure 82. Time-Sequential and Post-Impact Photographs, Test No. MWPF-10

Sequential and post damage photographs are shown in Figure 82. Contact marks were present along the top portion of the impact-side flange. A plastic hinge had formed in the post near the groundline, and the post flanges collapsed inward toward the web, but the post did not tear.

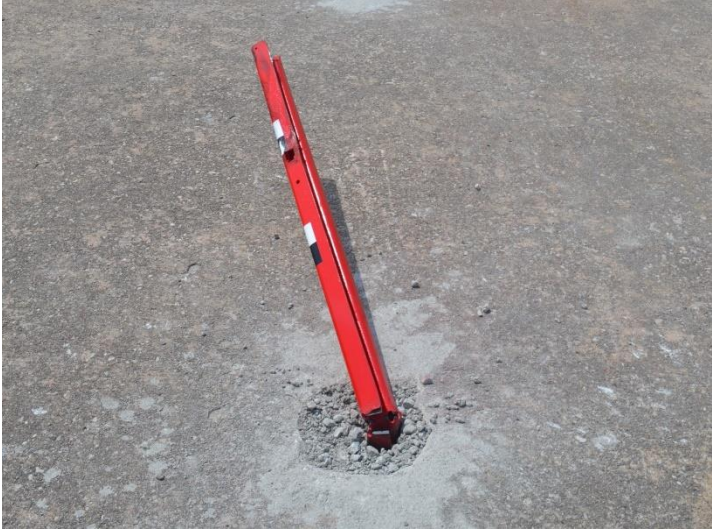
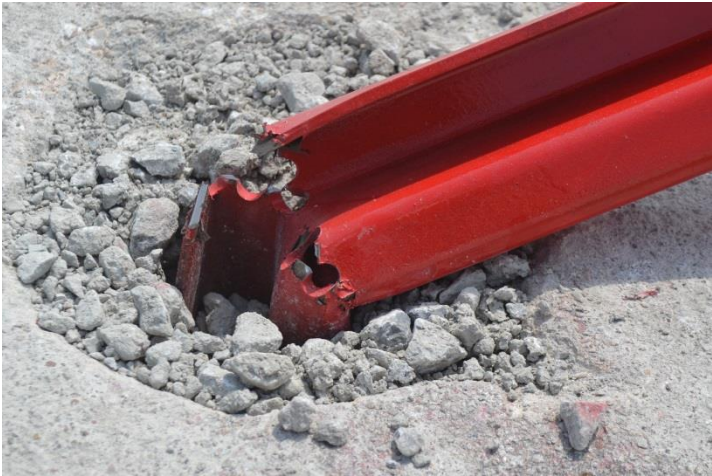
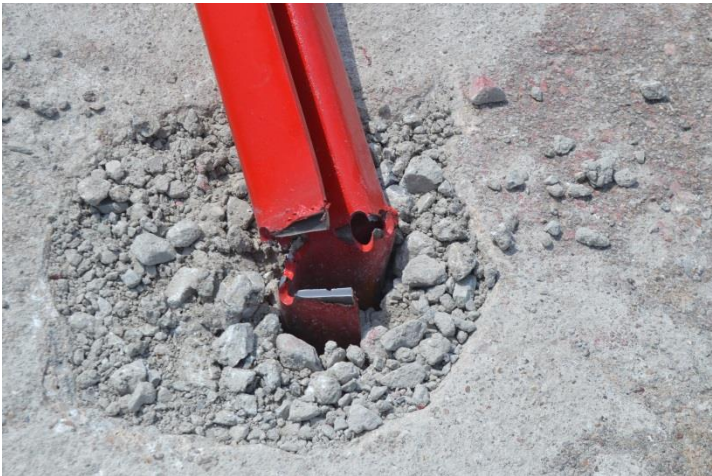
Figure 84. Time-Sequential and Post-Impact Photographs, Test No. MWPF-16 Post 1

Sequential and post damage photographs are shown in Figure 84. Contact marks were present along the top portion of the impact-side flange. The post was bent and tore near the groundline. The front flange was completely torn, and the tear extended through the adjacent weakening holes. A second tear occurred between the weakening holes on the backside of the post.

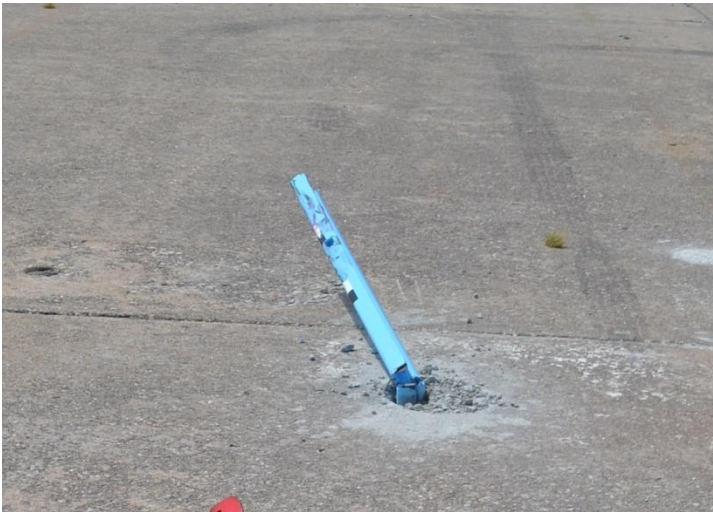
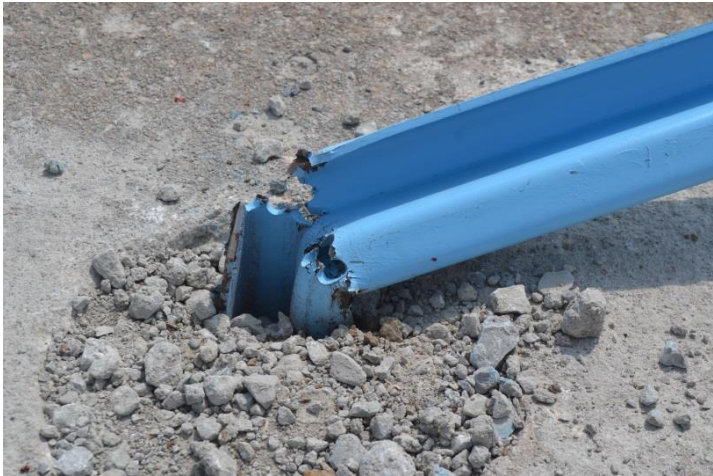
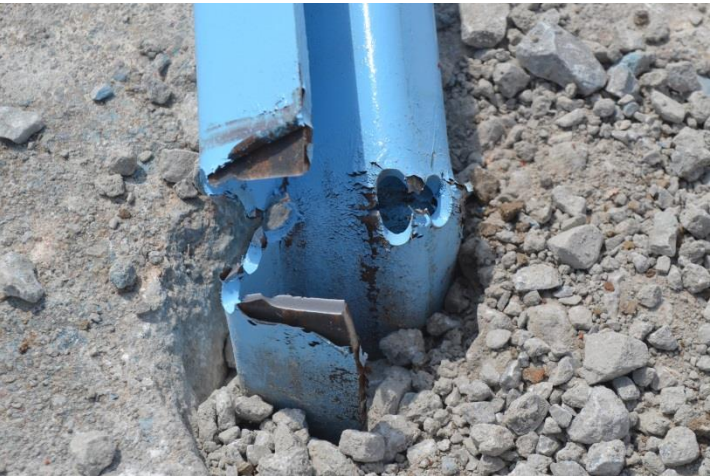
Figure 86. Time-Sequential and Post-Impact Photographs, Test No. MWPPF-16 Post 2

Sequential and post damage photographs are shown in Figure 86. Contact marks were present along the top portion of the impact-side flange. The post was bent and tore near the groundline. The front flange was completely torn, and the tear extended through the adjacent weakening holes. A second tear occurred between the weakening holes on the backside of the post.

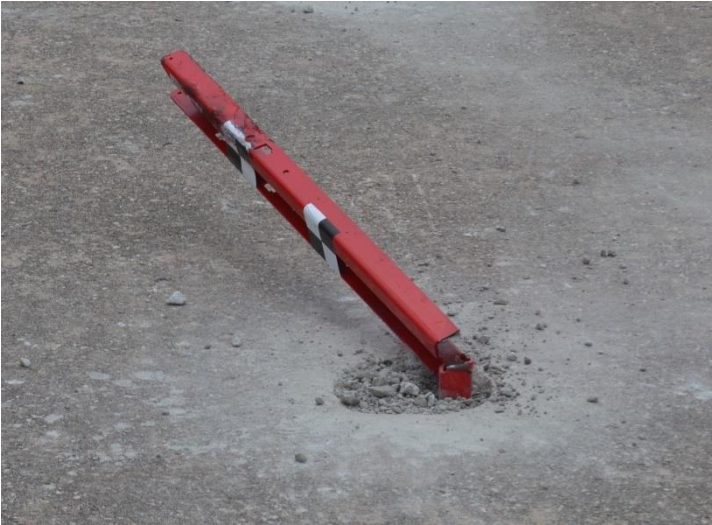
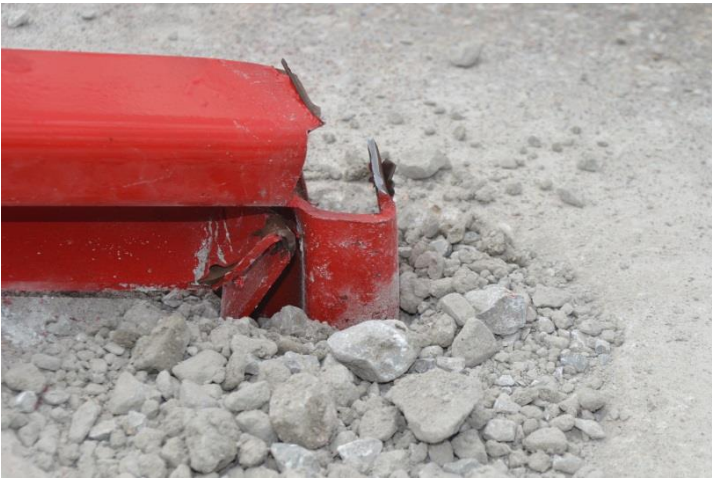
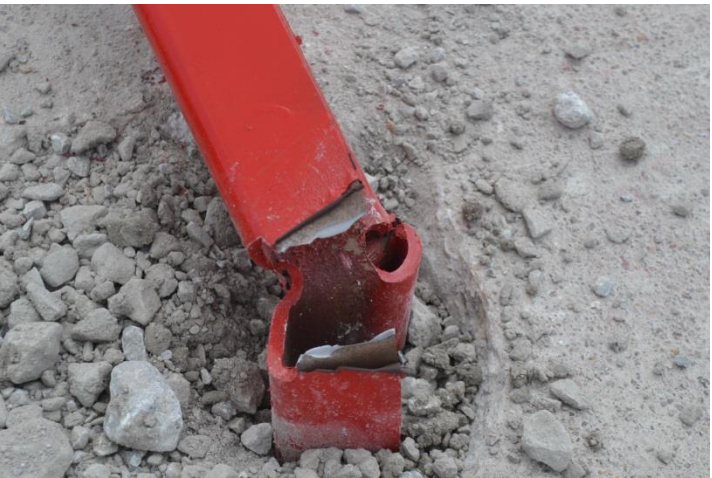
Figure 88. Time-Sequential and Post-Impact Photographs, Test No. MWFPF-17 Post 1

Sequential and post damage photographs are shown in Figure 88. Contact marks were present along the top portion of the impact-side flange. The post was bent near the groundline, and the front flange tore completely adjacent to the slot. The back flange buckled inward at the location of the plastic hinge. The slot adjacent to the back flange was deformed, but no additional tearing was observed.

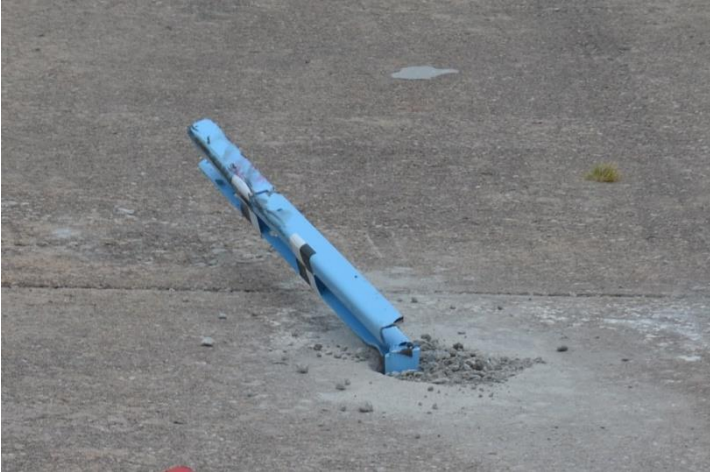
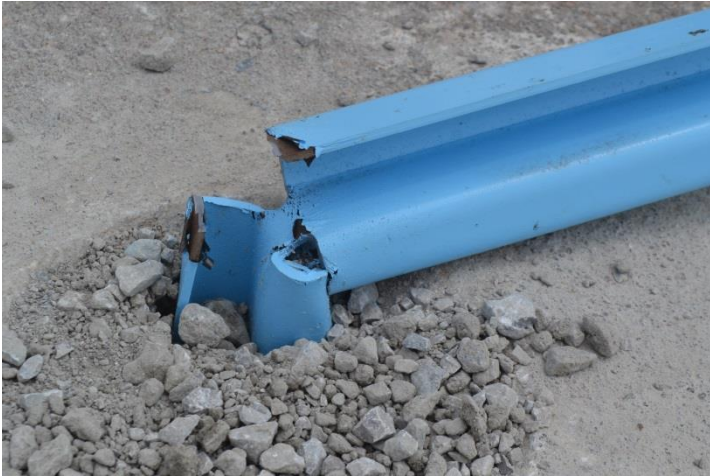
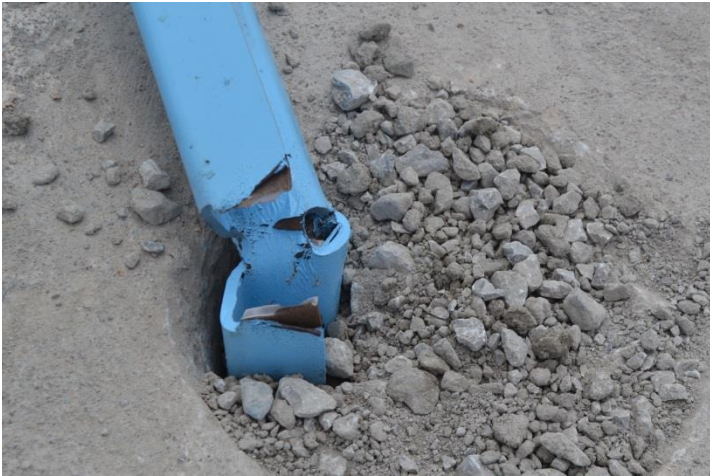
Figure 90. Time-Sequential and Post-Impact Photographs, Test No. MWFPF-17 Post 2

Sequential and post damage photographs are shown in Figure 90. Contact marks were present along the top portion of the impact-side flange. The post was bent near the groundline, and the front flange tore completely adjacent to the slot. The back flange buckled inward at the location of the plastic hinge. The slot adjacent to the back flange was deformed, but no additional tearing was observed.

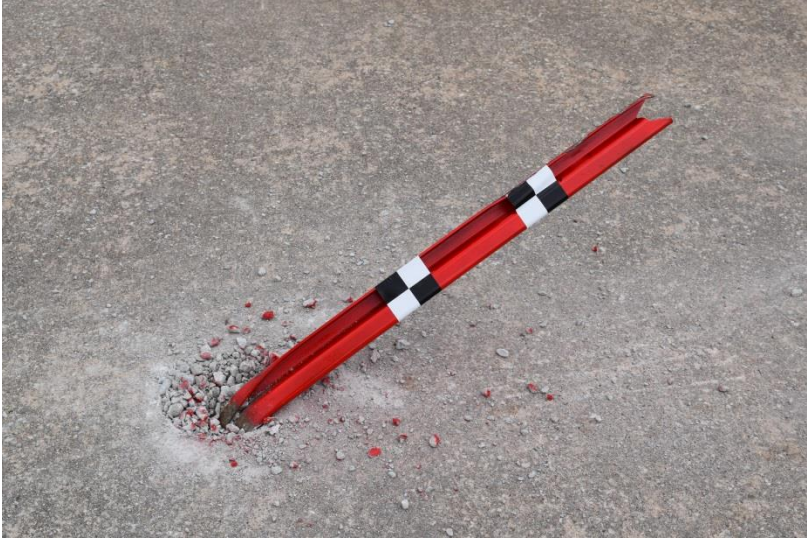
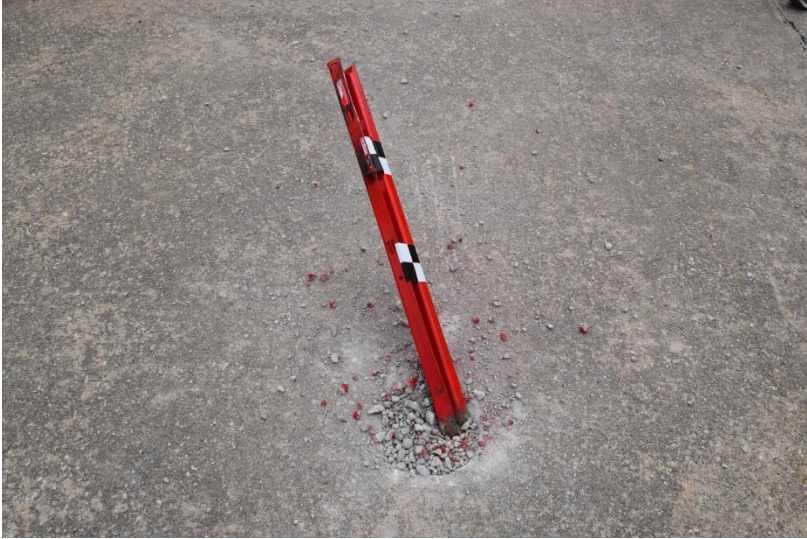
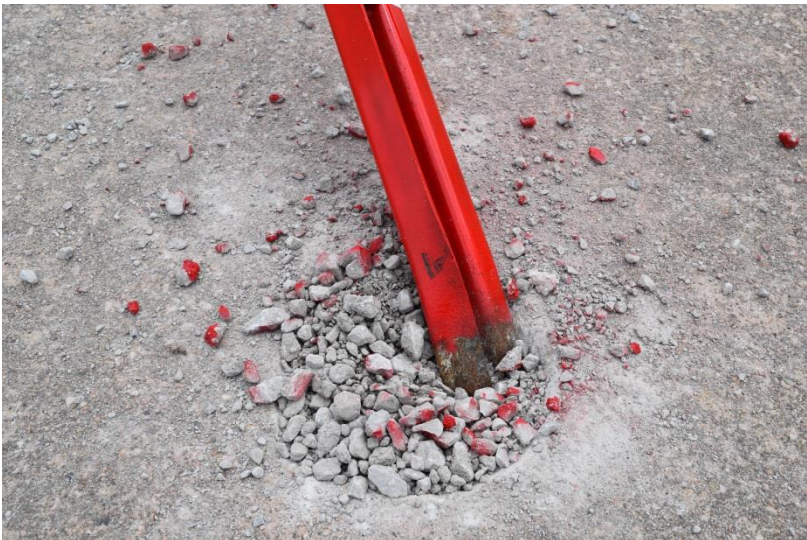
Figure 92. Time-Sequential and Post-Impact Photographs, Test No. MWFPF-19

Sequential and post damage photographs are shown in Figure 92. Contact marks were present along the top portion of the impact-side flange. A plastic hinge had formed in the post near the groundline, and the post flanges collapsed inward toward the web, but the post did not tear.

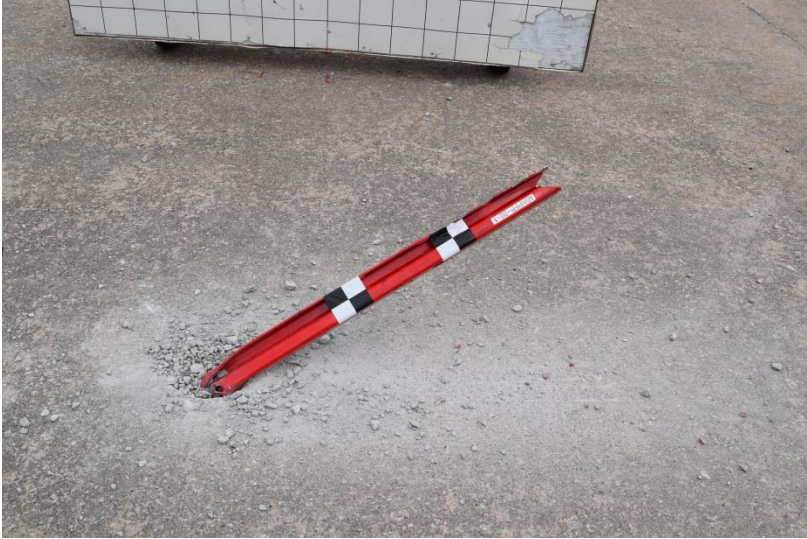
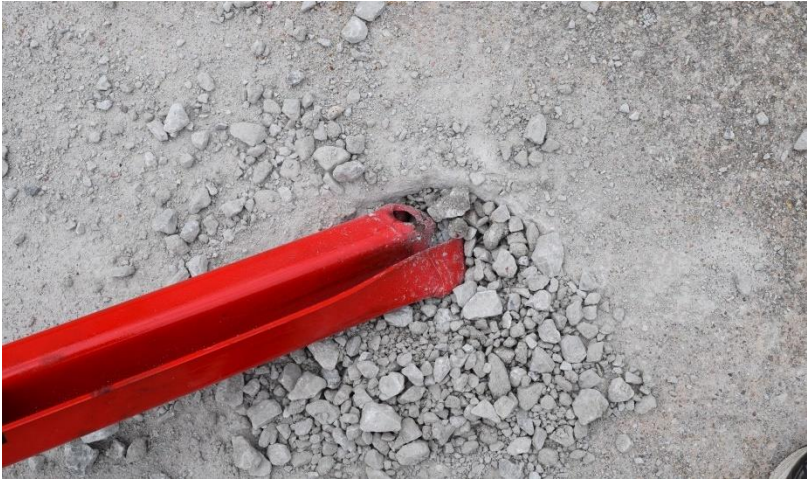
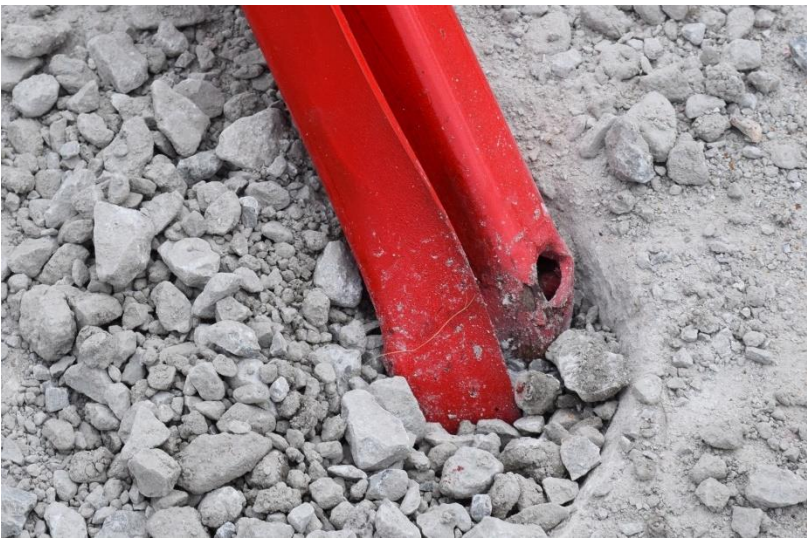
Figure 94. Time-Sequential and Post-Impact Photographs, Test No. MWPFP-20

Sequential and post damage photographs are shown in Figure 94. Contact marks were present along the top portion of the impact-side flange. A plastic hinge was observed around the weakening holes near the groundline, and the post flanges collapsed inward toward the web. The weakening holes were deformed, but did not tear.

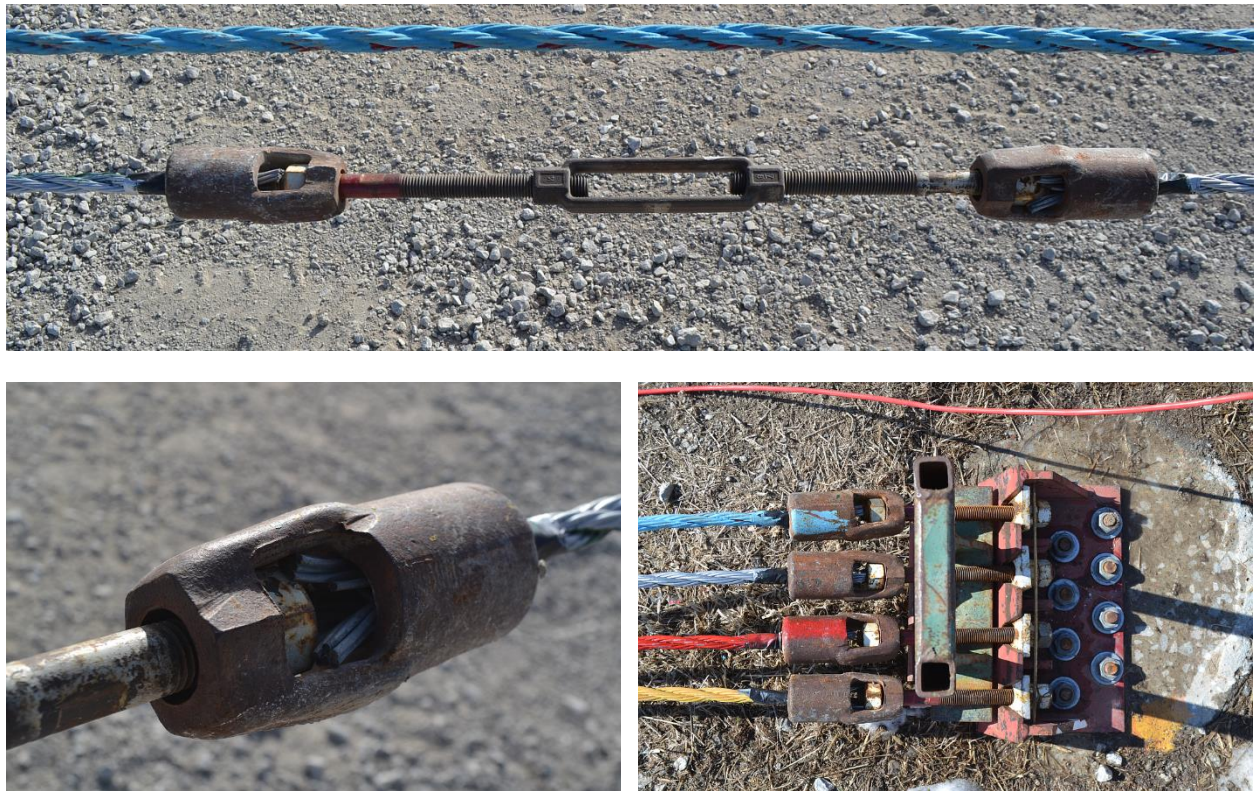
Figure 95. Bennett Bolt Works, Inc. Cable Coupler – Model No. CGBBHT

During full-scale crash testing, the cable splices located within the impact region of the barrier system have caused significant exterior sheet metal damage to the impacting vehicles. Due to the relatively large cross section of the coupler as compared to the cable, the couplers have snagged on vehicle doors and A-pillars, thus causing crushing and sheet metal tearing. Examples of this damage were observed in full-scale crash tests of small cars, sedans, and pickup trucks, as shown in Figure 96. The interaction between the vehicle and the couplers has not resulted in failure of the MASH safety performance criteria, but the undesired snagging and tearing did reveal some risk of eventual penetration into the occupant compartment. Therefore, an investigation was launched to investigate alternative cable splices that may mitigate snagging and decrease sheet metal damage.

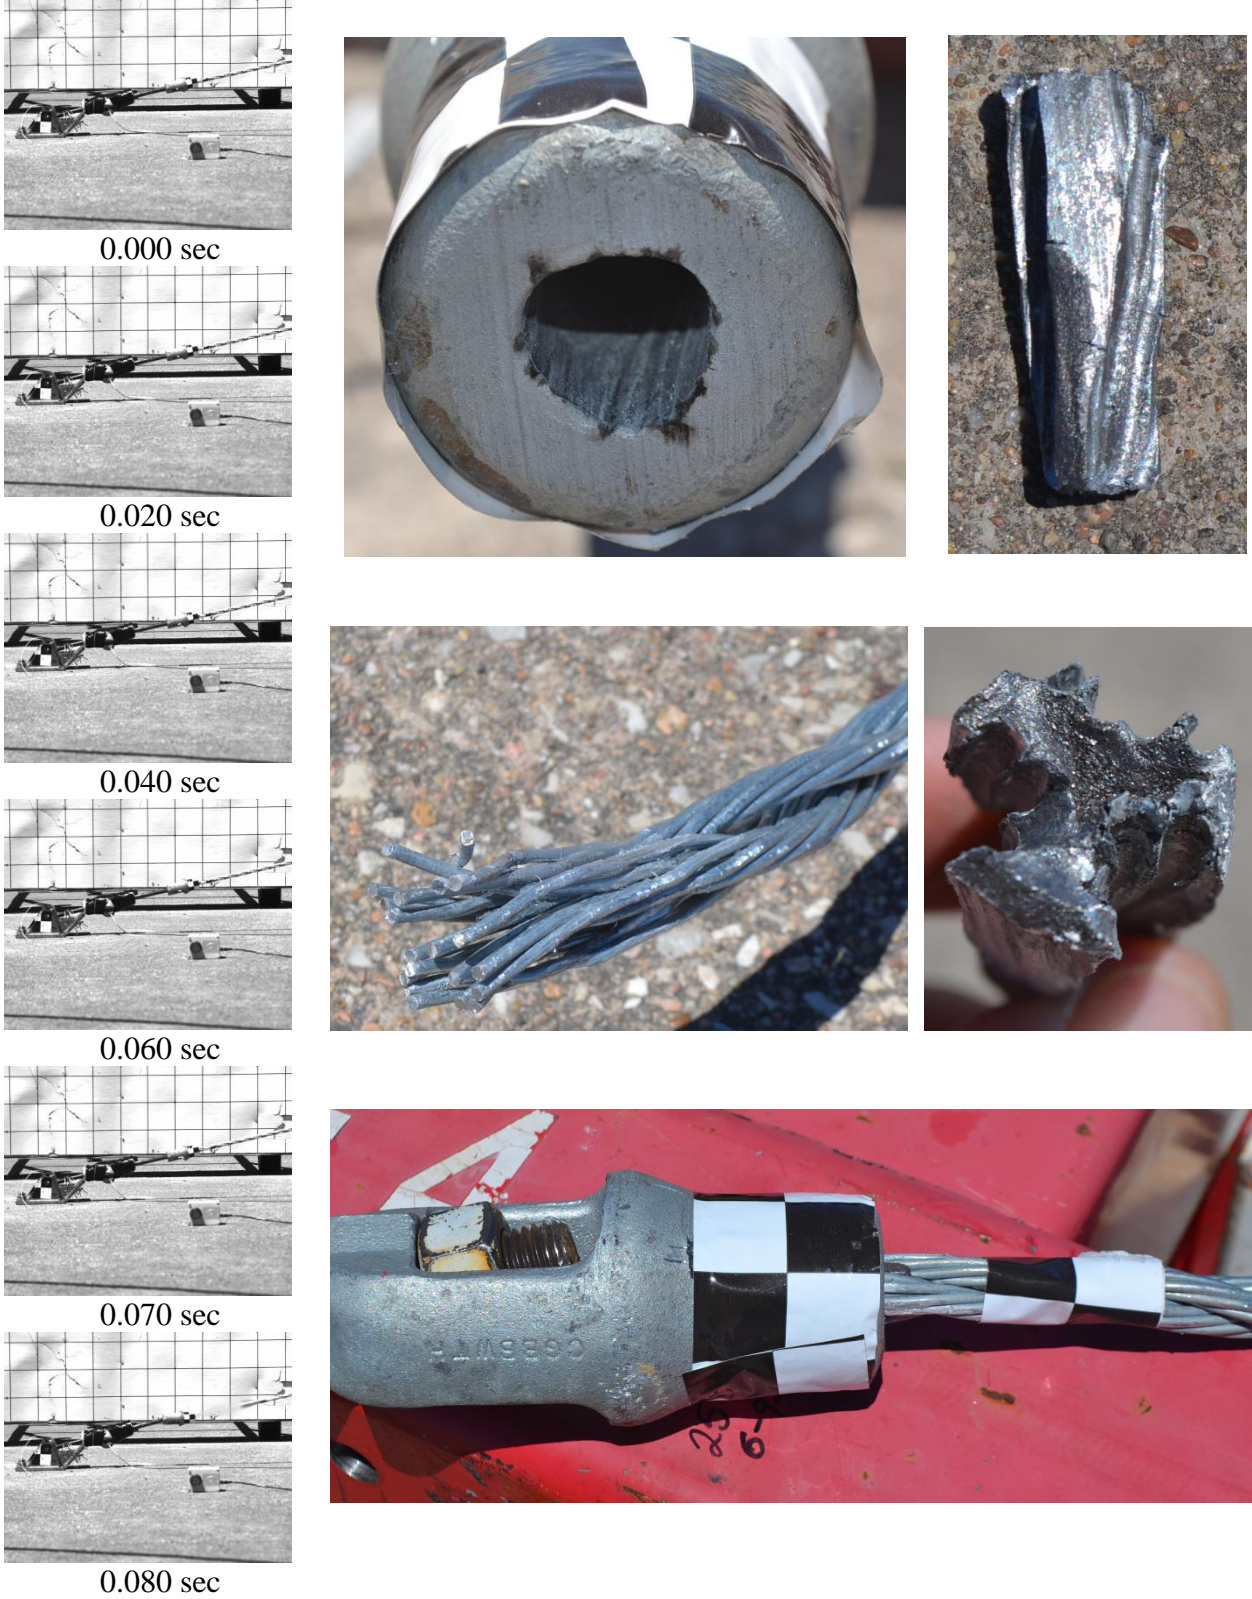
Test no. BBNC-2 was conducted with the newer Bennett cable couplers, model no. CGBBWTH, located on both ends of the cable. During the test, the cable was loaded to a maximum tension of 32.43 kips (144.26 kN), after which, the cable and wedge pulled through the coupler linking the cable to the anchor bracket. Sequential photographs and system damage photographs are shown in Figure 107.

The inside of the failed coupler had striations formed from the wire rope as it pulled through the opening, but the coupler was otherwise undamaged. The upstream end of the cable that pulled through the coupler was deformed and frayed, and the wedge was no longer entwined within the wire strands. The wedge was deformed and contained more pronounced striations than the coupler. The cable end attached to the bogie vehicle pulled $1\frac{1}{8}$ in. (29 mm) out of the coupler, and the wedge pulled $\frac{1}{4}$ in. (6 mm) out of the coupler.

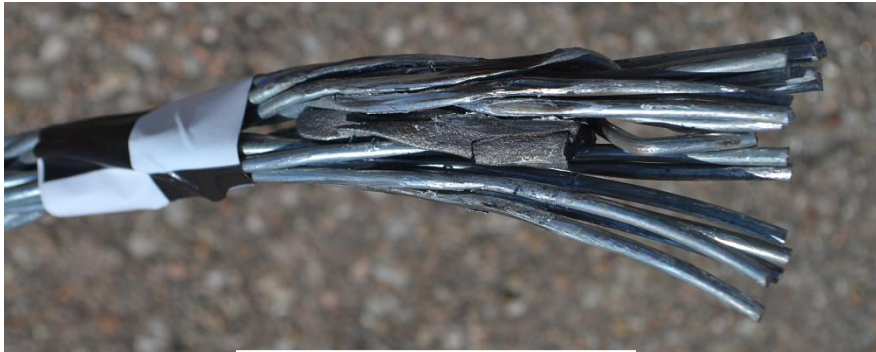
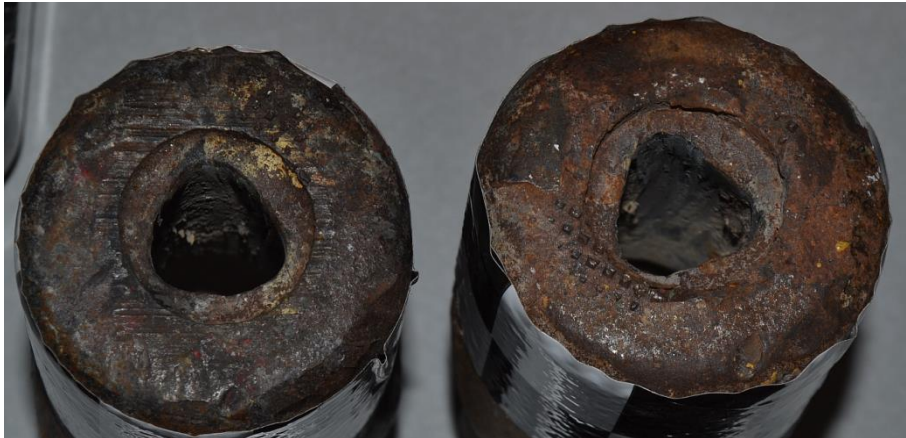
Figure 108. Time-Sequential and Post-Test Photographs, Test No. BBNC-3

Test no. BBNC-3 was conducted with the Bennett cable couplers currently utilized in full-scale crash testing of the cable barrier located on both ends of the cable, model no. CGBBHT. During the test, the cable was loaded to a maximum tension of 30.17 kips (134.20 kN), after which, the cable and wedge pulled through both couplers simultaneously. Sequential photographs and system damage photographs are shown in Figure 108.

The inside of the couplers contained striations formed from the wire rope as it pulled through the opening, but the couplers were otherwise undamaged. The cable ends were deformed and frayed, but unlike the previous tests, the wedges were still entwined within the wire strands at both ends. The wedges were crushed and plastically deformed around the individual wires of the cable.
