# PERFORMANCE OF ULTRA-THIN WHITETOPPING (UTW) IN OKLAHOMA

FINAL REPORT ~ FHWA-OK-10-05  
ODOT SP&R ITEM NUMBER 2222

DECEMBER 2010

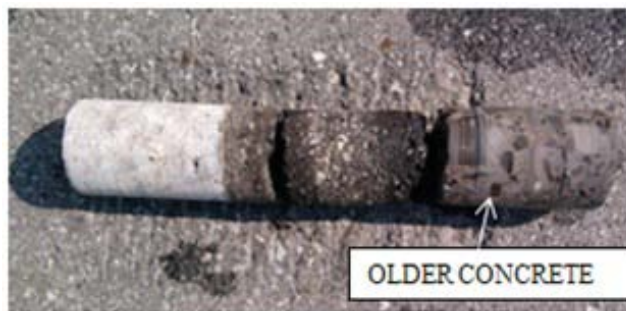
Coring gives the details about the depth of the different layers present below the overlay. The detailed information about the different layers gives a better understanding about the present and future performance of the overlay. It also provides the opportunity to run tests like dynamic cone penetrometer to determine the foundation properties of the subbase layer. In this project DCP tests were run at all the coring locations. However, different types of soil conditions were observed. So it was hard to decide the exact expressions to be used for finding the bearing capacity. Also it was thought that the number of DCP tests was less for such lengths of the overlays. However, a fair estimate of modulus of rupture has been given in Appendix – A for three overlays in McAlester area. Because of the violent nature of the coring it is hard to comment on the bond between concrete and asphalt. It was common for debonding to be observed between the two layers. Fig. 2.4 shows a typical core photo.

**Figure 2.4** – A typical core from an Oklahoma whitetopping.

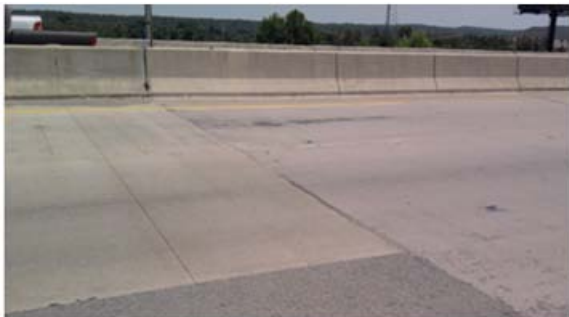
The overall condition of this overlay looked very good. However, there were some problems observed. The initial panels had been replaced with a new concrete panel (Fig. 2.10 a). A definite elevation difference was seen between the asphalt pavement and the approach thin white-topping panel at the beginning of the project. The elevation difference was very significant, with some cracking observed in the approach panels even after the replacement (Fig. 2.10 b). Some heavy polishing was seen in both driving and passing lanes of the overlay, stretching to over 30 panels in length. Longitudinal cracking was also seen, but it was insignificant as it was just at a couple of places over the overlay and also spanned only for two panels. At about 0.7 miles after the start of the overlay (at exit for US 270 west on the highway), two punch outs were seen, as shown in Fig. 2.11. Some corner cracking was also observed where the approach ramp meets the overlay after this exit. None of the problems stated above were extensive, but they should be monitored for future deterioration. The end of the overlay looked good without any sign of distress, as shown in Fig. 2.12, as it ends in a concrete bridge. Also, drainage of this overlay looked quite good and satisfactory.

**Figure 2.12** – The overlay terminates at a bridge and does not show any distress.

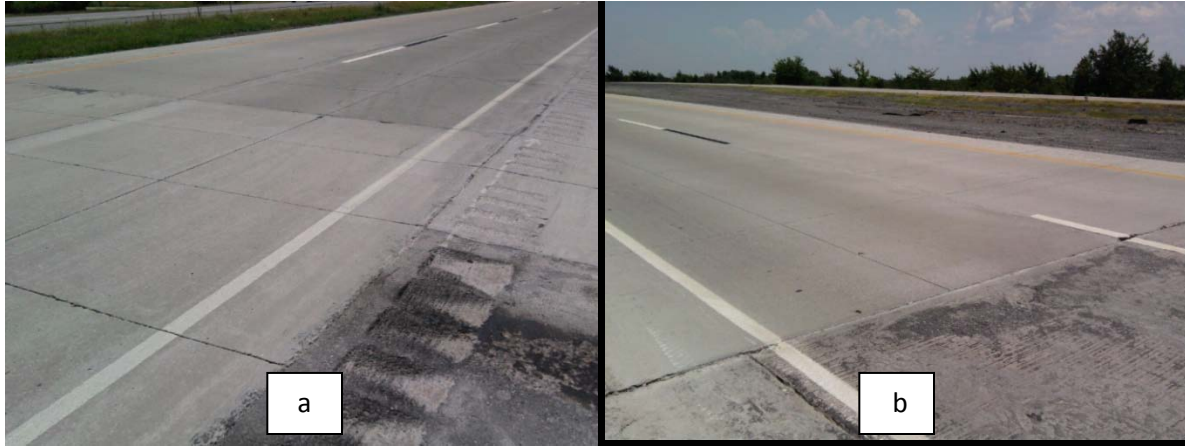
These overlays, being new, are in good shape and have not shown any notable sign of distress. The figures below show the good condition of the overlays. Figures 2.16 a and b show the start and the end of the south bound overlay. The good condition of the overlays is seen in all the photographs.

**Figure 2.16** - Photo a showing start and photo b showing end of the south bound overlay.

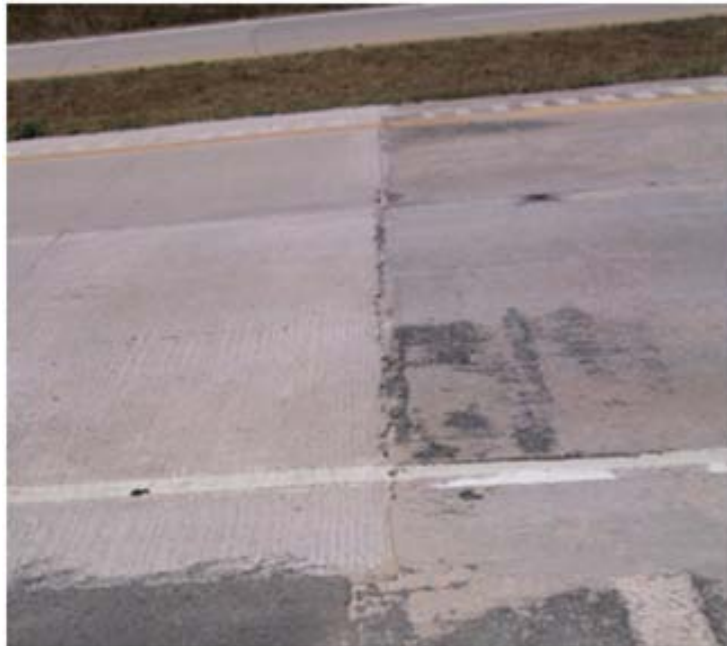
**Figure 2.20** – The interface of the overlay and the adjacent pavement is in good condition.

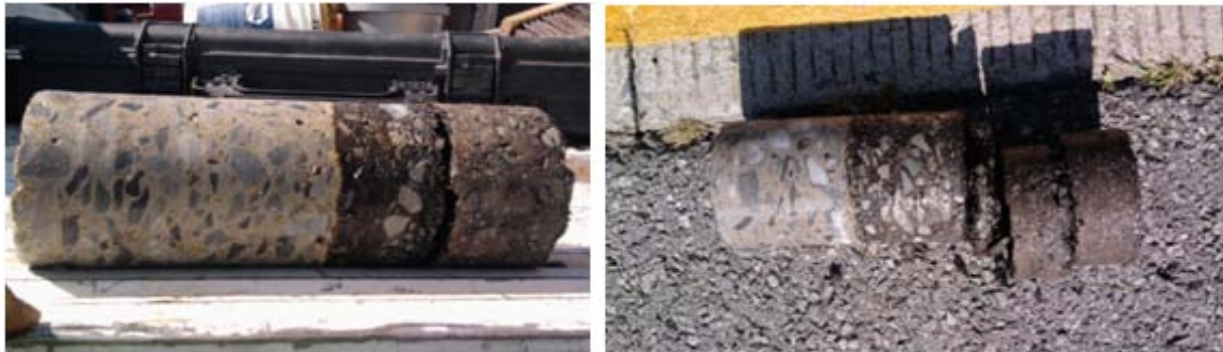
Fig. 2.26 shows the cores extracted from Oldest McAlester Whitetopping. The thickness of asphalt was found to be, at minimum, 9" and was on an average 11". This is likely one contributing factor into the positive performance of the overlay. Four cores were taken at the locations 1 and 5 from the driving lane and 3 and 7 from the passing lane as described in Table 2.9.

**Figure 2.26** - Cores extracted on the oldest McAlester Overlay.

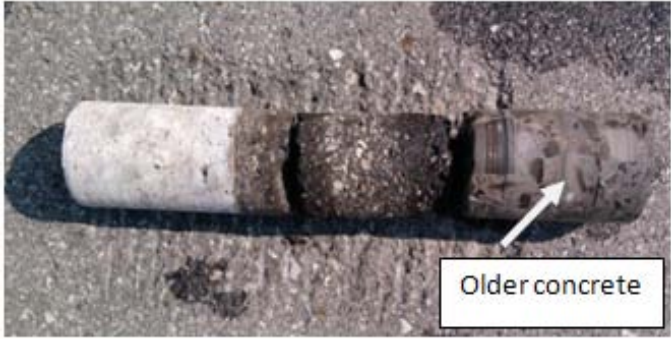
Coring on the Chockie Overlay showed that the asphalt that was placed on top of an old concrete layer. The asphalt layer was 8" to 9" in the driving lane and 10" to 12" in the passing lane. The constant depth of the old concrete pavement was 6". Four cores were taken at the locations 2 and 7 in the passing lane and 3 and 9 in the driving lane from Table 2.11. Figure 2.27 shows the core at location 9.

Figure 2.27 – Core from location 9.

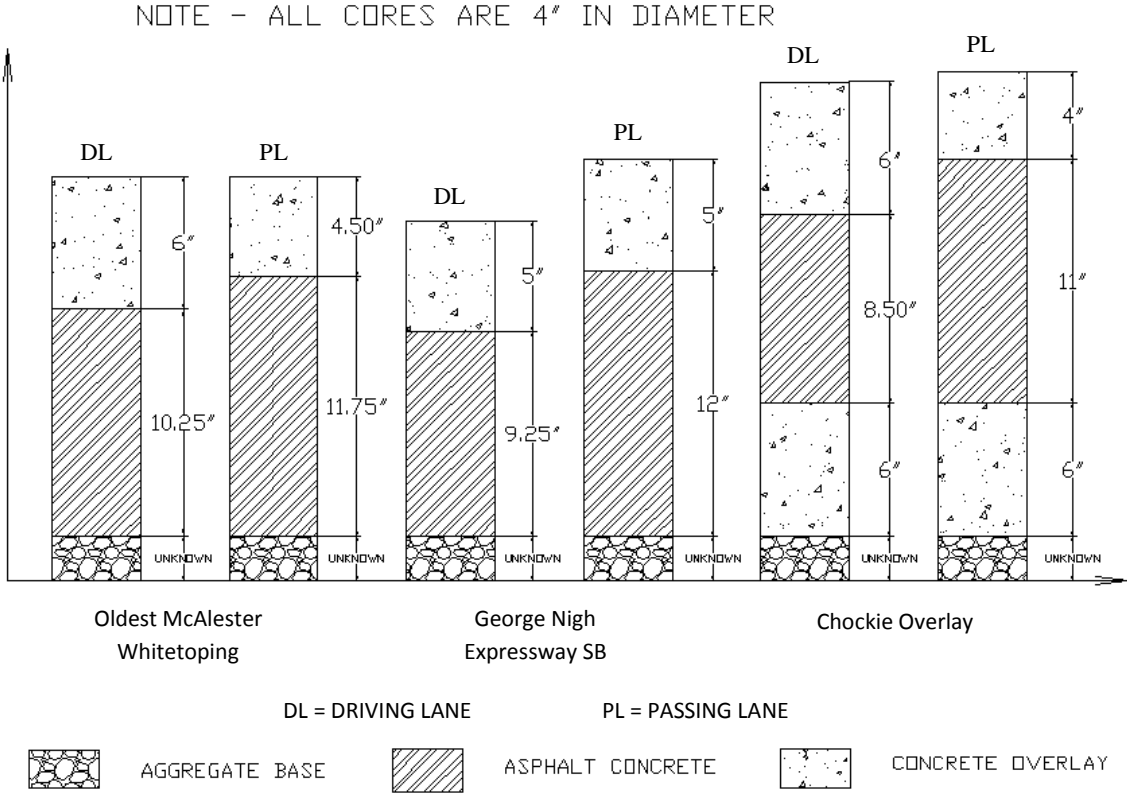
Figure 2.28 shows a comparison of the cores extracted from the overlays. As seen in the figure there is a difference between the overall depth of the material (concrete and asphalt) below each overlay. The George Nigh SB Whitetopping had the least amount of support material when compared to the other overlays but still shows satisfactory performance. It will be interesting to see how this material impacts the long term performance of this overlay compared to the others. The thickness of aggregate base is not included as the coring operations were only carried out from concrete overlay to the end of asphalt layer or to the end of the older concrete pavement for the Chockie Overlay.

Figure 2.28 - Details of different cores extracted from Overlay 1, Overlay 2 and Overlay 6 from left to right respectively. The values shown are an average of two core measurements.

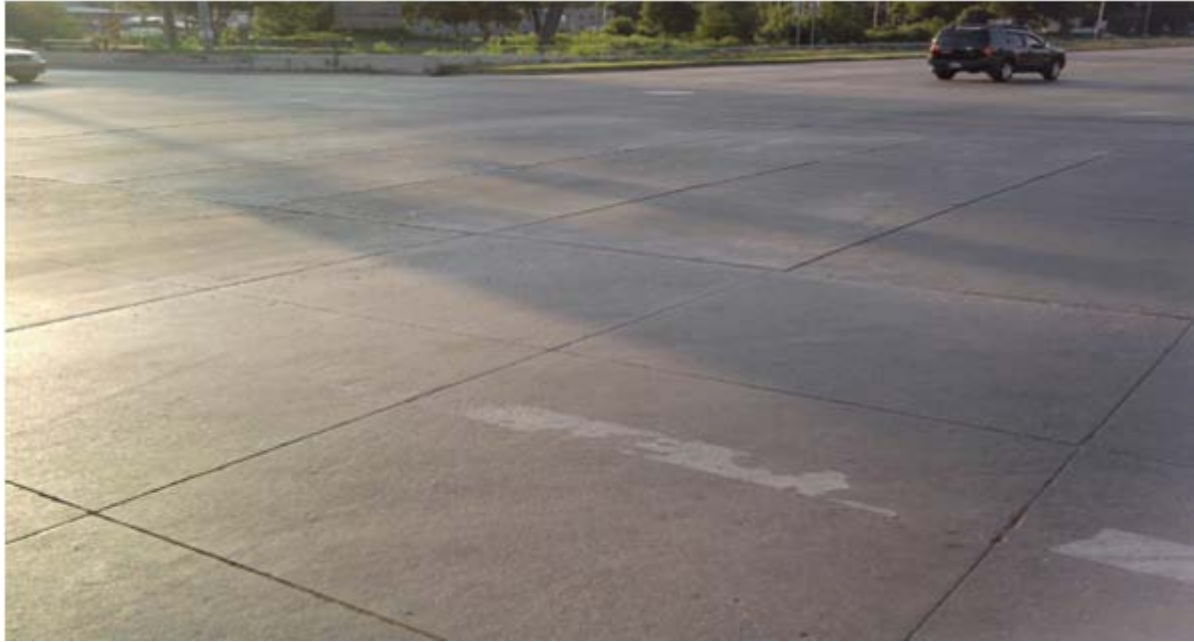
Fig. 2.31 is a photo taken from the edge of the gas station towards the north-west. The panels of the intersection seen in this photo look excellent. There was negligible amount of distress on this side of the intersection. Also the approach from south as shown in Fig. 2.32 does not show any damage. One explanation for this is that there was no elevation difference between the asphalt and concrete overlay. The panels, as seen in Fig. 2.33, on the approach lanes from south to the intersection on US – 177 look in good condition. Again Fig. 2.34 shows the same good conditions of the panels on the approach from the north to the intersection on US – 177. The area shown in Fig. 2.35 is the approach on US – 177 from the north side. Fig. 2.35 supports the hypothesis that if there is no elevation difference between the asphalt pavement and the concrete overlay, the initial panels will show good performance.

**Figure 2.31** - Intersection as seen from the edge of gas station towards north-west.

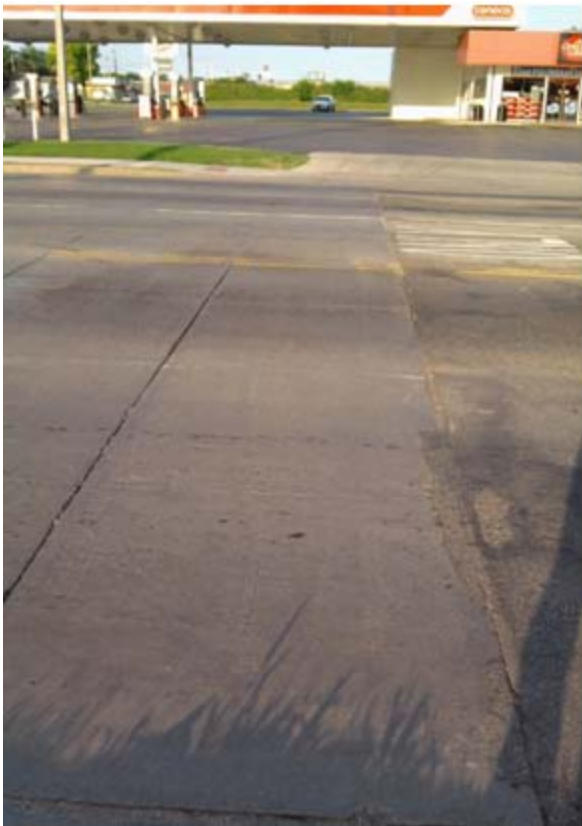
**Figure 2.32** - Approach on US 177 from south showing excellent condition of initial panels.

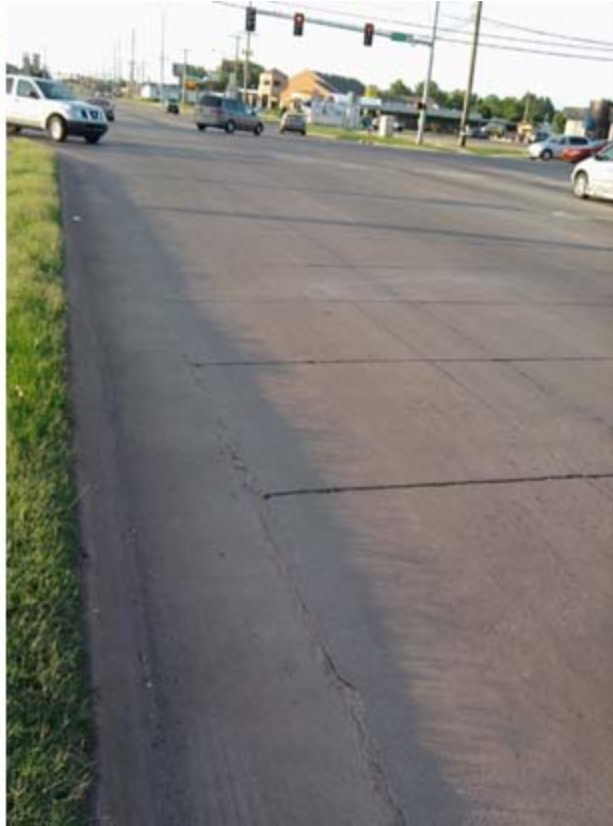
**Figure 2.33** - Excellent condition of panels on US 177 from the south.

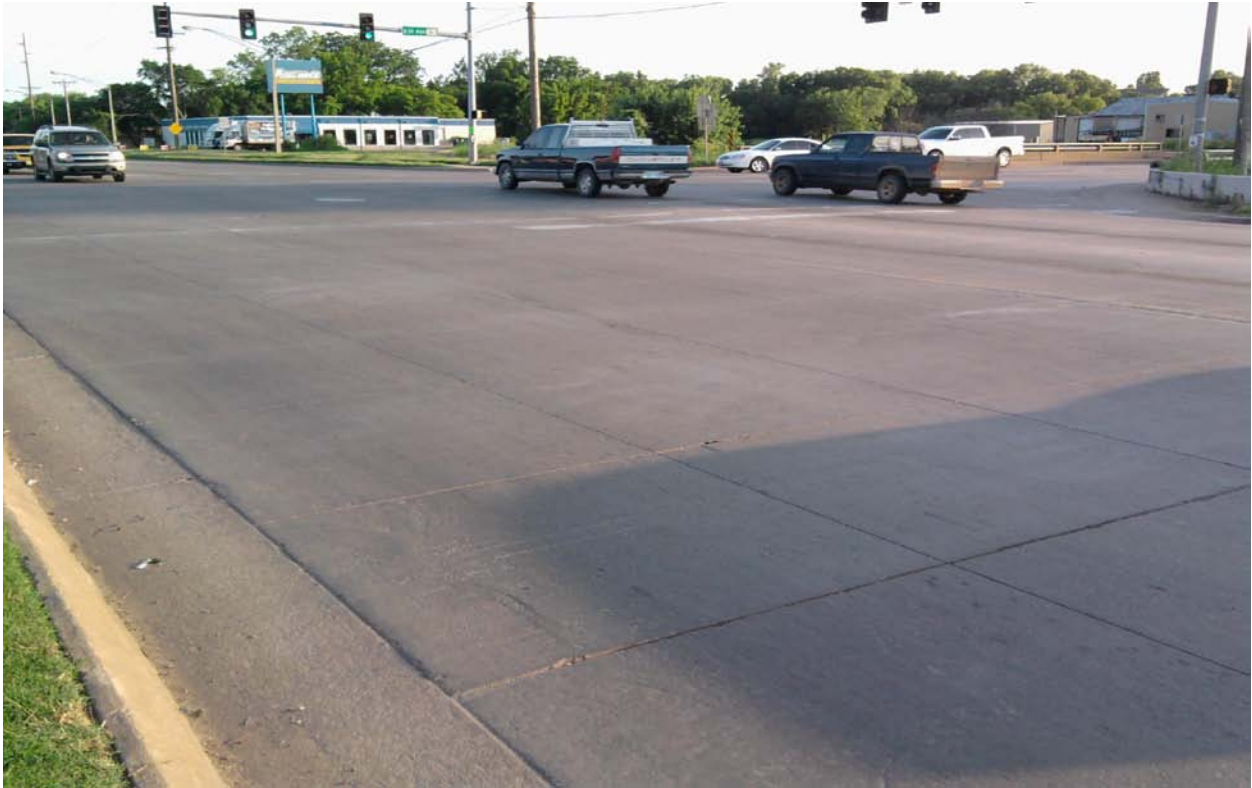
**Figure 2.34** - Photo of intersection seen on US 177 towards south-west showing excellent condition of overlay.

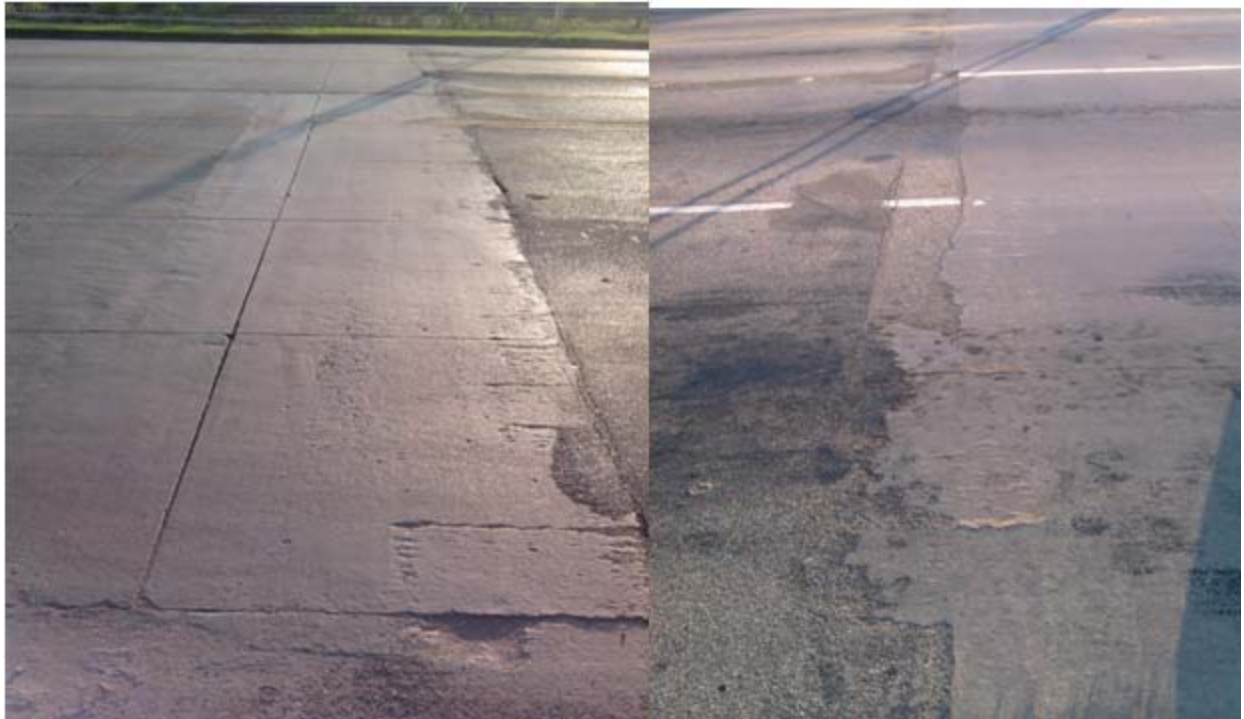
**Figure 2.35** - Approach on US 177 from north showing absence in panel failures. Note the small difference in the elevation between the approach and leave pavements.

2. Maintaining close elevation difference at the approach panels may reduce the possibility of initial panel failures due to impact loading.

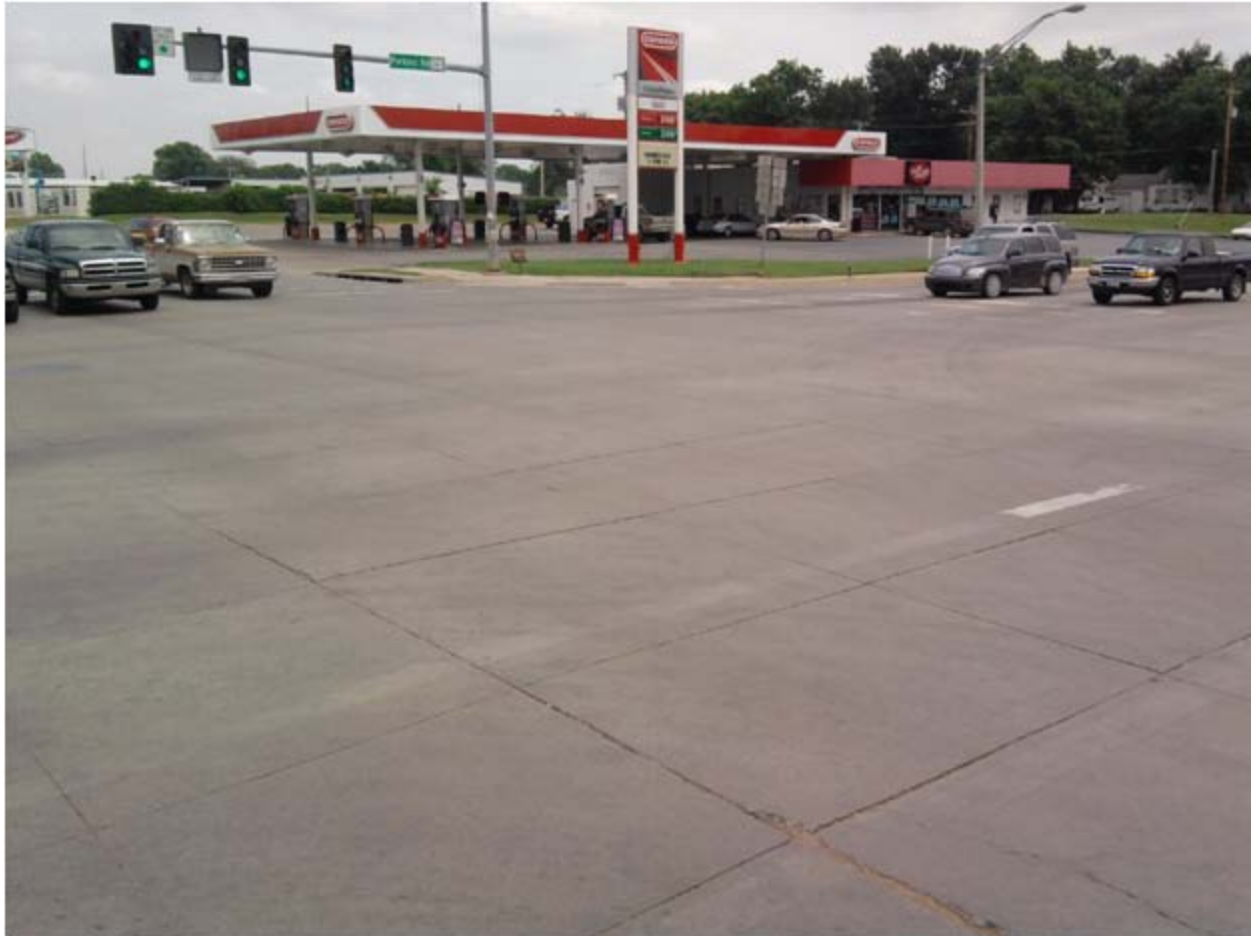
However, overall condition of the overlay in the intersection looked satisfactory as shown in Fig. 2.45.

**Figure 2.45** - Overview of the intersection.

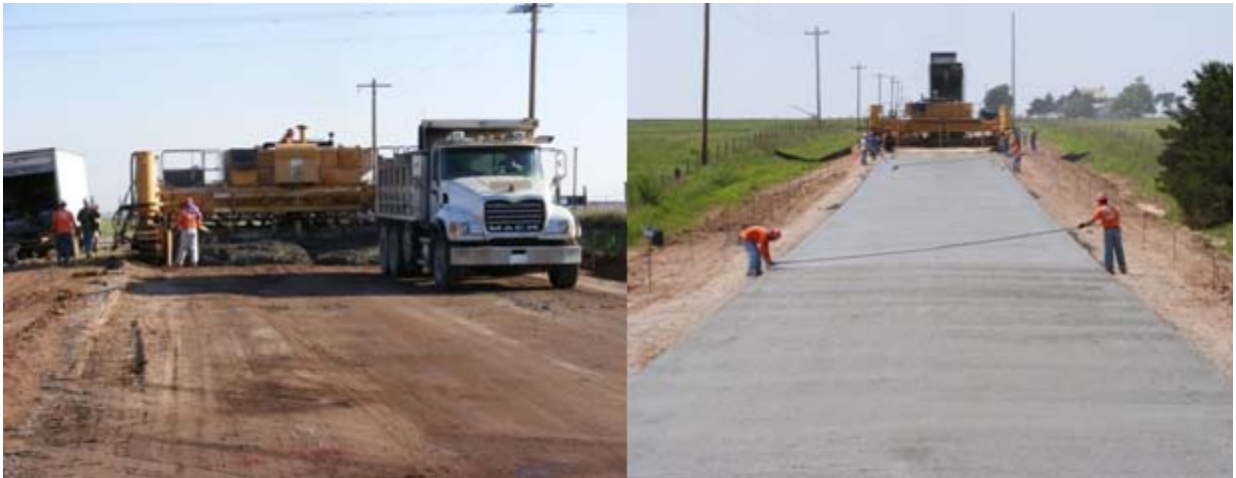
- 3) During the construction the old asphalt pavement surface was not milled and may not have been accurately cleaned. This can be seen in Fig. 2.48. Therefore, it is possible that the asphalt and concrete may not have a good bond. If de-bonding occurs then one would expect a significant decrease in performance for the overlay.

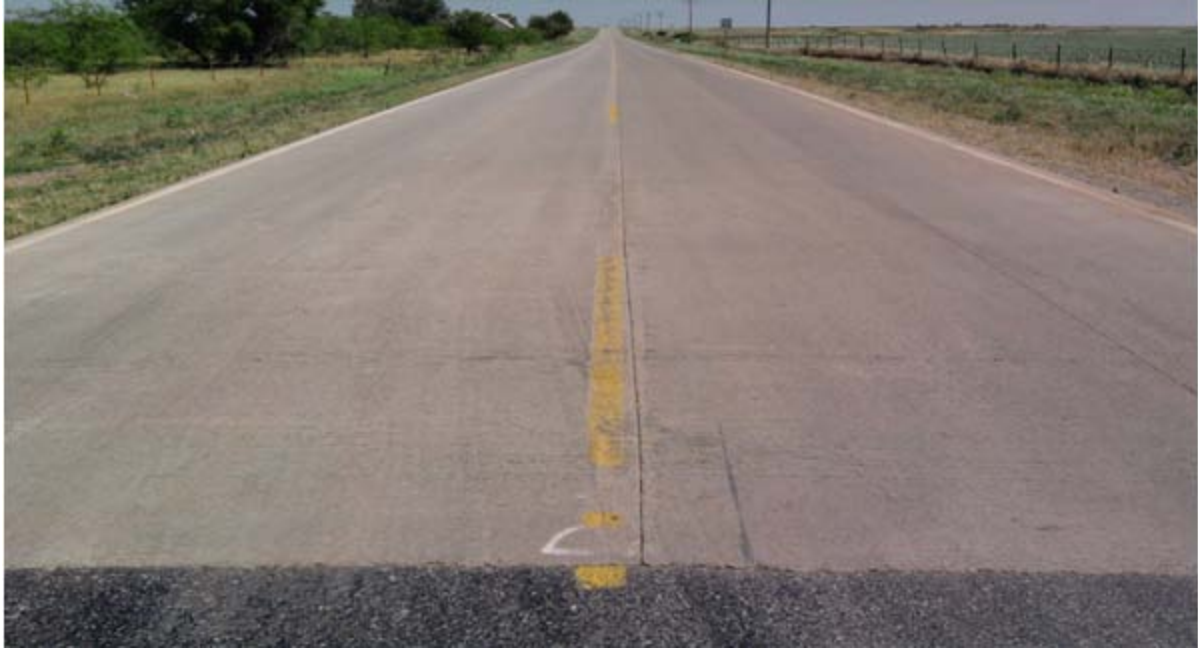
Figs 2.50 & 2.51 show the beginning of the overlay on its south side. The initial panels, which from previous experiences are the most critical, look un-cracked.

**Figure 2.51** - Photo shows the overlay from south direction (looking towards north).

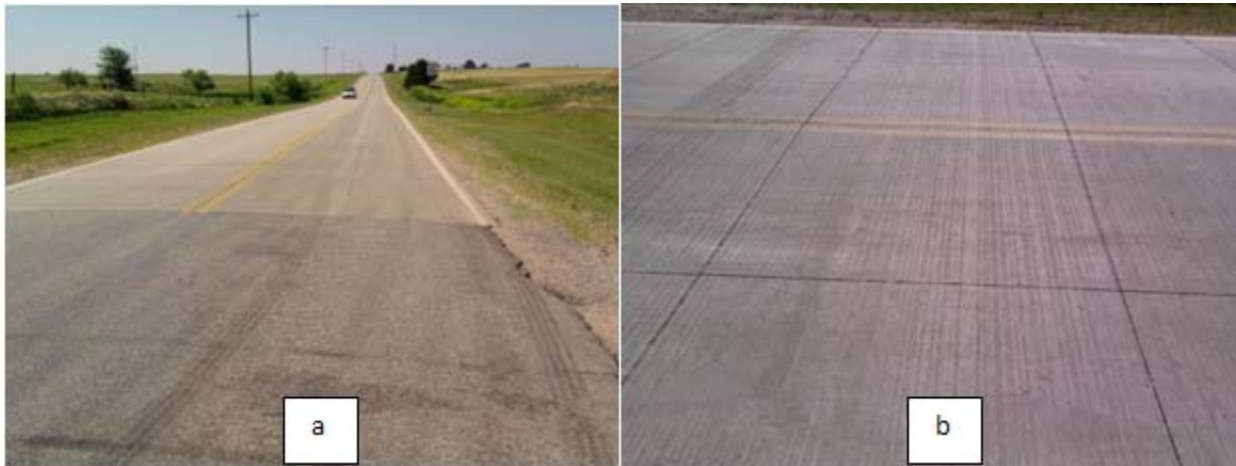
Fig. 2.52 shows the condition of the overlay where it ends on the north side. The elevation difference in between concrete and asphalt pavements was thought to be insignificant. The good condition of the initial panels suggests that if the same elevation for approach and leave pavements is maintained, the initial panels on the overlay are less likely to fail assuming that there is good bond between the concrete and the underlying asphalt.

**Figure 2.52** - North end of overlay. Photo a is taken looking towards south direction. Photo b is seven panel series from the end of the overlay.

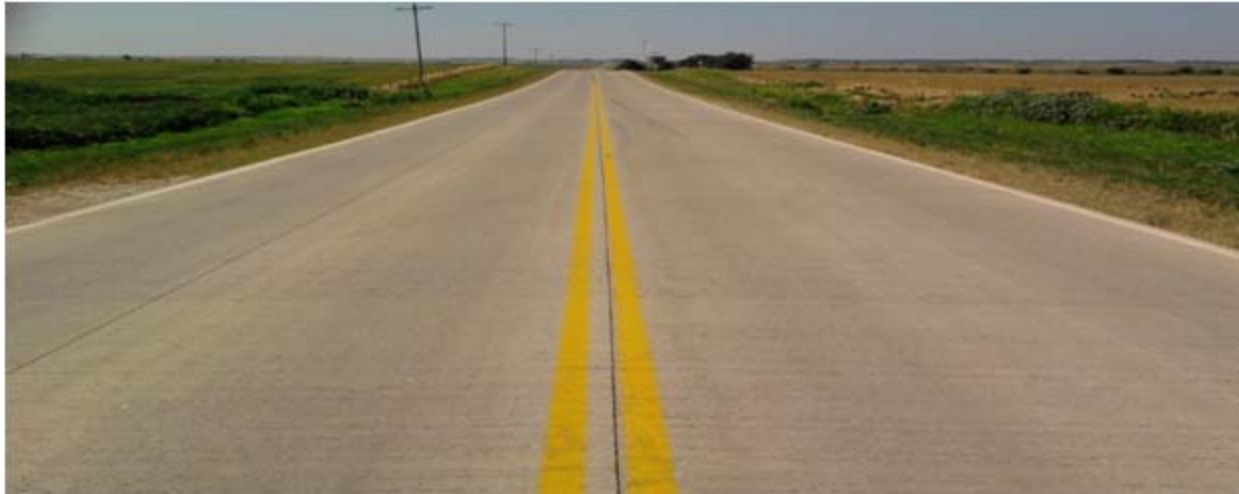
**Figure 2.53** - Photo showing the excellent condition of the overlay.

The overall condition of the thin white topping is excellent as shown in Fig. 2.53. The research team did not notice any longitudinal cracks, transverse cracks, fatigue distress or pop outs.
