The Seal Cove Shipwreck Project: Investigating an Historical Wooden Vessel on Mount Desert Island, Maine

Franklin H. Price, Stephen Dilk, and Baylus C. Brooks, Jr.

Two one-week field projects, carried out during the summers of 2011 and 2012, investigated an historical wooden shipwreck in the intertidal zone on the western side of Mount Desert Island, Maine. Salvage, tide, ice, and other environmental forces have reduced the wreck to a keel, frames, and outer hull planking. Despite this, some observations can be made from the limited surviving evidence. The vessel appears to have been heavily-built, with a full-bodied hull, and constructed in the mid to late 19th century. Its location, hull, and the wood shavings and brick chips found between its timbers suggest that it may represent a sailing vessel engaged in the coasting trade. Archaeological investigation of the site also served as an informal field school, providing experience in maritime site recording to Acadia National Park staff and members of the public.

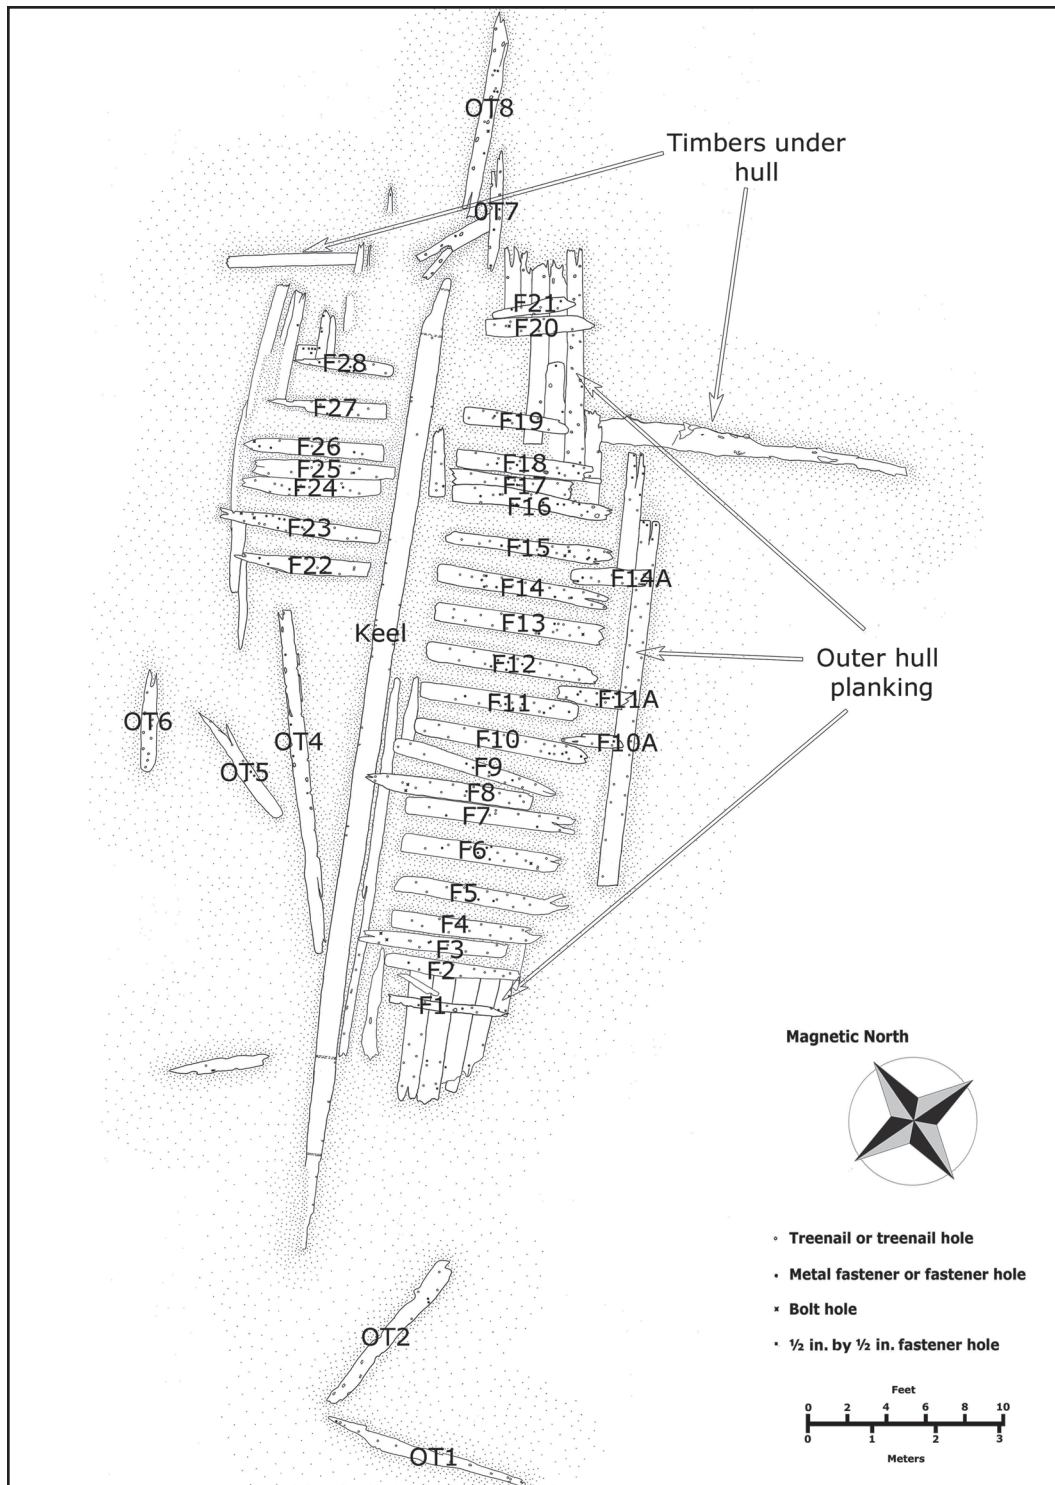
Figure 2. Site plan. (Figure by Franklin H. Price, 2013. Funded by the National Park Service and the Institute of Maritime History.)

The remaining continuous structure is close to 23 ft. (7 m) wide and nearly 50 ft. (15.24 m) long. A nonstructural timber extends eastward from under the hull. Overall dimensions of the site, including elements from the vessel scattered nearby, are 74 × 42 ft. (22.56 × 12.80 m). The three remaining identifiable components are the keel, the frames, and the outer hull planking (FIG. 6). The vessel lacks any indication of a form of propulsion, because the parts that would have provided this evidence are missing. If there were one or more mast steps, they would have been on the keelson, which is absent. There is no evident engine bed. The deadwood stern assembly, which would have been drilled to fit a propeller shaft were this vessel engine powered, is also missing.

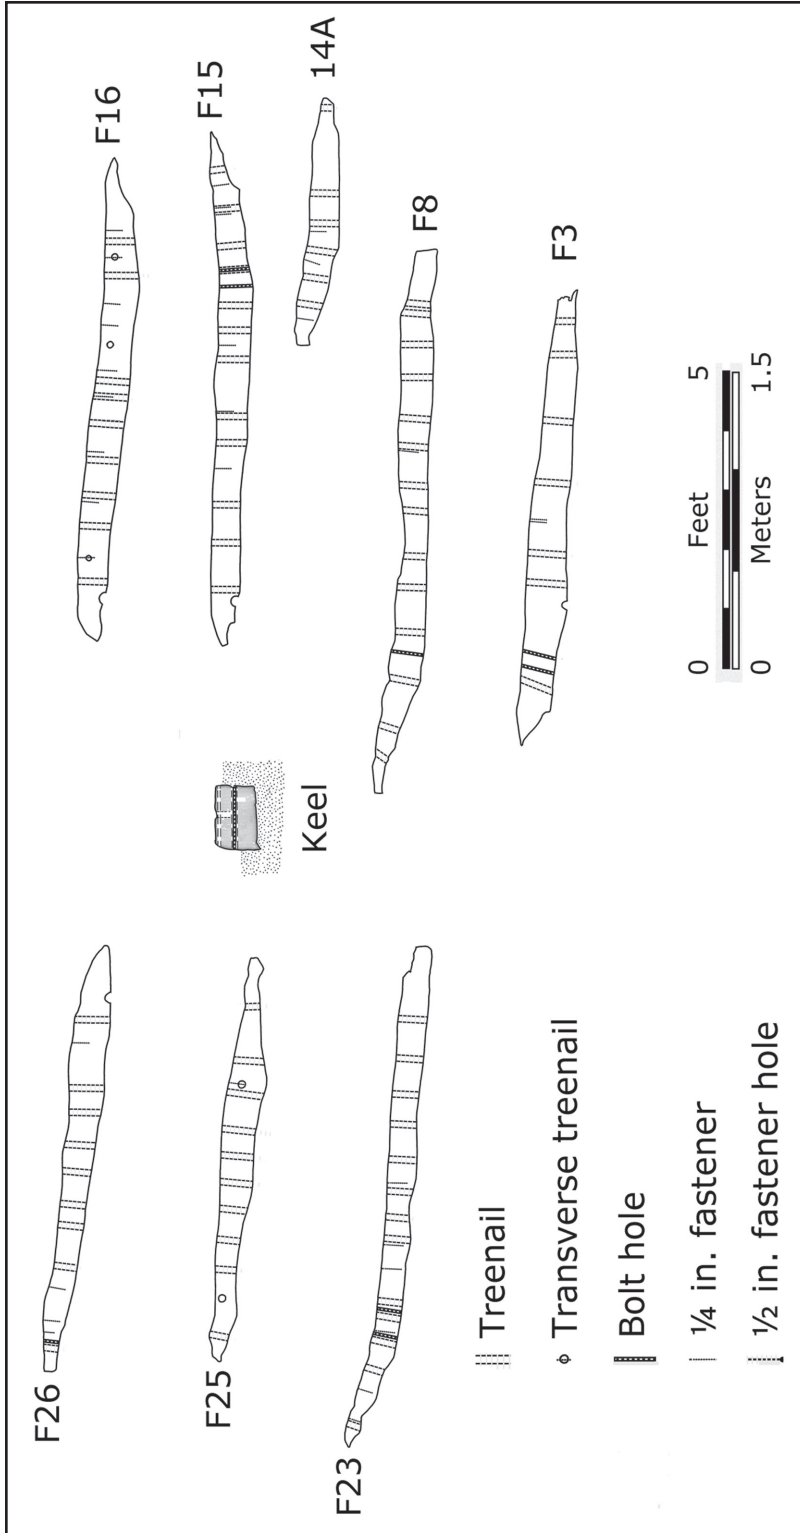
Figure 3. Selected frame profiles, and keel in cross-section. (Figure by Franklin H. Price, 2011.)

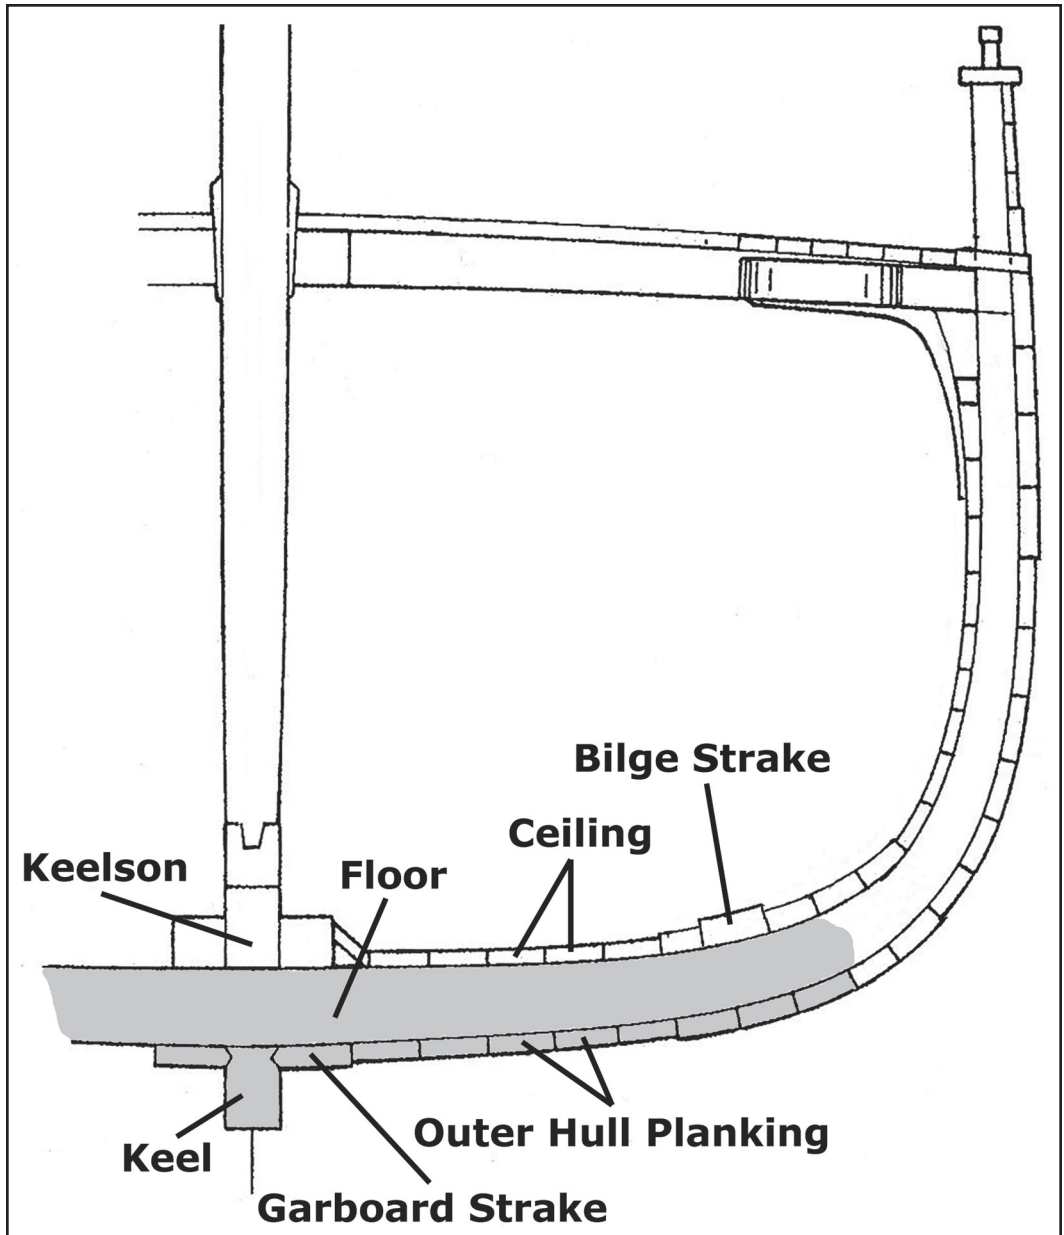
Figure 6. Cross section of 19th-century schooner, remaining structure at Seal Cove in gray. (Drawing after Greenhill and Manning, 1988.)

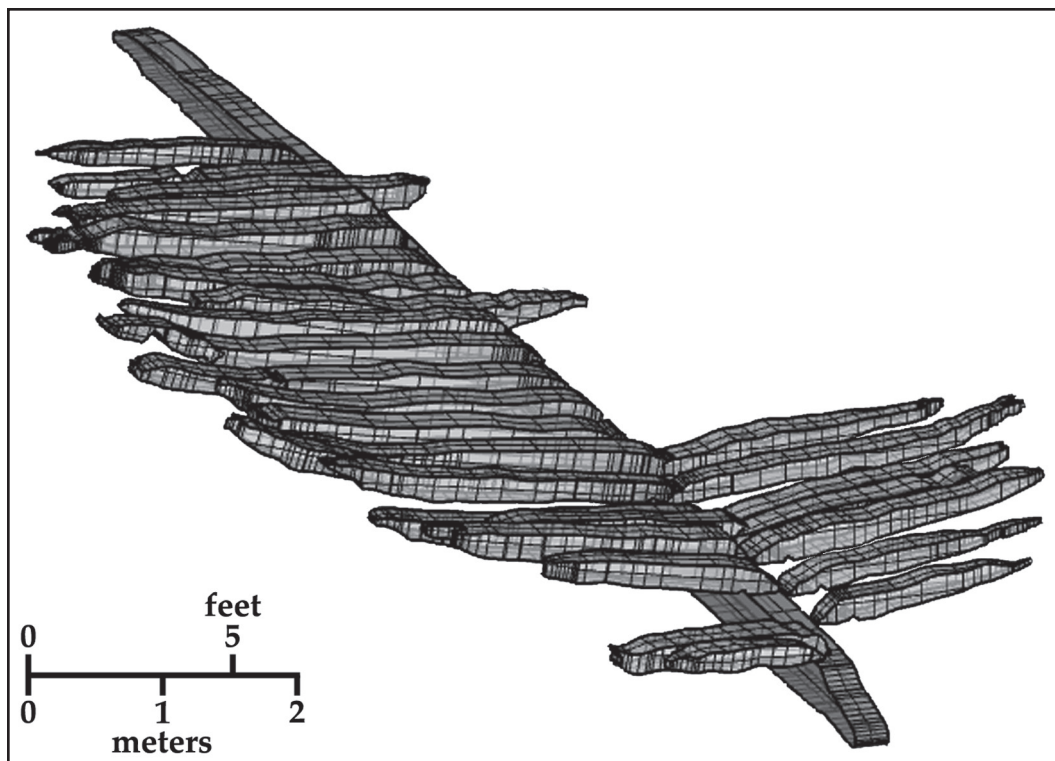
The three-dimensional reconstruction also assists in understanding the site-formation process. The current state of the wreck is the result of structural collapse, ice damage, and decades of alternating exposure to air and water twice daily. The frames have cracked, and while the outer hull planking has held

Figure 9. Three-dimensional reconstruction, looking south southwest. (Image by Joshua Daniel and Franklin H. Price, 2013.)

them in their original positions relative to one another, the frames are not in their original positions relative to the keel. The keel has fallen over and the hull has broken, with the frames and hull planking falling outward and away from the keel on either side. The weight of the collapse has warped some of the frames, cracking the outboard third and flattening their lines from the original shapes. Before the frames were distorted, the hull shape exhibited a more pronounced curve.

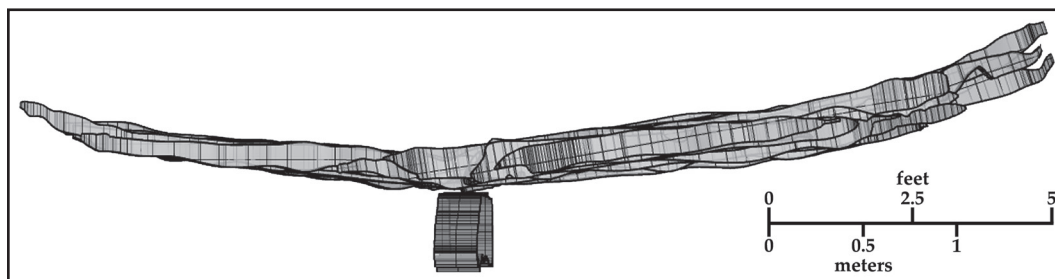
reconstruction. First, the Seal Cove wreck appears to have a mild deadrise, not inconsistent with plans for full-bodied sailing vessels (FIG. 10). In other words, the rise of the floor between the keel and the turn of the bilge results in a shape suitable for carrying cargo. Second, the heels of the futtocks touch, or nearly touch, one another on the keel (FIG. 11). This has ramifications for the potential date of the wreck, as will be explored below. Third, in three-dimensional space the frames farthest north on the vessel are more readily interpreted as cant frames. Cant frames fill the spaces as a vessel narrows toward the bow and stern, suggesting that the vessel narrowed significantly near frames F20 and F21. This allows for an interpretation of the potential length and shape of the vessel.

Figure 10. Three-dimensional reconstruction showing deadrise, looking northwest. (Image by Joshua Daniel and Franklin H. Price, 2013.)

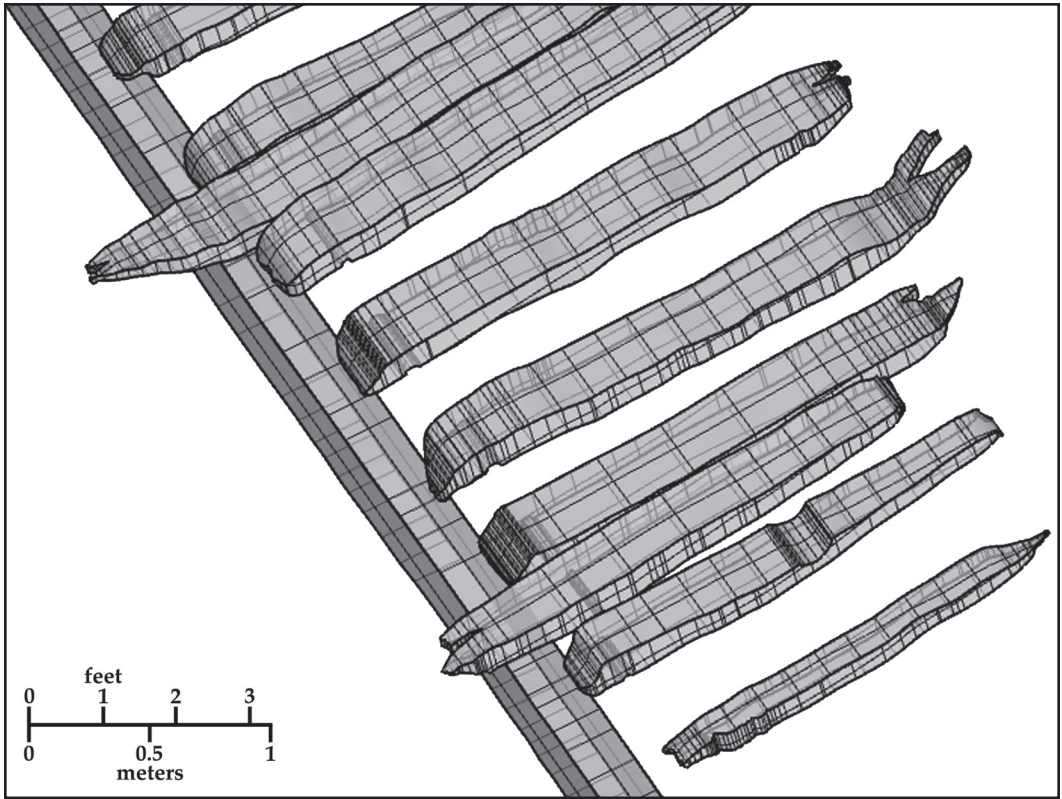
Figure 11. Three-dimensional reconstruction with futtock heel placement, top view. (Image by Joshua Daniel and Franklin H. Price, 2013)
