South Dakota State University Agricultural
Experiment Station

5-1-1940

Paints and Plasters for Rammed Earth Walls

R. L. Patty

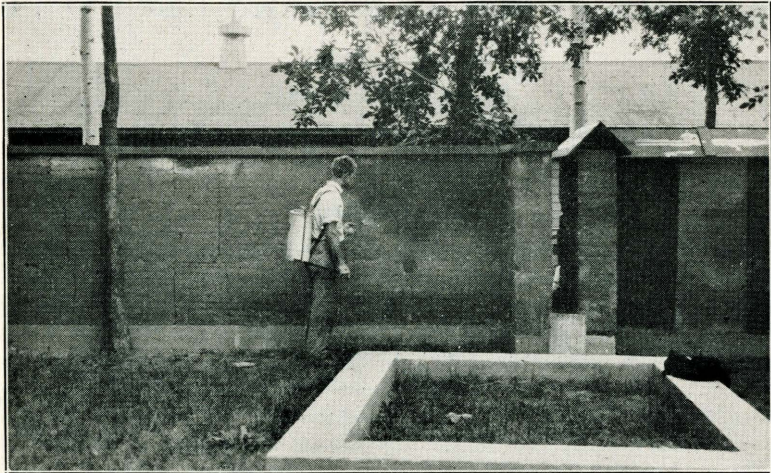
Fig. 2. Wetting Down a Rammed Earth Wall Before Plastering.

Before plastering the earth wall it is wet down so that the moisture will not be drawn from the plaster. A garden sprinkler or a hose can be used in place of this small spray machine.

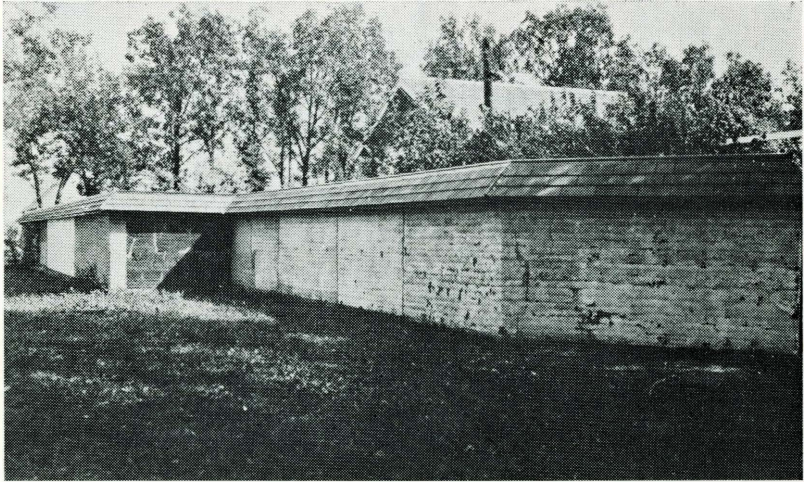
Fig. 15. One of the Paint Panel Walls Used In the Test.

On these wall sections paints were applied to panels from one hour after the section was finished up to one year later. Different weight priming coats were used and different qualities of soils were used in the wall sections.

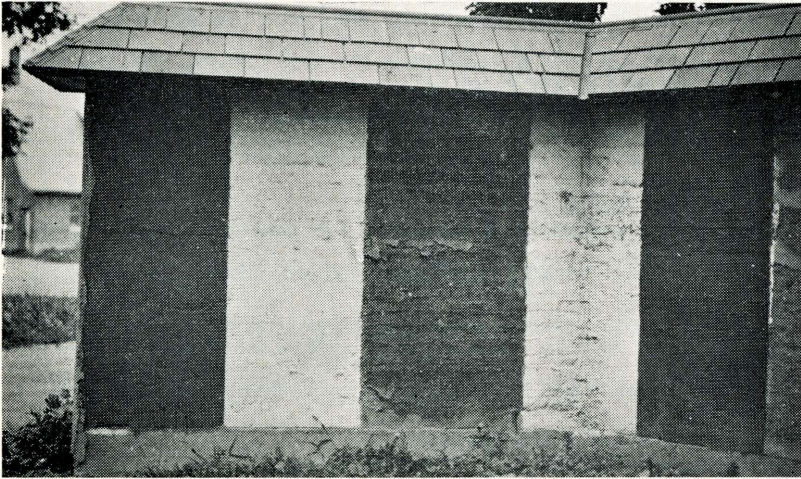
Fig. 18. Some Small Paint Panels For First-time Exposures.

When a paint covering indicated on the small panels that it might be successful, it was checked on larger panels, usually in duplicate. These are panels No. 101T, 102T, 103T, 104T, and 105T.

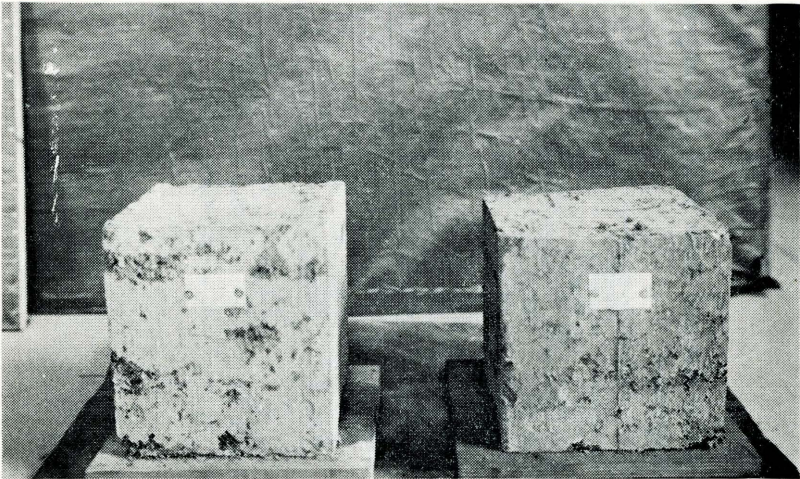
Fig. 22. Test Pieces Containing an Admixture of Cinders As Compared to Sand in Table No. 2.

The surface of these blocks are comparable to the surface of a wall in which cinders are used. The block at the right contains 1 volume of cinders to 2 of dirt; the one at the left contains 1 volume of cinders to 1 of dirt.
