# The Fall and Rise of “Owl”

Robert Oddy

To my knowledge, only one of my windows, Owl, has suffered a really devastating accident. Owl is a 22" x 39" residential stained glass window (figure 1) that I made in 1988, three years after I began working in this medium. However soundly we construct our stained glass artwork, we cannot avoid the simple fact that glass is a fragile medium. Like Humpty Dumpty, Owl did not respond well to falling a few feet to the floor. The window's owner had moved house and taken the window with him. It was temporarily displayed on a window sill in the new home, awaiting a decision on where to re-install it, when a draft caught it and tipped it onto the floor. Fortunately, the distressed owner called me instead of depending on all the king's horses and all the king's men!

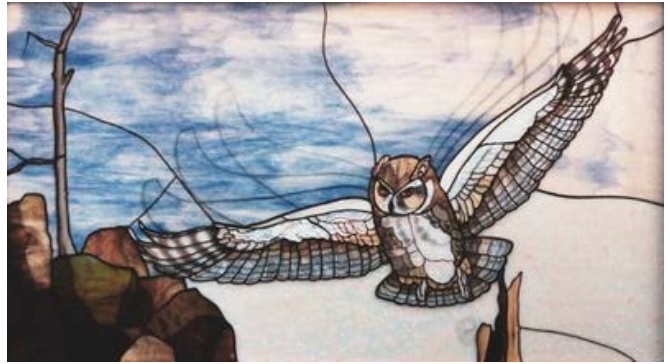
Figure 1: Owl (1988) 22" x 39" stained glass

Robert Oddy, the original window

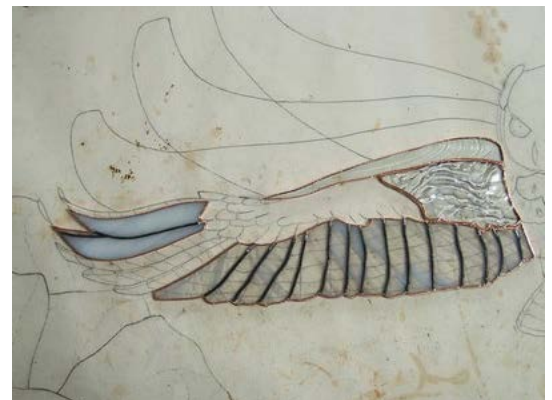
Figure 11: Parts salvaged from top layer of a wing

When the undamaged parts were separated from the broken pieces, the old copper foil was scraped away from the edges with a knife. Then the edges were thoroughly cleaned, the old adhesive was removed, and the pieces were refoiled (figures 11 & 12).

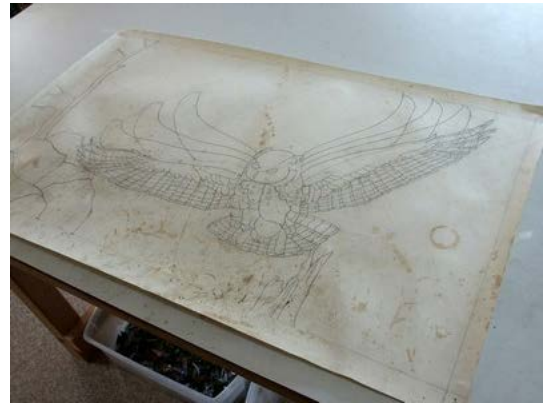
Owl window (figure 13). It was a little the worse for wear, showing historic evidence of the original fabrication that included burns and stains from flux, patina and blood! However, it was usable. I tackled each wing and the bird's head/body separately, as I had when first making it.

Figure 13: The original cartoon
