MLM-1180
M-3679 (32nd Ed.)
C-92a, Isotopic
SNAP Program

DESTRUCTIVE EXAMINATION OF A SNAP HEAT SOURCE

Date: November 25, 1963

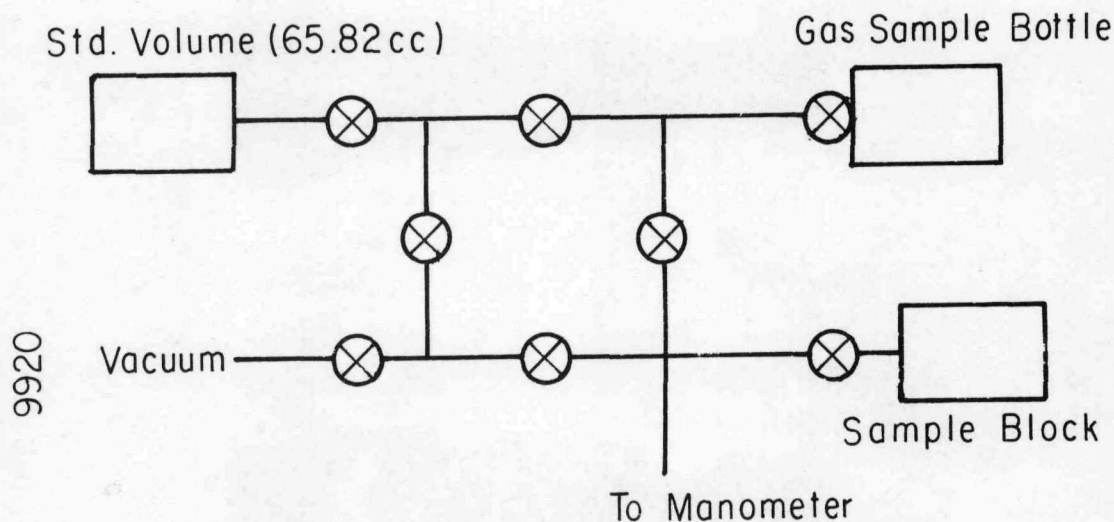
The capsule was punctured to measure the increase in internal pressure due to helium from alpha decay. Figure 3 is a schematic of the pressure test system which was used for this purpose. The source was fitted inside a sample block which was connected to the pressure measuring system. A standard volume, a gas collection bottle and a Wallace and Tiernan precision dial manometer were also connected to this system.

HEAT SOURCE INTERNAL PRESSURE MEASURING SYSTEM
