### ASSESSMENT OF EXTENT AND DEGREE OF THERMAL DAMAGE TO POLYMERIC MATERIALS IN THE THREE MILE ISLAND UNIT 2 REACTOR BUILDING

N. J. Alvares

Published February 1984

Lawrence Livermore National Laboratory  
Livermore, California

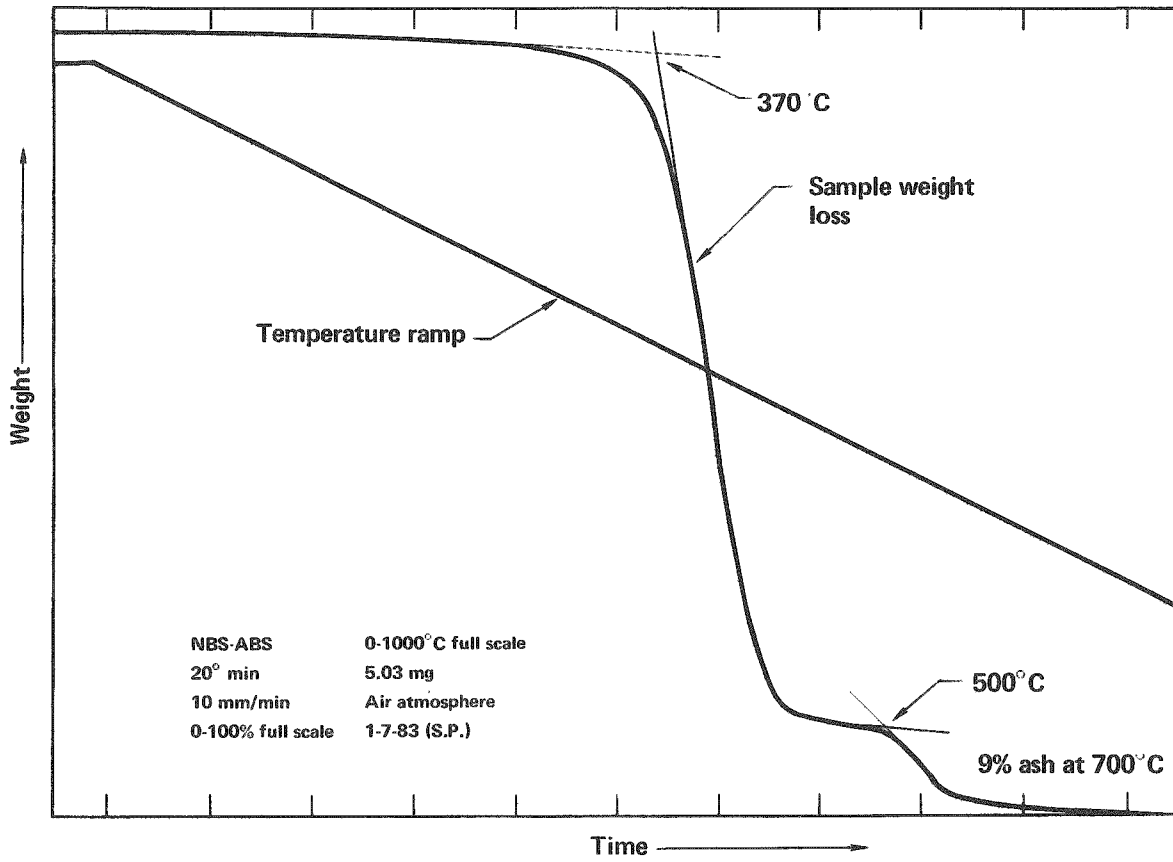
These figures are included to illustrate how different TGA records can be used to analyze performance of exposure materials. Figure 7 shows that NBS-ABS commences major weight loss at 370°C and terminates at 500°C. Most flammable pyrolyzates are emitted in this range, leaving about 20% inert material as residue. This material is flammable and, with an external ignition source, it will ignite within this range. Figure 8 shows two major weight-loss periods, the first occurring at 265°C and the second at 365°C. This ABS formulation included bromine- and antimony-containing fire retardants that release upon pyrolysis to inhibit flaming combustion.

Figure 7. Thermogram of NBS-ABS.

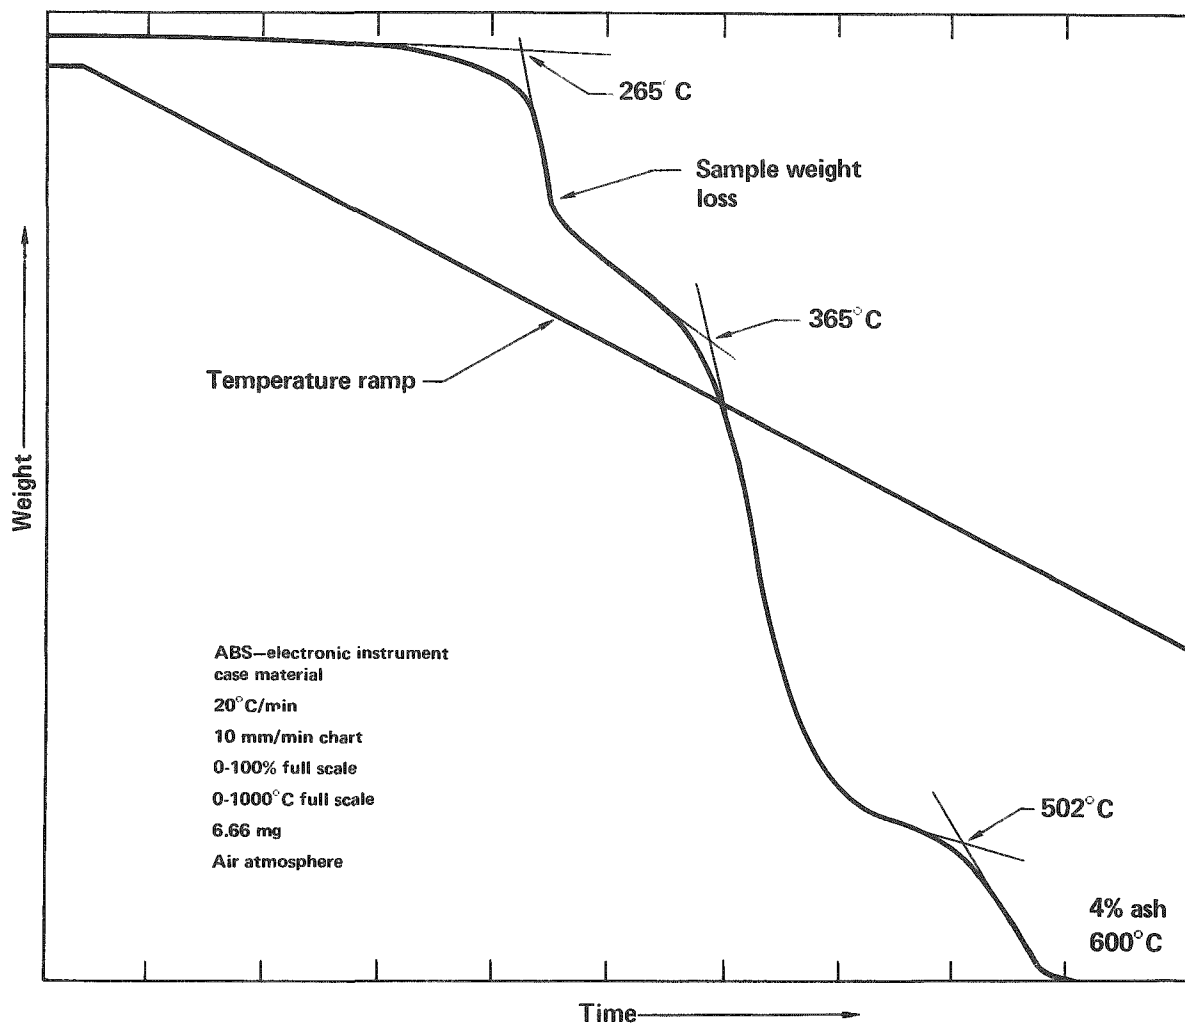
Figure 8. Thermogram of instrument-case ABS.
