DOE/NASA/20370-20
NASA TM-82594

Aluminum-Blade Development for the Mod-0A 200-Kilowatt Wind Turbine

Bradford S. Linscott and Richard K. Shaltens
National Aeronautics and Space Administration
Lewis Research Center

December 1981

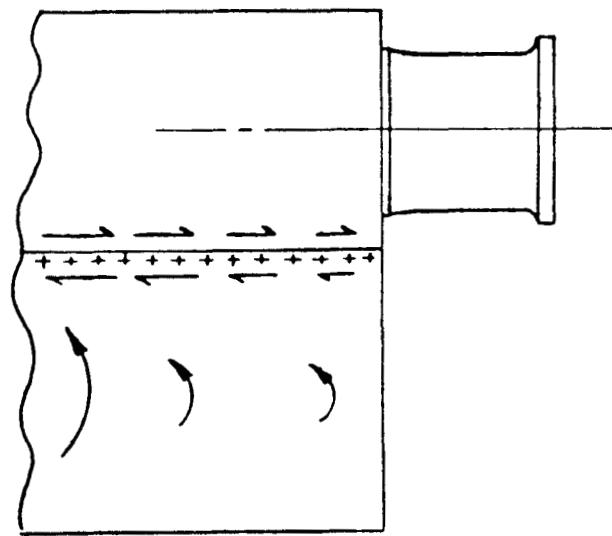
Figure 15. - Mod-0A blade trailing edge - D-spar fastener loads.

During the blade inspection at the Lewis Research Center, three types of blade damage were found. Figure 14 illustrates the nature and location of the damage. The damage included (1) loose and broken fasteners, (2) wear, and (3) cracking. It was concluded that damage at (1) was due to a design deficiency located along the line of fasteners joining the trailing edge skin to the D-spar (fig. 15). It was determined that the joint could not carry the applied shear loads shown in figure 15. The shear loads occur primarily due to the chordwise bending moments, blade weight being a major contributor. As a result, broken and loose fasteners were found, and cracks were found in several angle stringers located in the root end of the D-spar. This design deficiency was corrected by adding doublers on the exterior of the blade between station 48 and 100 as shown in figures 16 and 17.
