# RESULTS FROM THE RUN-BEYOND-CLADDING-BREACH IRRADIATION OF A PREFECTED FUEL PIN (RBCB-7)

## Hanford Engineering Development Laboratory

D.C. Langstaff  
M.Y. Almassy  
D.F. Washburn

February 1980

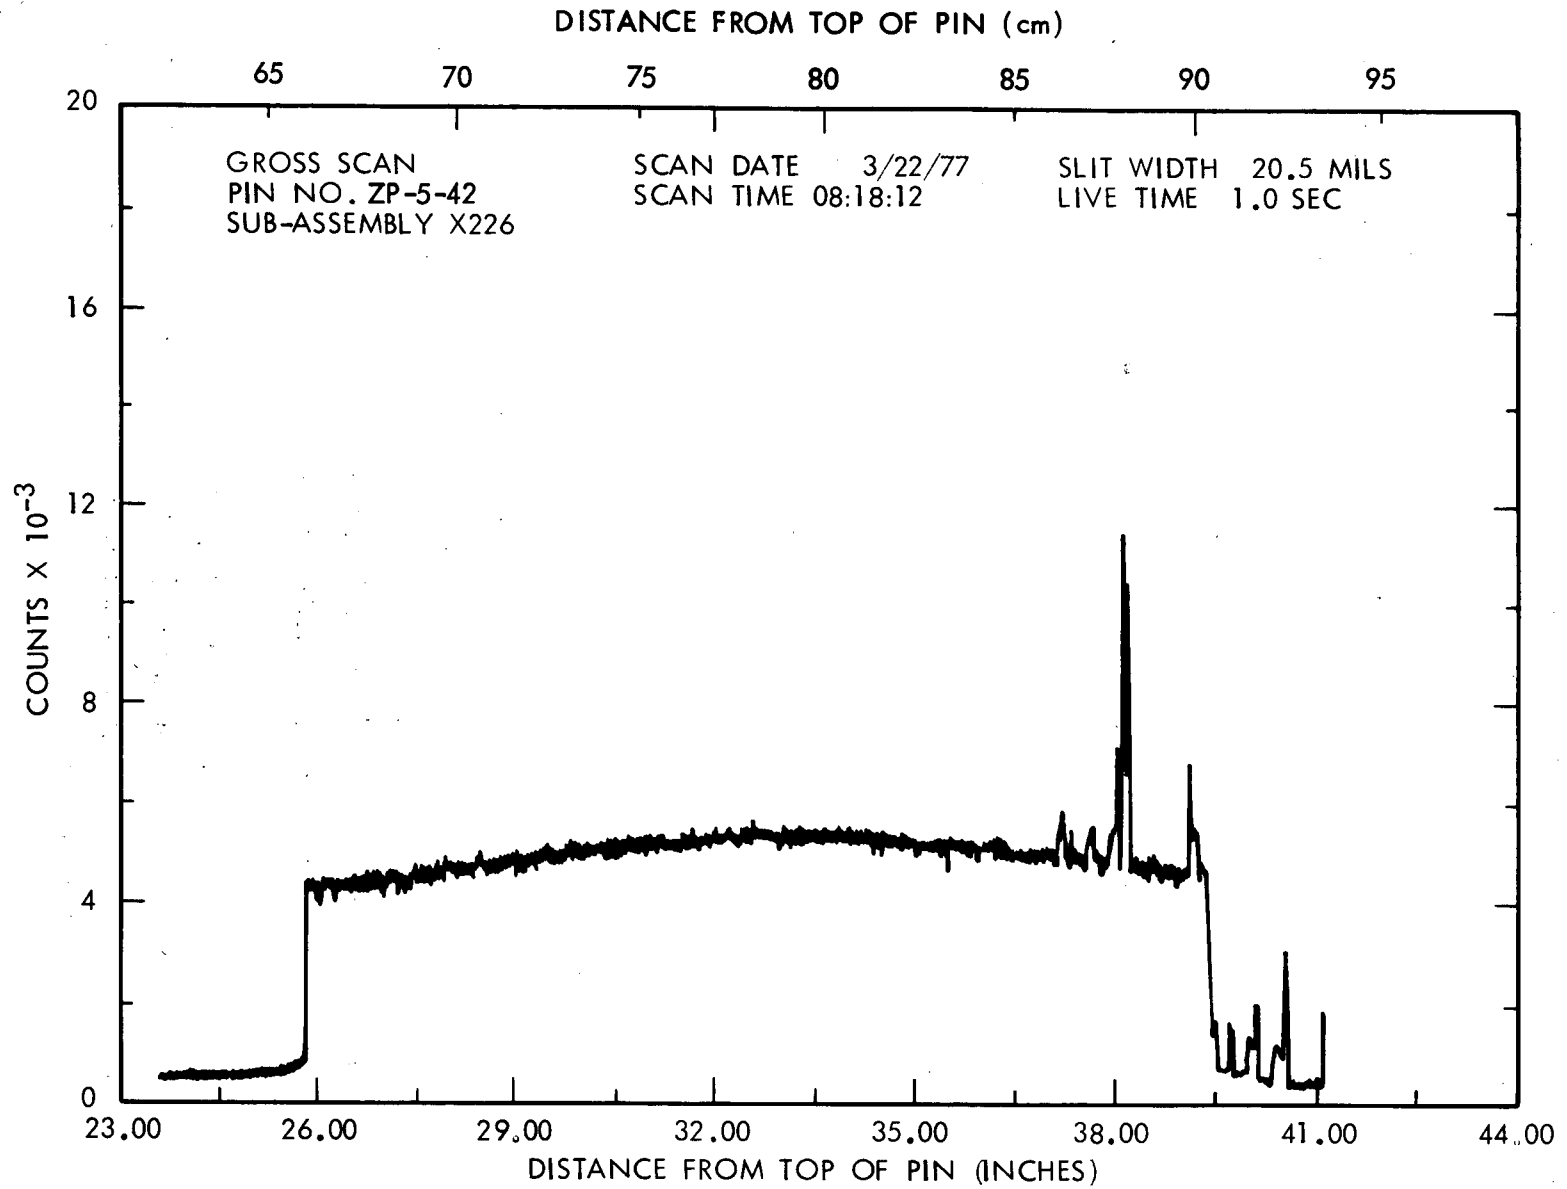
FIGURE 5. Gross Gamma-Scan for ZP-5-42 Prior to RBCB Irradiation. Neg 7909733-7

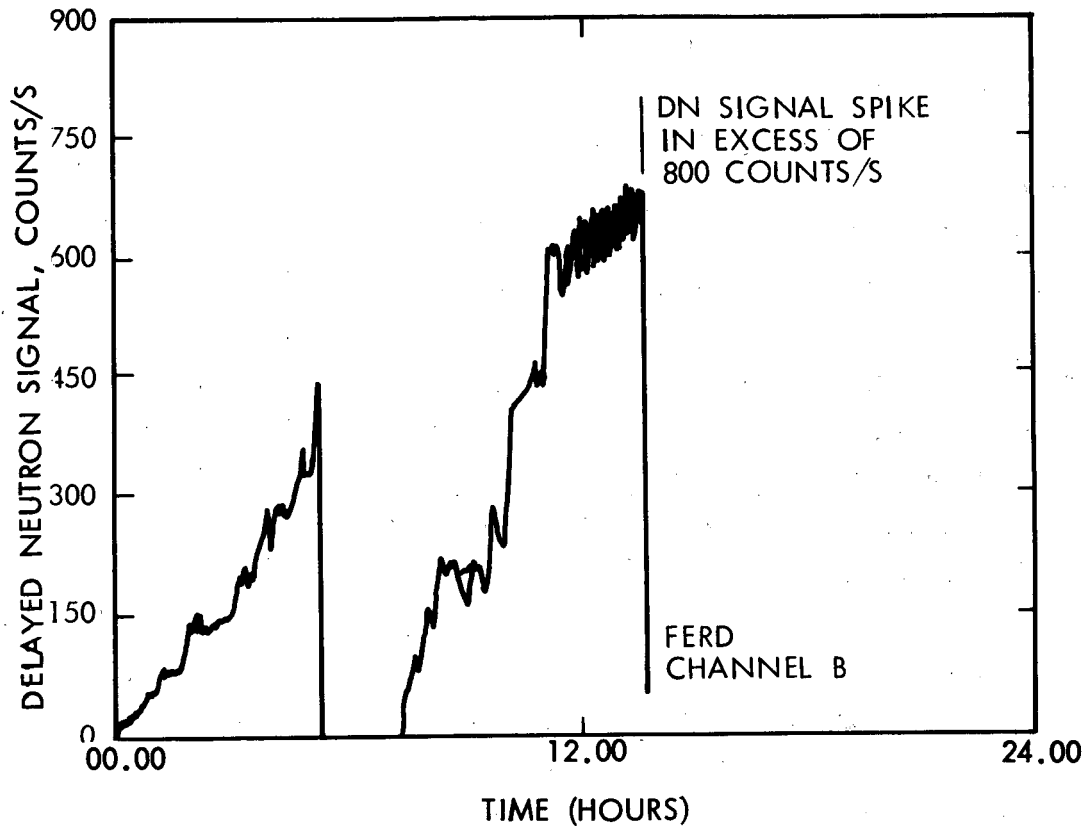
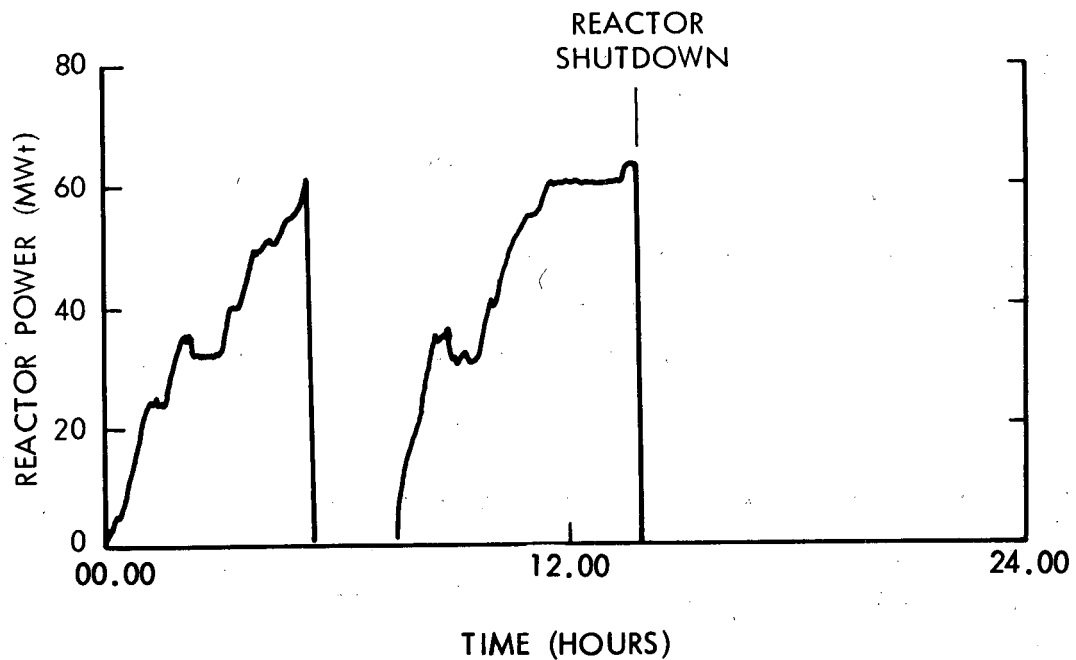
The behavior of the DN signal and reactor power with time are shown in Figure 8. The FERD system alarm setting was established during the initial rise to power. The alarm setting was twice the full power DN signal (425 counts/s) minus the normal background (50 counts/s) or 800 count/s. The DN signals were higher during the reactor restart than during the initial startup (Figure 9).

FIGURE 8. Reactor Power and Delayed Neutron Signal Time History During RBCB-7, EBR-II Run 90A. Neg 7909733-4

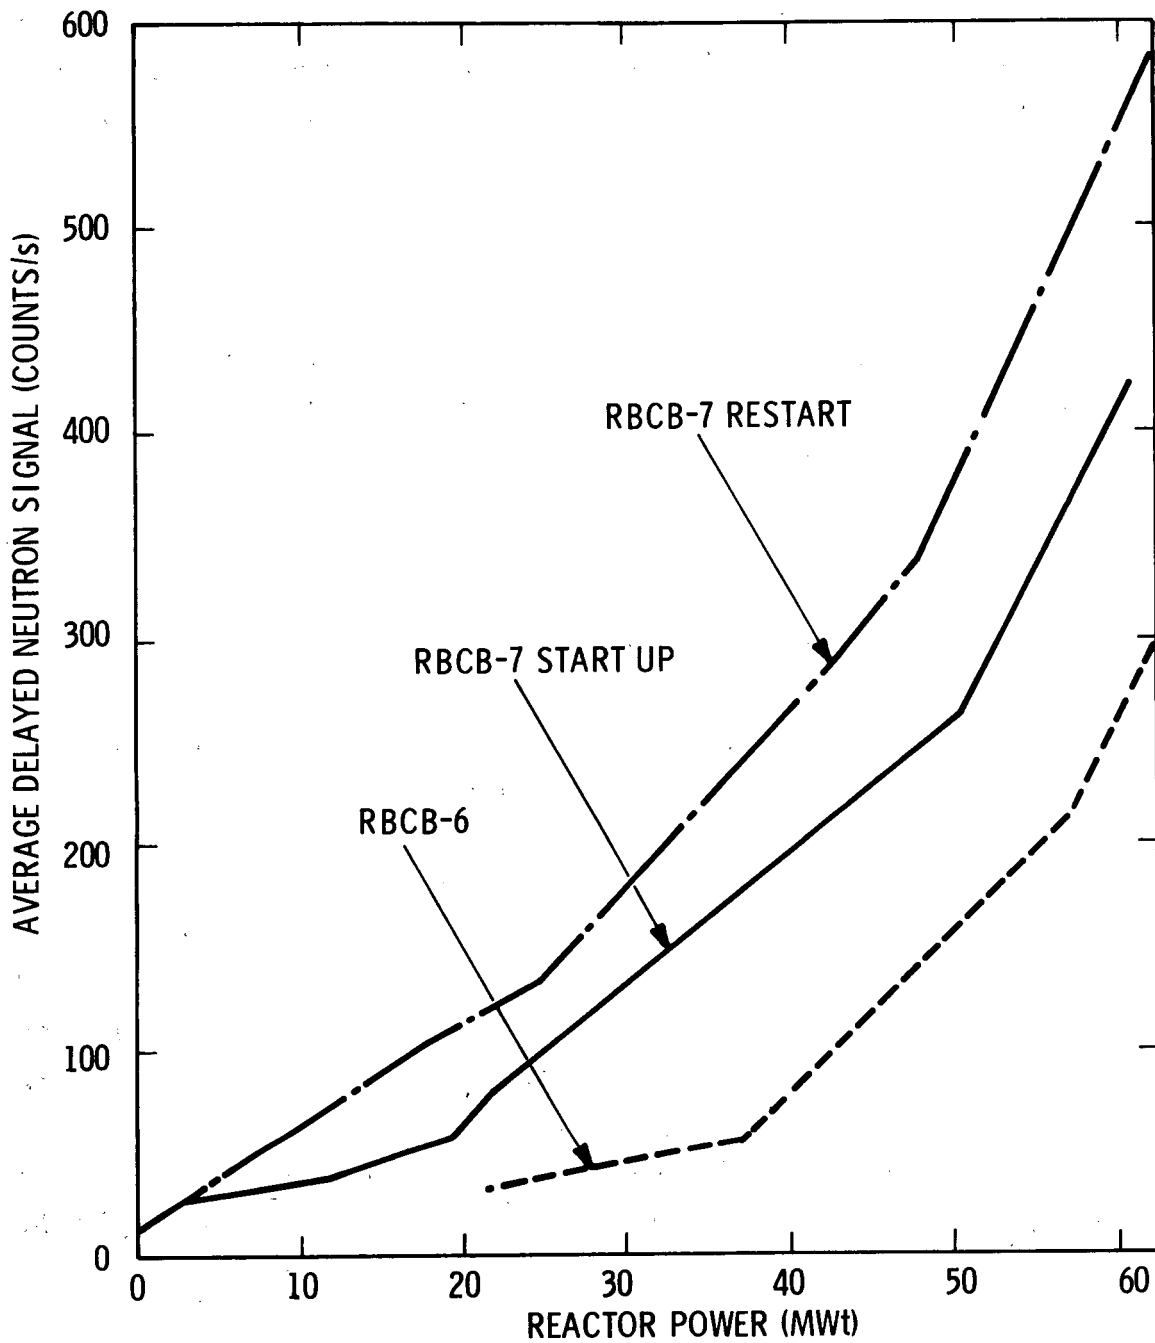
Both RBCB-6 and -7 exhibited nonlinear DN behavior with respect to reactor or pin power (Figure 9). The DN signals from RBCB-7 were generally higher than those in RBCB-6, especially in the nonlinear region.

FIGURE 9. Delayed Neutron Signal from RBCB-7 Increased Nonlinearly with Reactor (or Pin) Power. Neg 7909733-1

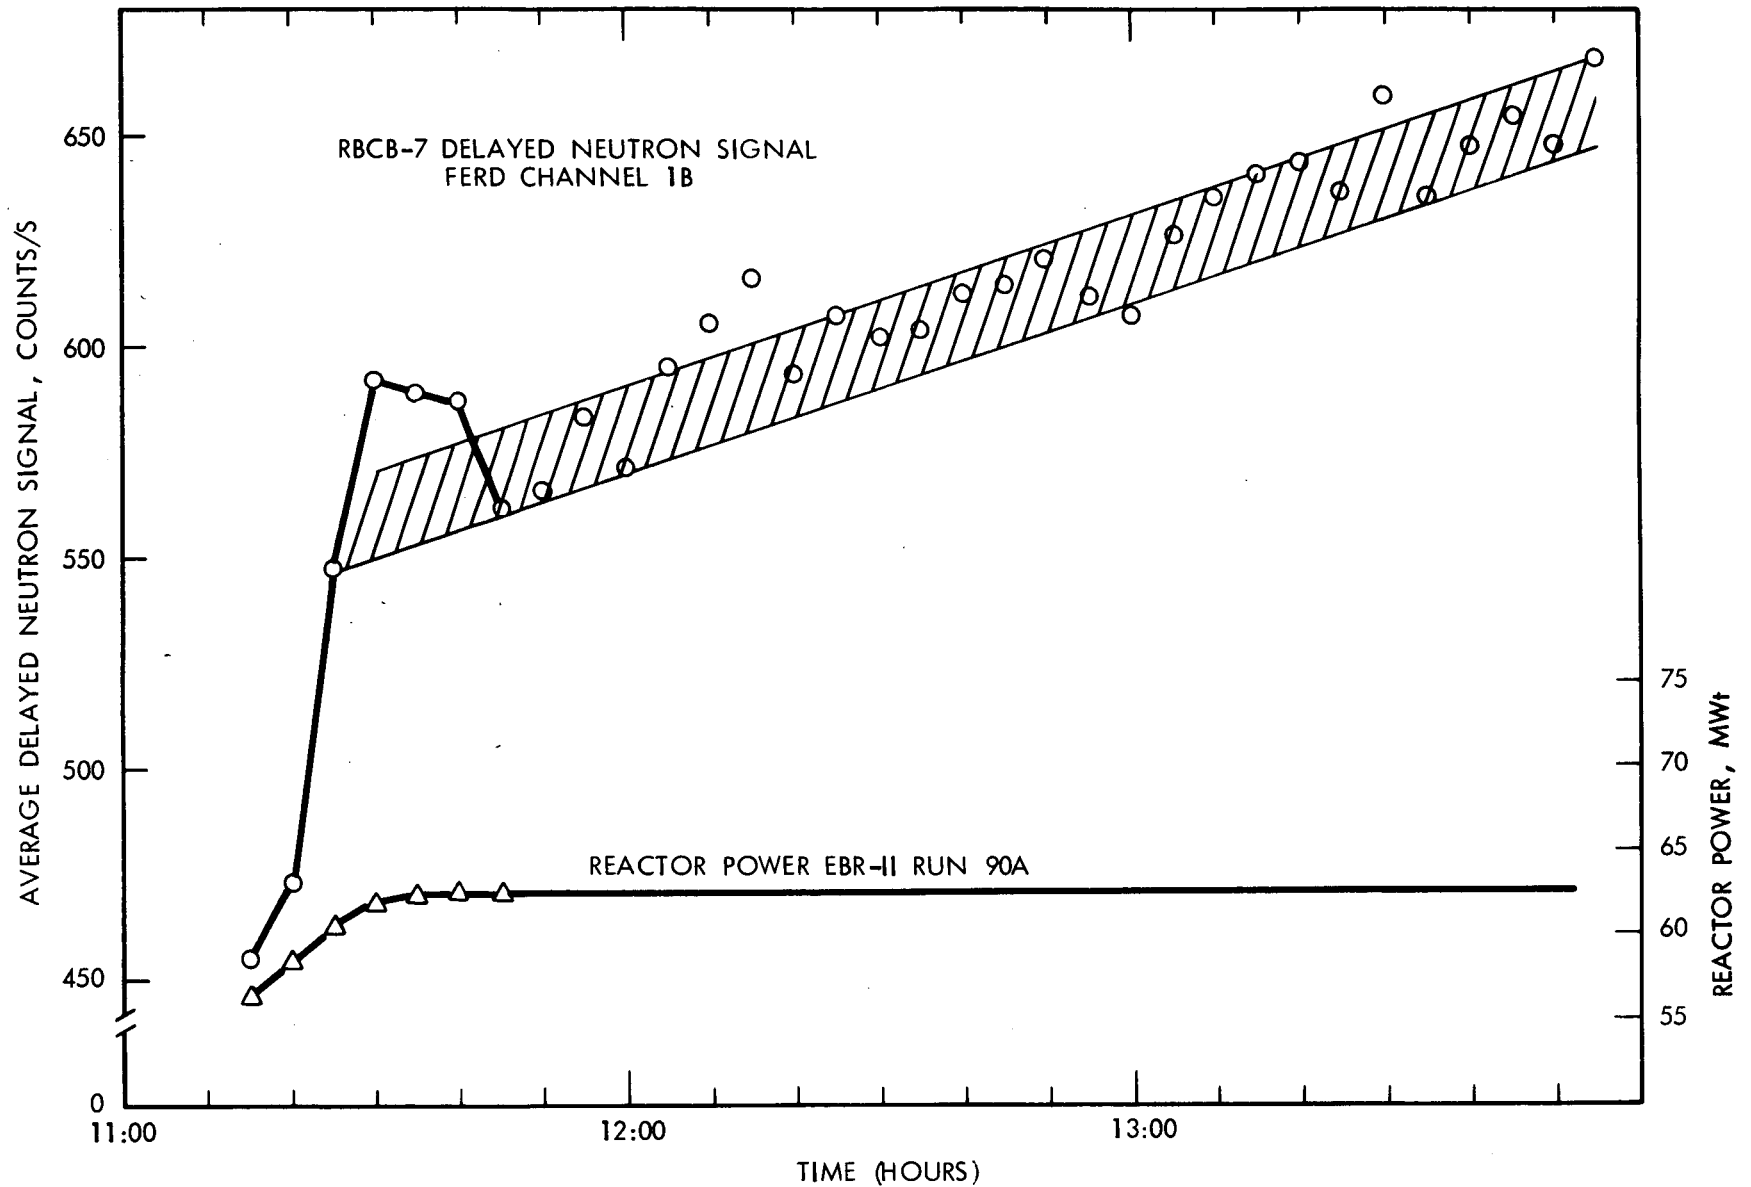
During operation at full power, the DN signal continued to increase gradually as shown in Figure 10. The data points in Figure 10 were obtained by averaging DN data recorded at a rate of two points per second over five-minute intervals.

FIGURE 10. The Average Delayed Neutron Signal Increased Continuously Until the Administrative Shutdown Limit was Reached. Neg 7909733-8

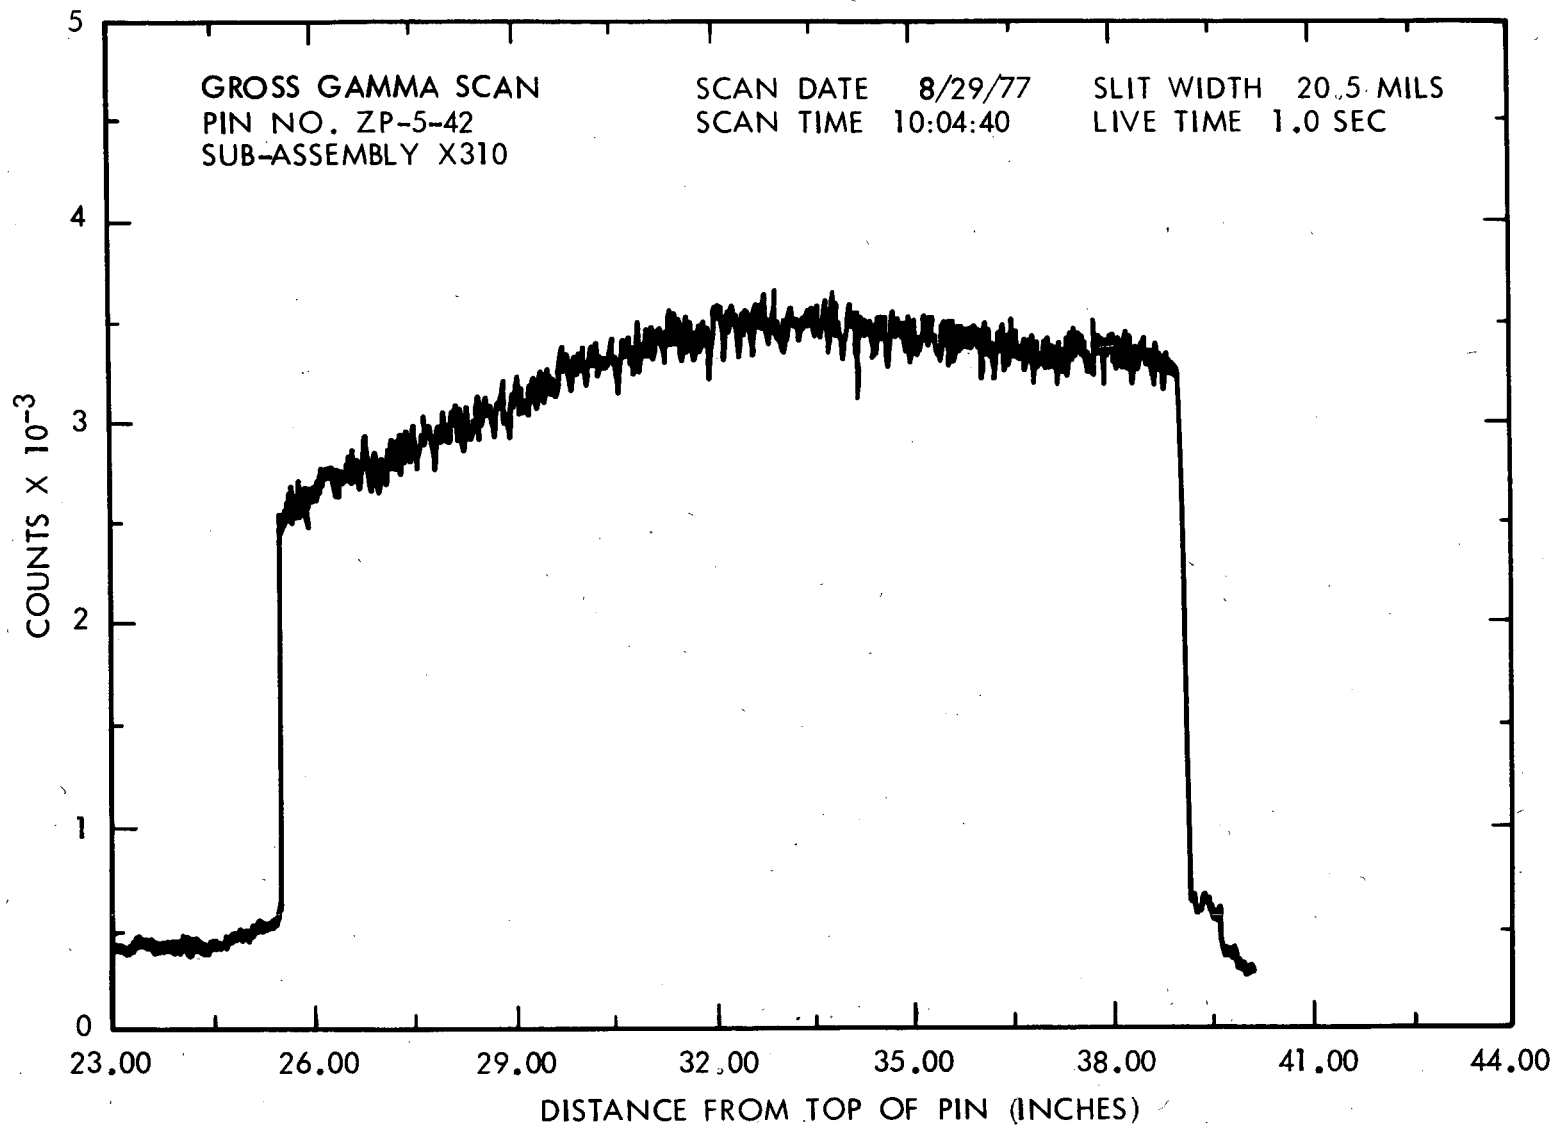
The post-RBCB gross gamma scan (Figure 14) was relatively flat from the bottom of the fuel (BOF) to about 21.6 cm (8-1/2 in.) above the BOF at which point the scan began to decrease until a one-third decrease in intensity was achieved at the top of the fuel column. This same type of profile also occurred in some of the other fuel pins from X224, X225 and X226.

FIGURE 14. Gross Gamma Scan for ZP-5-42 after RBCB Irradiation. Neg 7909733-3

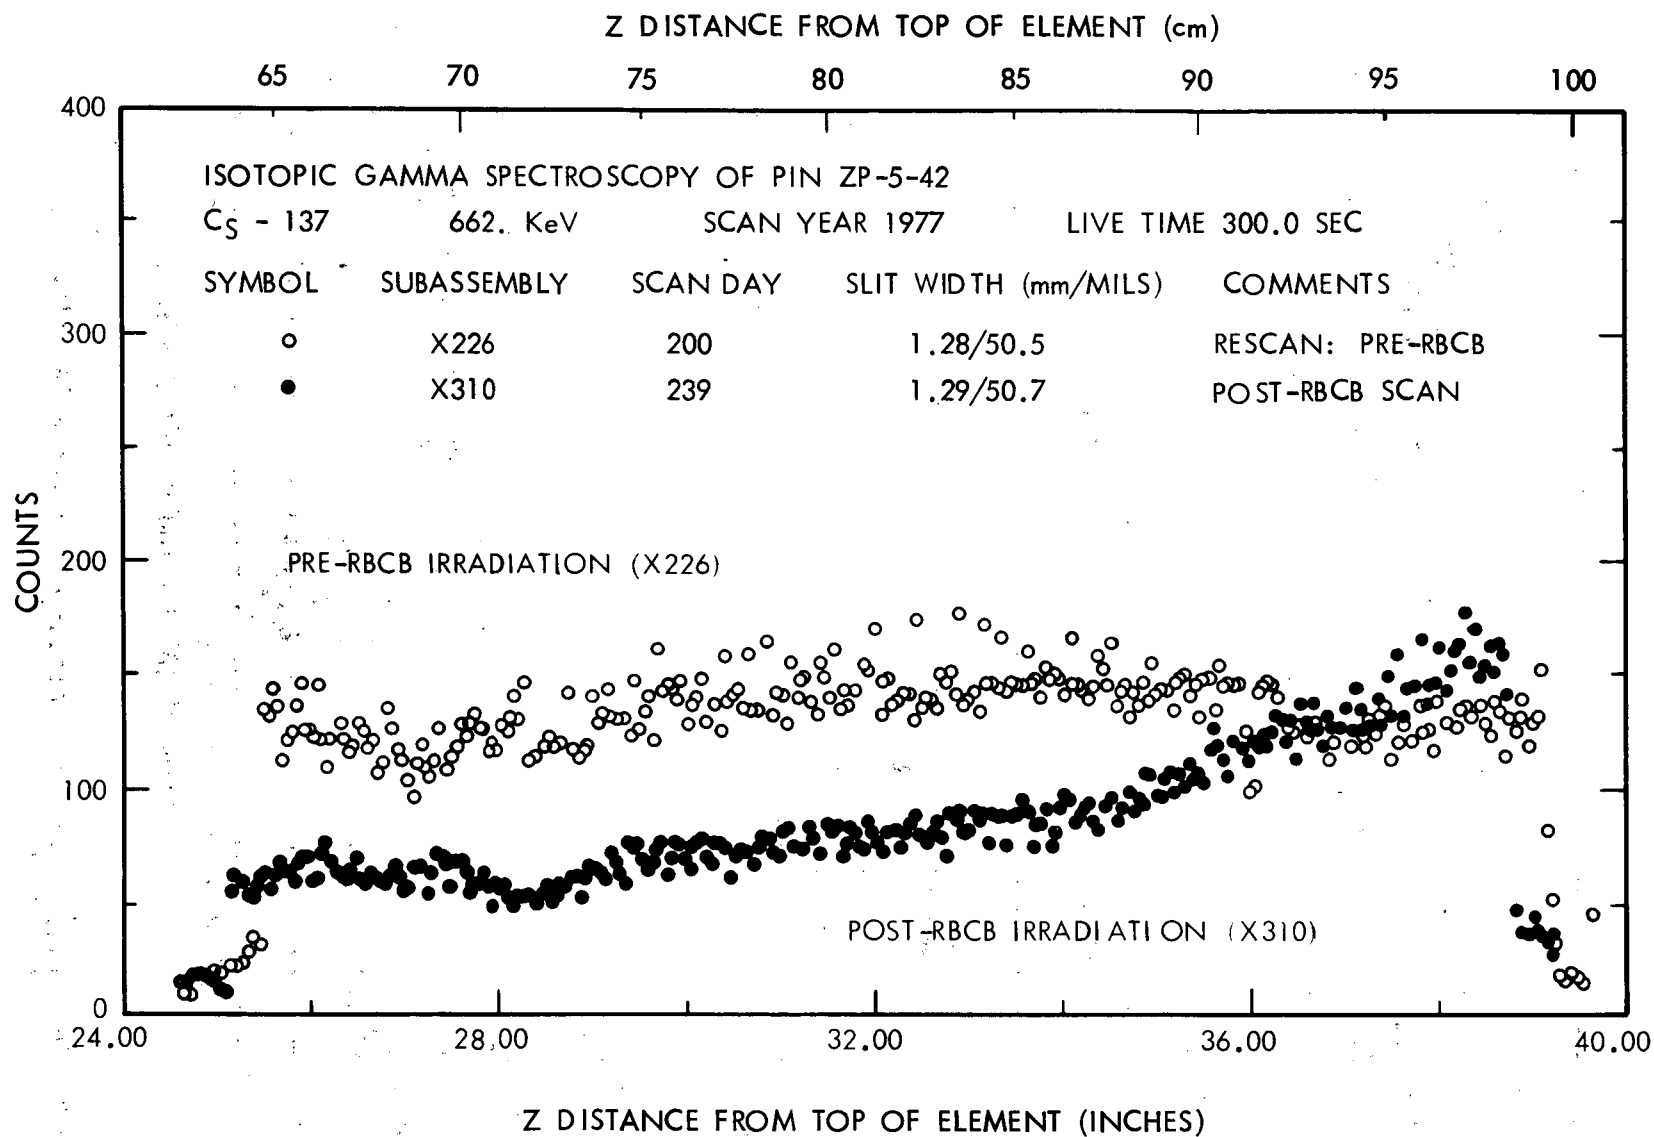
- 1) Even though cladding material was removed during machining of the slit, a local loss of cladding material was not evident from a comparison of either the  $^{54}\text{Mn}$  scans or the  $^{58}\text{Co}$  scans.
- 2) There was no indication of a change in the distribution of  $^{95}\text{Nb}$  or  $^{95}\text{Zr}$ , which are dispersed in the fuel matrix and are relatively immobile. For this reason, it is unlikely that there was any significant fuel loss during RBCB irradiation.
- 3) The  $^{137}\text{Cs}$  in the upper two-thirds of the fuel column was significantly reduced during the RBCB irradiation (Figure 15). The decrease in Cs activity in the top two-thirds of the pin is attributed to the release of the more mobile cesium into the sodium coolant.

FIGURE 15. Cesium Gamma Scan for ZP-5-42 Before and After RBCB Irradiation. Neg 7909-733-2

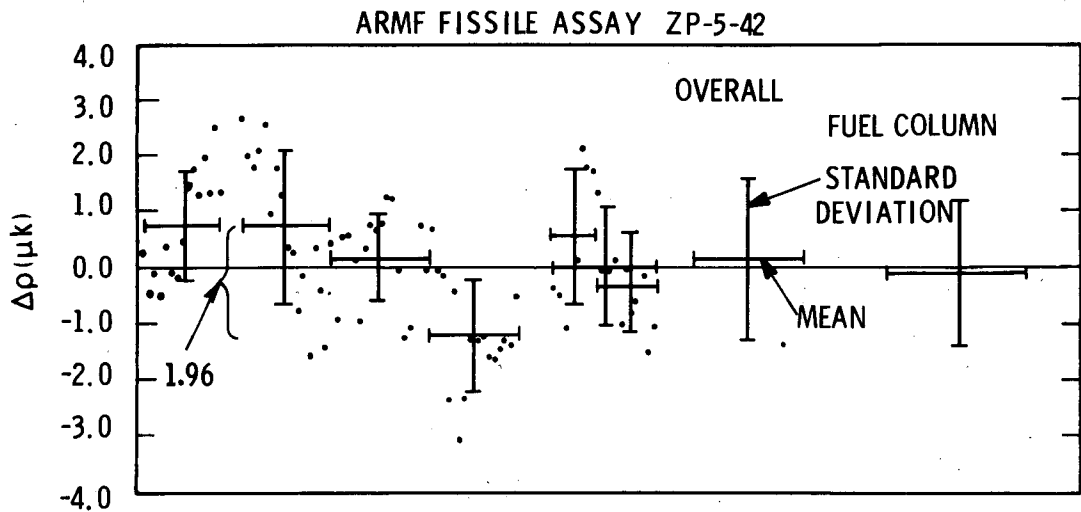
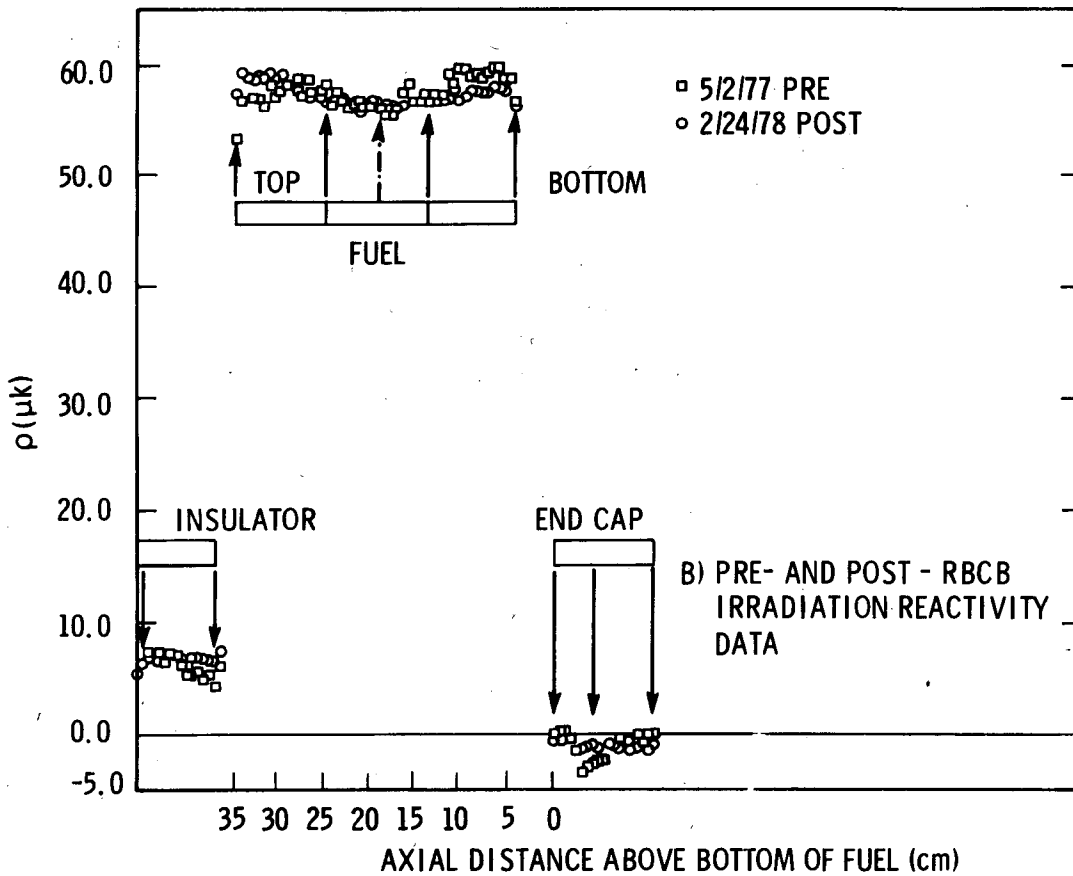
A fission assay technique was developed by EG&G at the Advanced Reactor Measurement Facility (ARMF)<sup>(9)</sup> to determine the fuel losses from RBCB fuel pins. Reactivity profiles determined for the predefected, irradiated fuel pin (ZP-5-42) after defecting and again after subsequent irradiation are shown in Figure 16.

The scatter in the data made it difficult to discern any effects of the RBCB irradiation. A statistical analysis was performed to determine whether or not the pre- and postirradiation profiles were statistically the same. Using Student's "t" test, the hypothesis that the pre- and postirradiation

FIGURE 16. Fissile Assay Reactivity Data for RCB-7 (ZP-5-42).  
Neg 7911487-2

means were the same could not be rejected. This implied that there was no measurable change in fuel content over the length of the fuel column during RBCB irradiation.

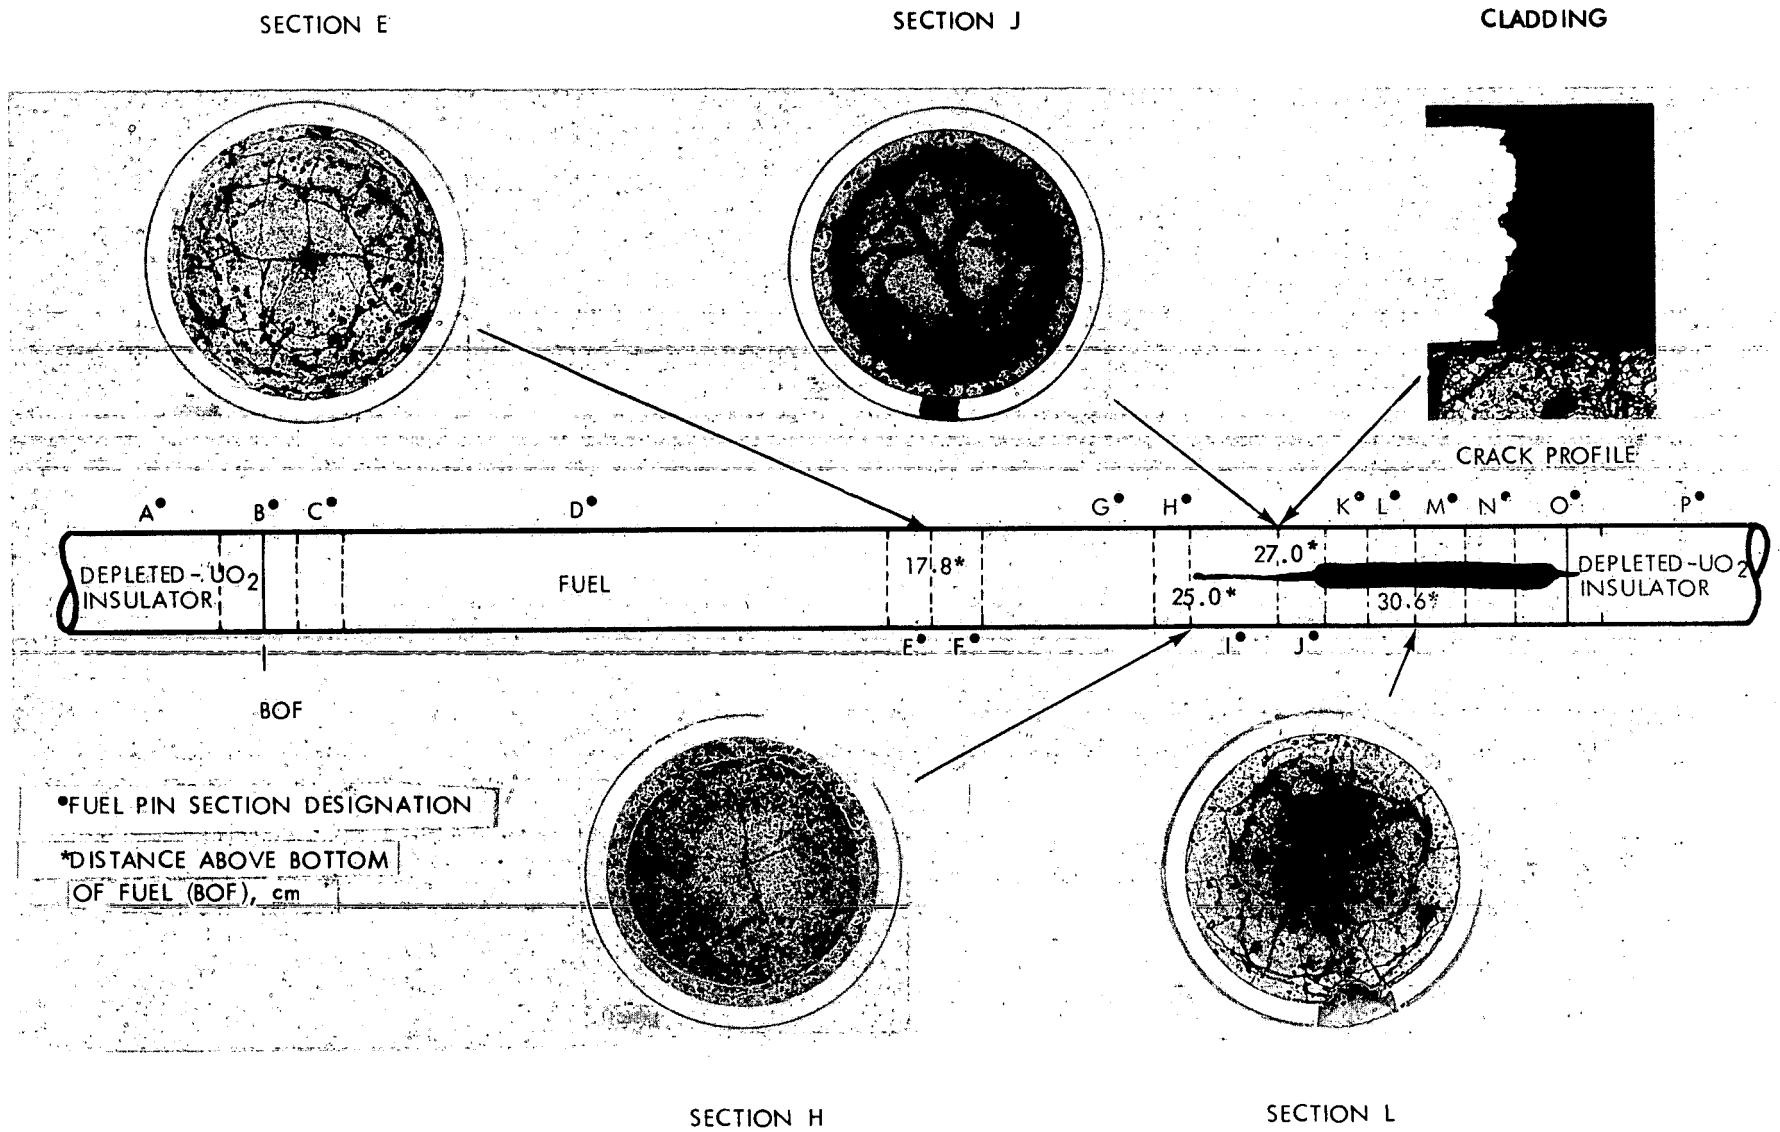
FIGURE 19. A Summary of the Photomicrography for ZP-5-42. Neg 7909733-14

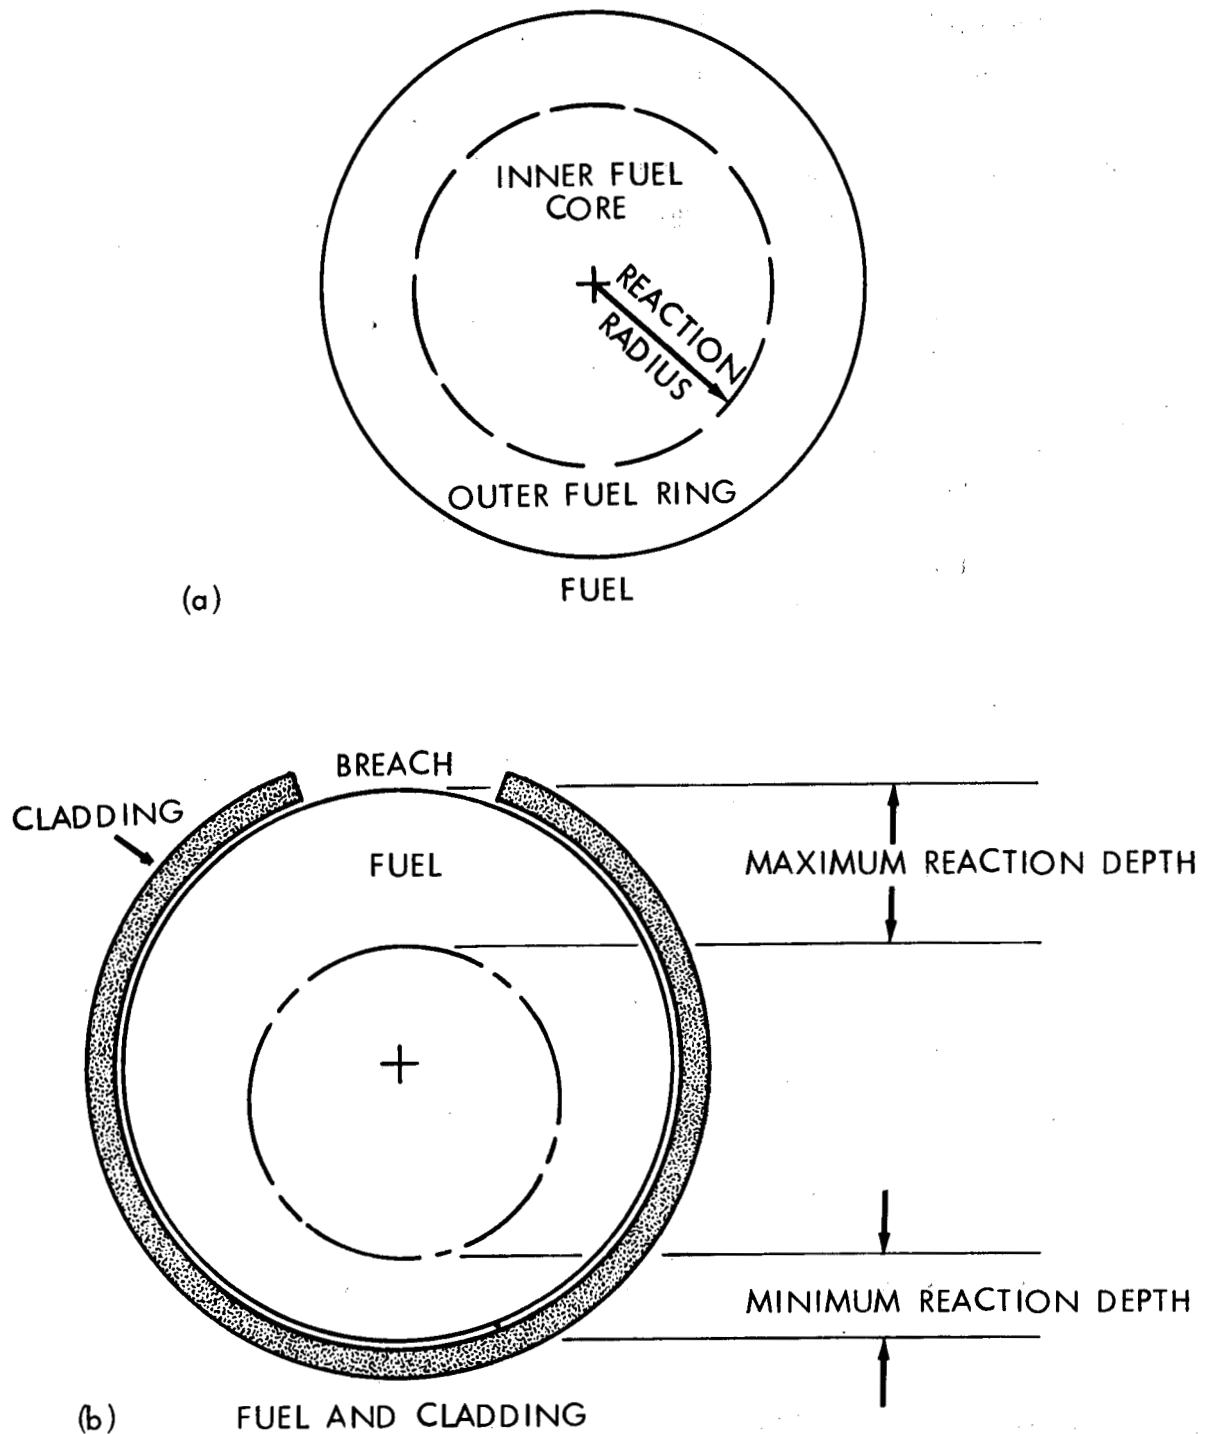
The intergranular sodium-fuel reaction product appeared only in the outer fuel rim, generally beyond a radius of 2.1 mm in both pins (see Figure 33). The intergranular reaction product occurred over a ring of fuel from 0.4 mm to 0.6 mm thick. In general, the reaction zone was thicker adjacent to the cladding slit extension. This resulted in an asymmetric sodium-fuel reaction distribution about the pin axis. Examples of isolated rounded islands of reaction product also occurred in the outer rim but were more common in the inner fuel core.

The minimal depth of intergranular reaction product was uniform ( $0.4 \pm 0.1$  mm) for all sections measured, measuring from the geometric center of the fuel. In a fuel section with a reaction zone of varying thickness, the greater penetration usually occurred near the breach site itself. For example, the reaction depth varied from 0.56 mm adjacent to

FIGURE 33. Schematic Diagram Illustrating the Terms Used to Describe the Sodium-Fuel Reaction Product Distribution: a) Fuel Structure and b) Reaction Depth. Neg 7909733-1
