LA-10232-SR
Status Report

General-Purpose Heat Source Development: Safety Test Program

Postimpact Evaluation, Design Iteration Test 5

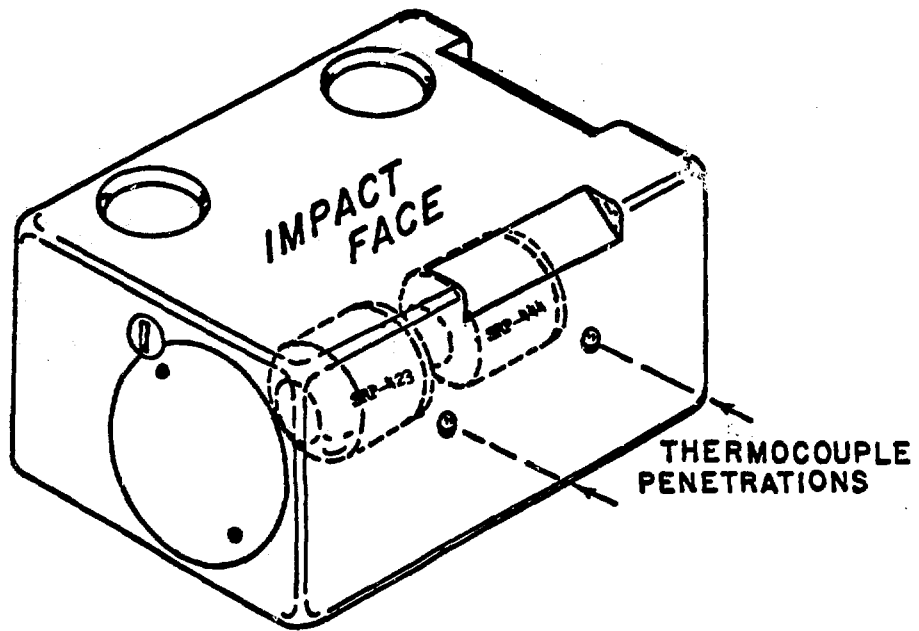
Radiographic examination indicated that both fuel pellets were severely cracked before testing (Figs. 1 and 2); although it is not apparent in the radiographs, pellet HF-444 was reported to be nonintegral at loading (two pieces). Postimpact examination of the as-opened fuel capsules (Figs. 40 and 41) revealed that both pellets were badly fragmented. The fuel in capsule SRP-444 fractured cleanly along an axial plane (Fig. 41) and pushed through the clad in a line running the length of the impact face (Fig. 8). Pellet HF-423 fractured in a more random manner (Fig. 40) and produced less clad damage.

Fig. 2. Radiographic prints of the fuel capsules after aging at 1310°C for 30 days. (a) SRP-444 and (b) SRP-423. Approximately 1X.

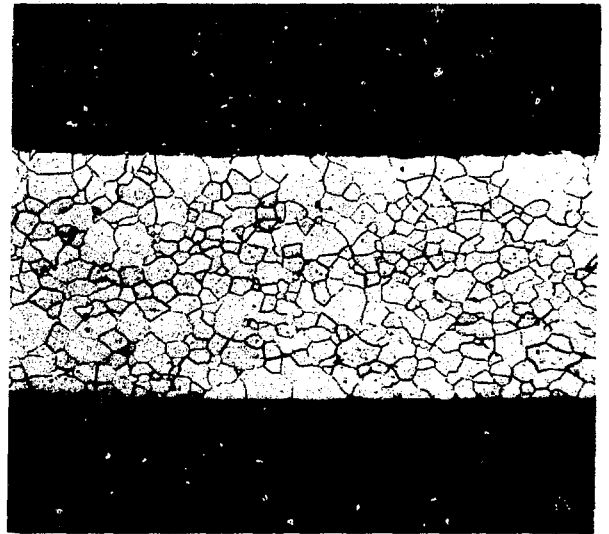
The iridium grain size in the SRP-423 cups ranged from 15 to 22 grains/0.635-mm nominal wall thickness. Although isolated areas of grain growth were observed in the vent cup (Fig. 26), the microstructure was generally fine grained (Fig. 27). The shield cup also had a fine-grained microstructure (Fig. 28).

Fig. 27. The microstructure of the SRP-423 vent cup was generally fine grained. 50X.

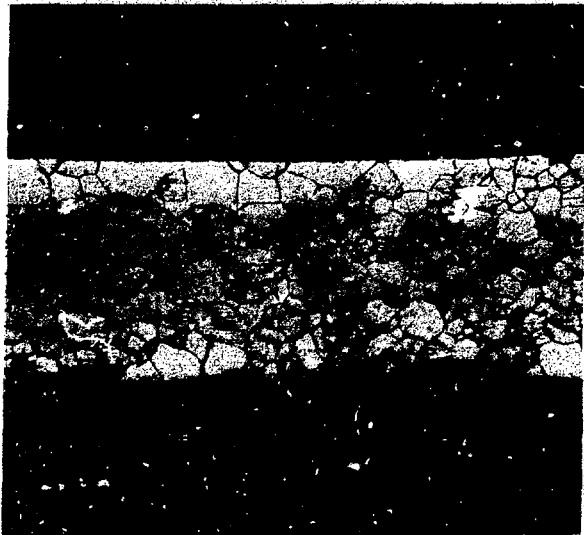
Fig. 28. The SRP-423 weld-shield cup had an average of 15.5 grains/thickness. 50X.

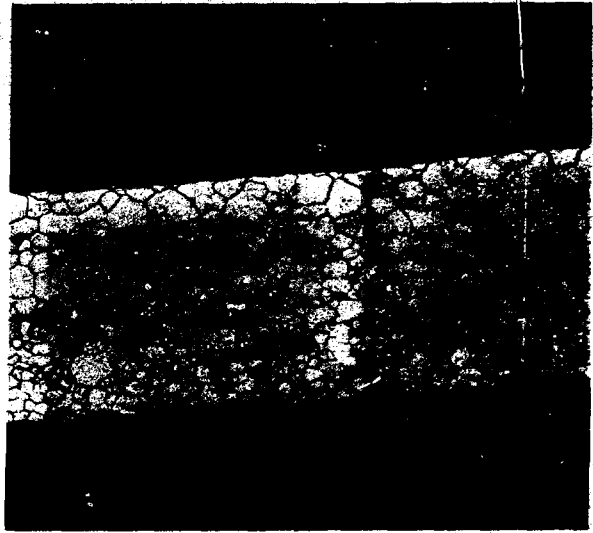
cup microstructure was generally fine grained (Fig. 32). Slight grain coarsening was also observed on the vent cup interior (Fig. 33).

Fig. 32. The microstructure of the SRP-444 shield cup was generally fine grained. 50X.

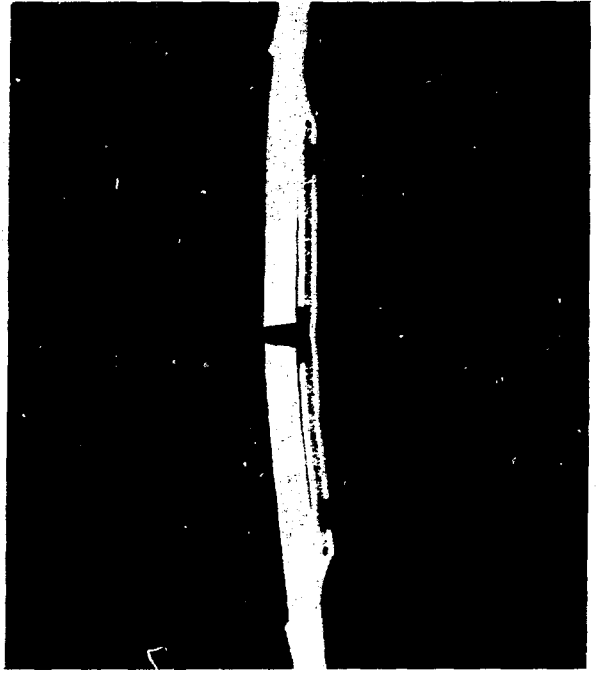
The capsule vents were carefully examined to determine the effects of the preimpact heat treatment (30 days at 1310°C) and to further define the impact response of the vent structure. Macroscopic examination revealed that both vents survived impact with only minor deformation (Figs. 34 and 35). No mechanical defects were observed in either vent, and both vent frits were uniform and properly aligned. A small crack was, however, observed in the SRP-423 vent assembly weld (Fig. 36). The crack was generally intergranular (Fig. 37) but did split a small grain near the inner surface. In addition, unusual amounts of grain growth were observed in wall sections adjacent to the vent cover welds in both capsules (Figs. 38 and 39).

Fig. 35. The SRP-444 vent was undamaged. 7X.

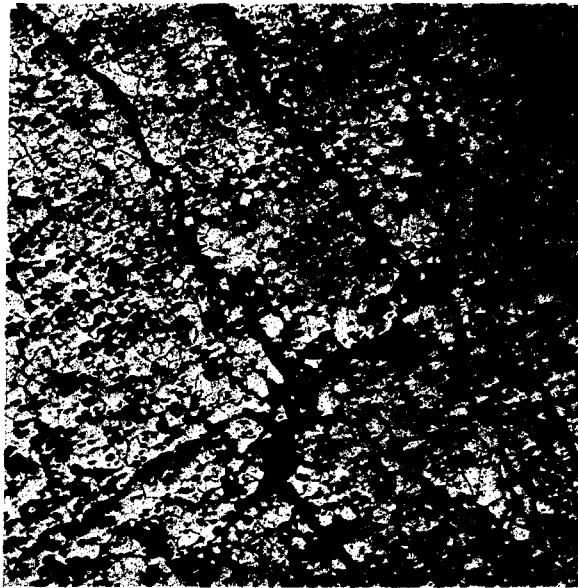
Fig. 43. Ceramographic specimen removed from the exterior of pellet SRP-423. (a) Macrograph, 10X; (b) micrograph, as polished, 100X; and (c) as etched, 100X.

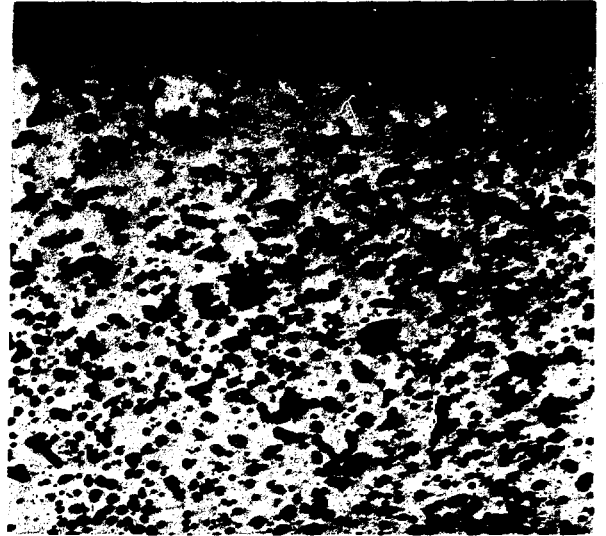
Fig. 45. Ceramographic specimen removed from the exterior of pellet SRP-444. (a) Macrograph, 10X; (b) micrograph, as polished, 100X; and (c) as etched, 100X.
