**LA-10012-SR
Status Report**

General-Purpose Heat Source Development: Safety Test Program

Postimpact Evaluation, Design Iteration Test 2

F. W. Schonfeld
T. G. George

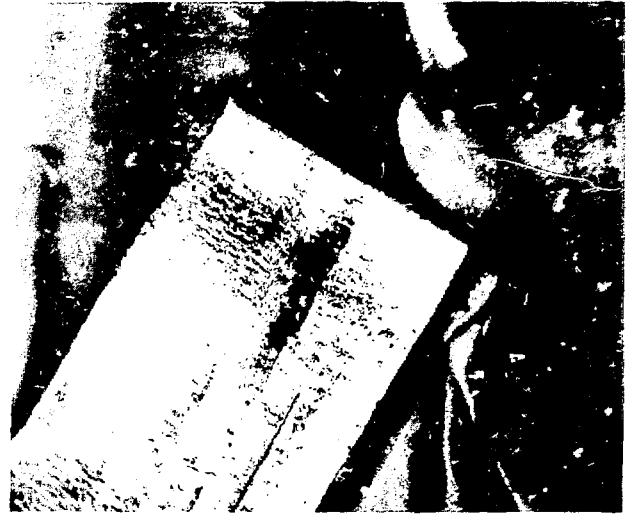
Fig. 10. Three crack families were observed on the interior of capsule SR-106. (a) In the reverse-bend region nearest the weld overlap; (b) on the second reverse bend; and (c) on the capsule back. All 6X.

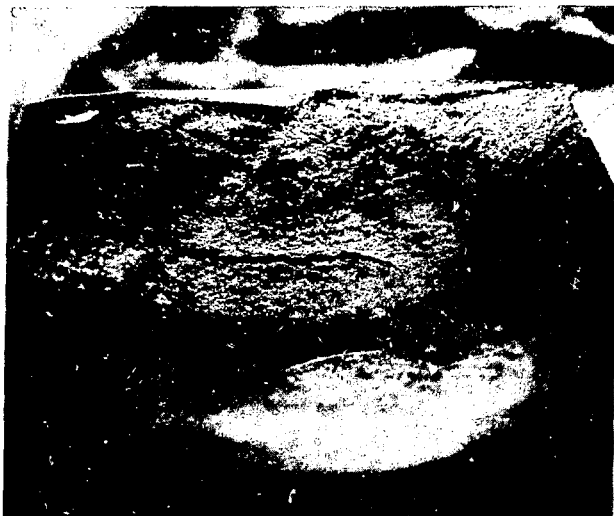
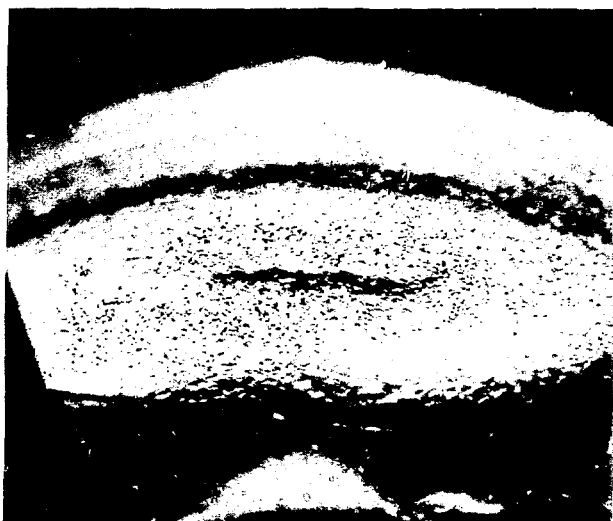
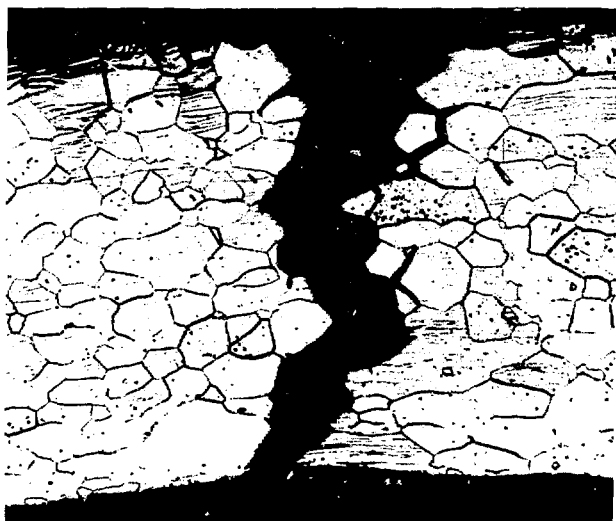
Capsule SR-110 deformation mirrored that of SR-107, including the crack which breached the wall in the radiused portion of the vent end. However, note that the crack in SR-110 was slightly higher and closer to the vent. Internal cracking of the weld bead in SR-110 was not nearly as extensive as that found in capsule SR-107. We observed only one set of cracks in the SR-110 weld bead (Fig. 15). Figure 9 shows the location of these cracks relative to the weld submergence and end. The breaching crack is shown in Fig. 10.

Fig. 16. Breach in the vent-end radius of capsule SR-110. (a) External surface, 6X; (b) internal surface, 6X; and (c) etched cross section, 100X.

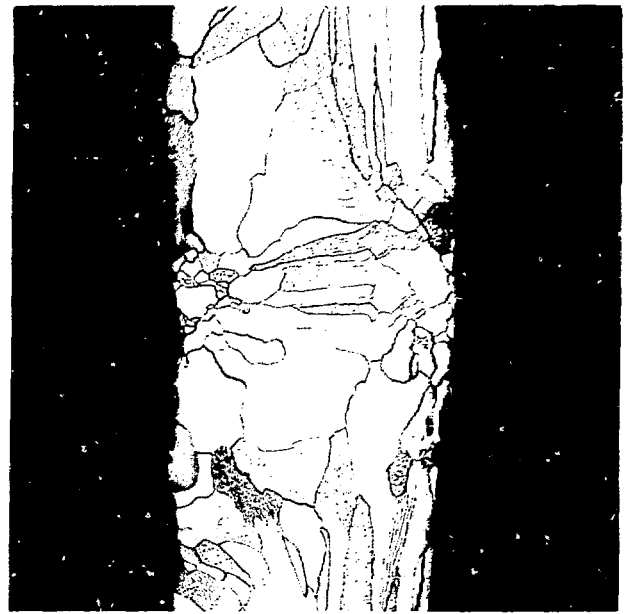
The single-pass weld section of capsule SR-107, shown in Fig. 21, appeared to be sound and contained no unusual microstructural features. The overlap cross section was quite porous (Fig. 22a). This porosity was largely confined to the grain boundaries of the remnant first-pass weld metal (Fig. 22b). Figure 22c verifies this observation within the central portion of the weld bead; Fig. 22d shows that the same phenomenon is present at the root of the weld bead.

Figures 22c and d clearly indicate that gas evolution can take place at grain boundaries in the weld metal when it is reheated to temperatures approaching the melting point. Figure 23 (SR-105) demonstrates that this type of porosity can be produced in wrought as well as cast (weld bead) iridium alloy. The section shown in Fig. 23 was cut parallel to the weld direction and slightly above the centerline and includes both unmelted wall and weld bead. Reverse bending on impact seems to have produced the crack that originated on the inside surface, and grain-boundary porosity obviously contributed to the failure. Whether the gas evolution that causes grain-boundary porosity is independent of or part of the "hot short" weld cracking problem, which we observed previously, is unclear; however, some degree of interaction is likely.

The welds on all four of the DIT-2 capsules were generally of acceptable quality and contained no significant defects. The weld in capsule SR-107, however, was quite porous in the overlap region (Fig. 22). Similar porosity was observed in a wall section removed from capsule SR-105 (Fig. 23). Apparently, reheating the iridium alloy to temperatures approaching the melting point caused grain-boundary porosity in both capsules. Because such porosity appears to be a characteristic response of iridium alloy exposed to temperatures near the melting point, grain-boundary porosity is a possibility in any overlap weld.

Fig. 22. Porosity was present in the overlap region of the SR-107 weld. (a) As-polished, 50X; (b) same area, etched, 50X; (c) SEM photograph of porosity in the central portion of the weld bead, 700X; and (d) SEM photograph of porosity at the root of the weld bead, 700X.

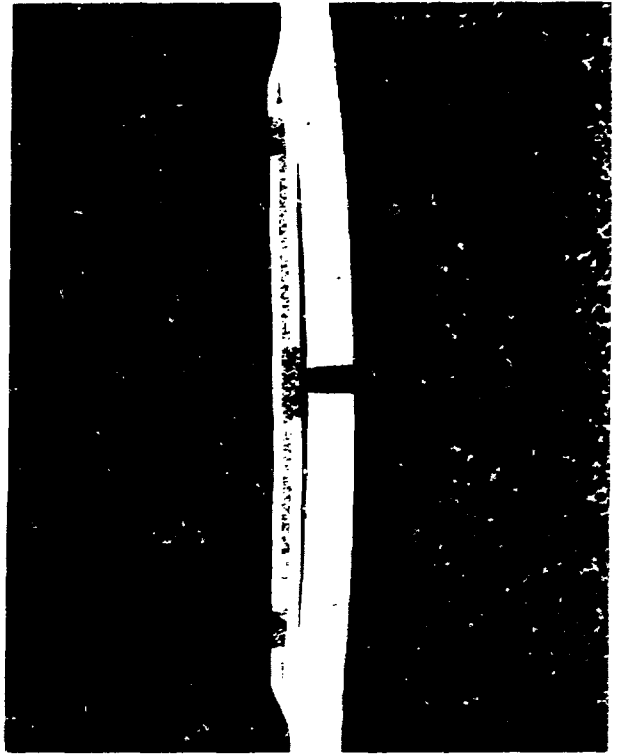
The four vent structures were carefully examined to determine if the pretest heat treatment (100 h at 1300°C) had caused the transport of any fuel components and to further define the mechanical response of the vent assembly. No mechanical defects were observed in any of the vent sections. All of the frits were uniform and properly aligned. No significant amounts of fuel impurities were detected in the vent cross sections. All vents, shown in Figs. 28 through 31, survived the test without significant damage. The SR-106 and SR-107 vents exhibited a small amount of plastic strain, and the SR-110 vent weld had a small crack. However, these defects are minor, and the overall response of the four vents is satisfactory.

Fig. 28. A vertical section through the capsule SR-105 vent, 10X.

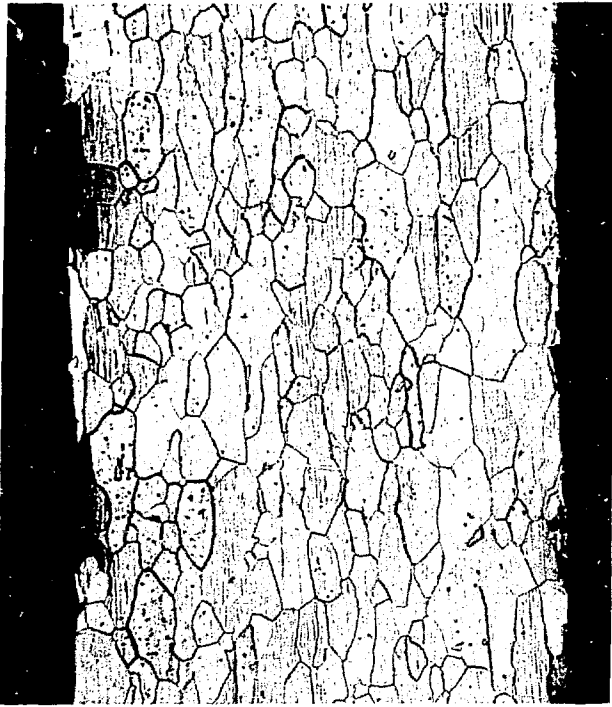
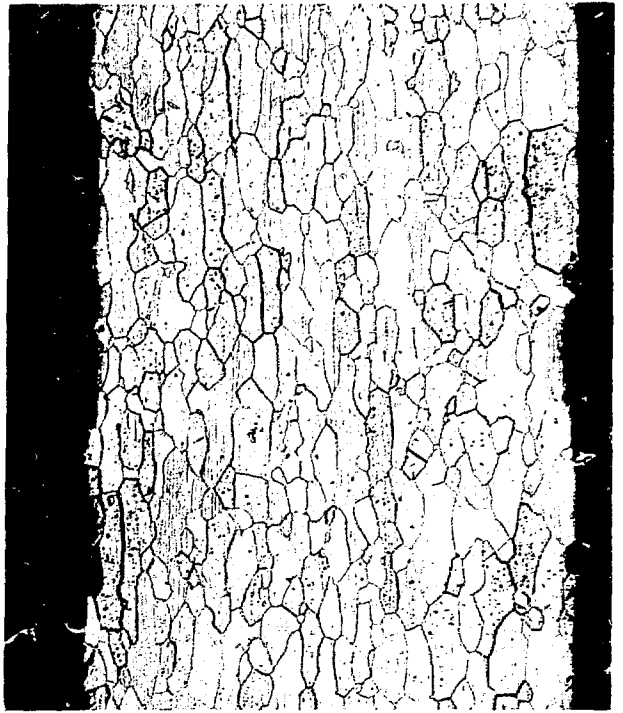
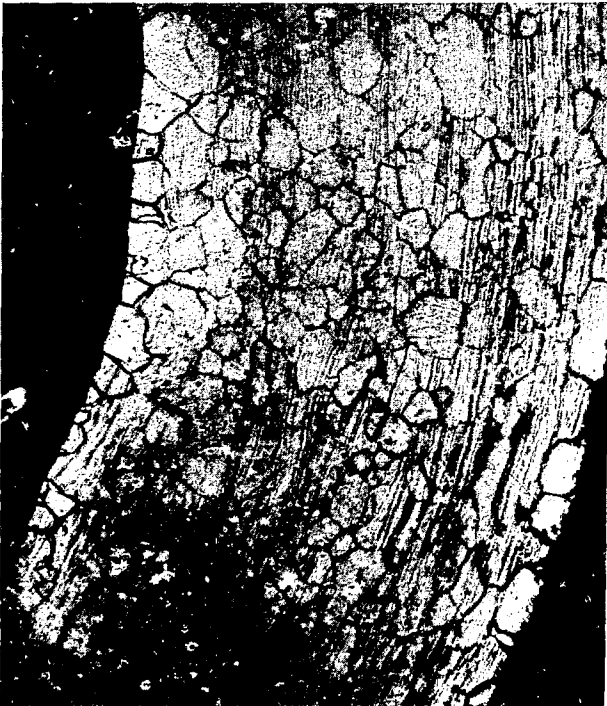
Fig. 32. Microstructures of wall samples taken from capsule SR-105. Polished and etched. (a) Weld-shield cup, (b) vent cup, and (c) deformed portion of vent cup wall. All 100X.

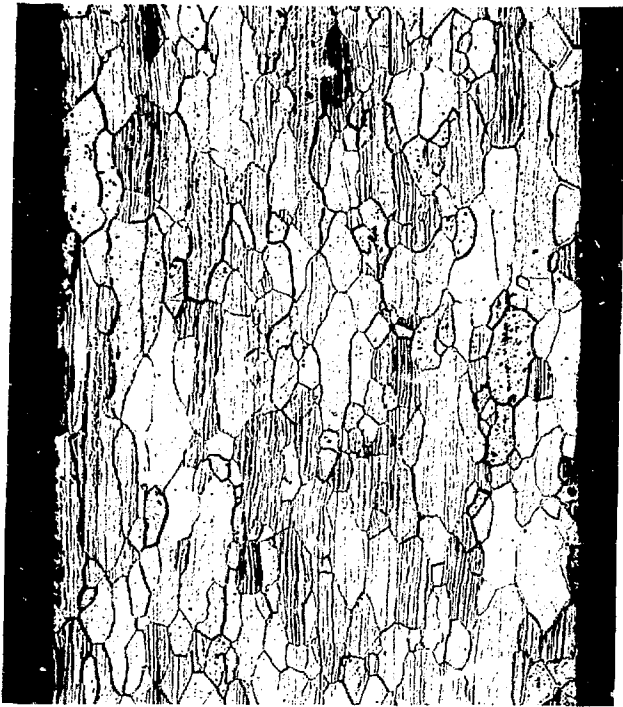
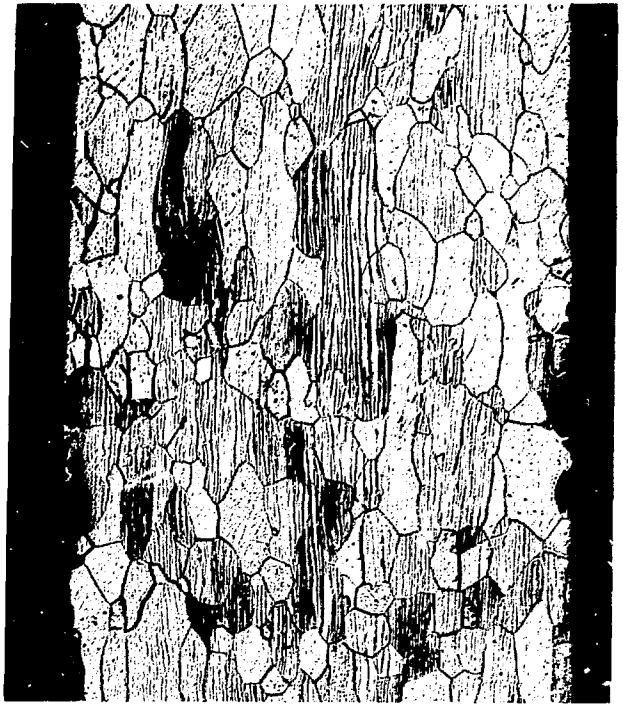
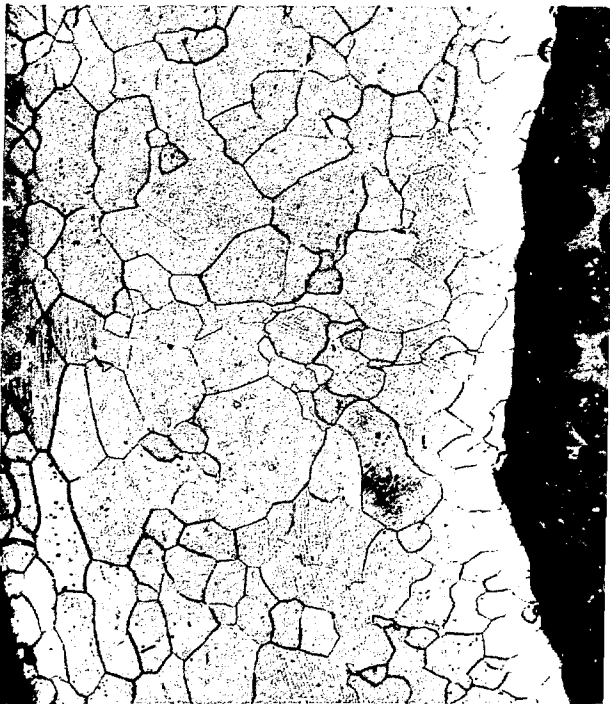
Fig. 33. Microstructures of wall samples taken from capsule SR-106. Polished and etched. (a) Weld-shield cup, (b) vent cup, and (c) deformed portion of vent cup wall. All 100X.

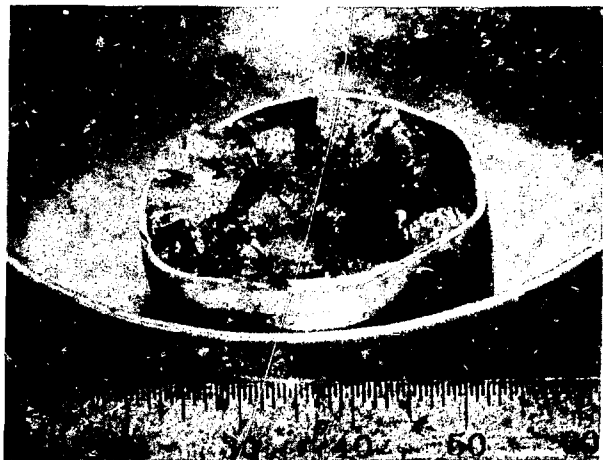
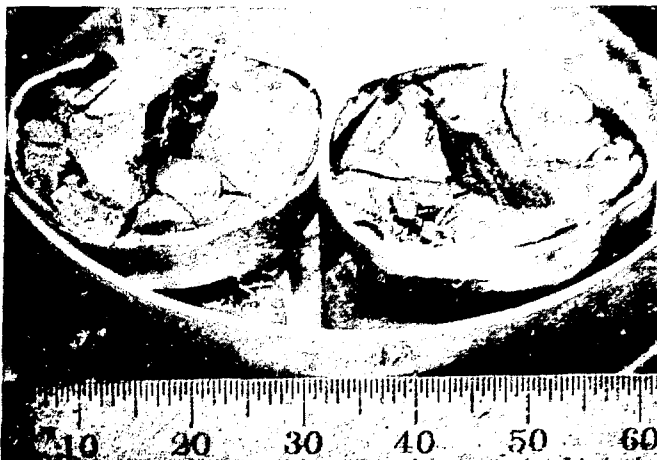
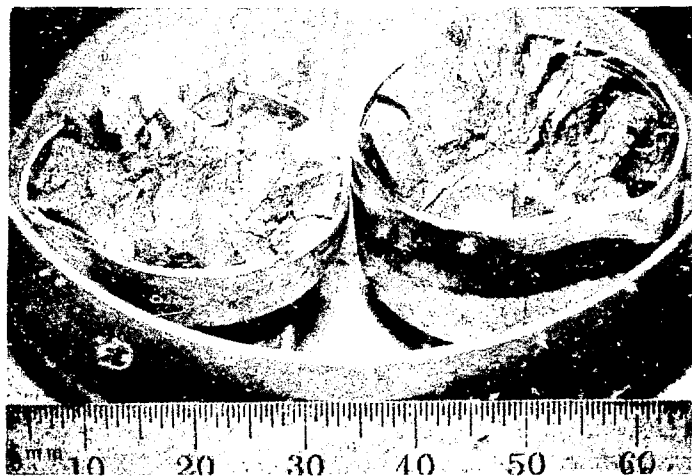
All DIT-2 fuel pellets fractured in a similar manner; apparently, each fuel pellet responded to the impact stresses by fracturing in a completely brittle mode. Figures 36 and 37 show the general patterns of fuel breakup. Although pellet SR-106 contained large cracks before testing [identified by Los Alamos radiographic inspection (Fig. 36)] and capsules SR-107 and SR-110 experienced larger total deformations than SR-105 or SR-106, the fuel fracture mechanism was apparently the same in all four pellets.

Fig. 37. Macrographs of opened DIT-2 capsules, illustrating the patterns of fuel breakup. (a) SR-105, (b) SR-106, (c) SR-107, and (d) SR-110. All 1.5X.

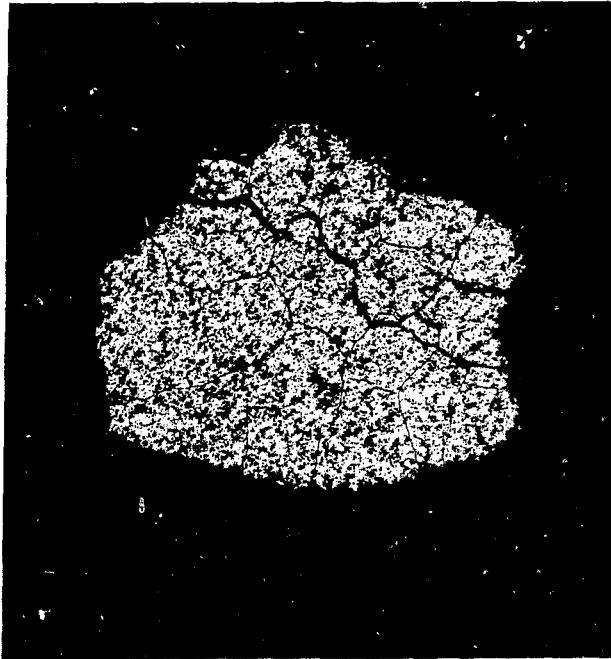
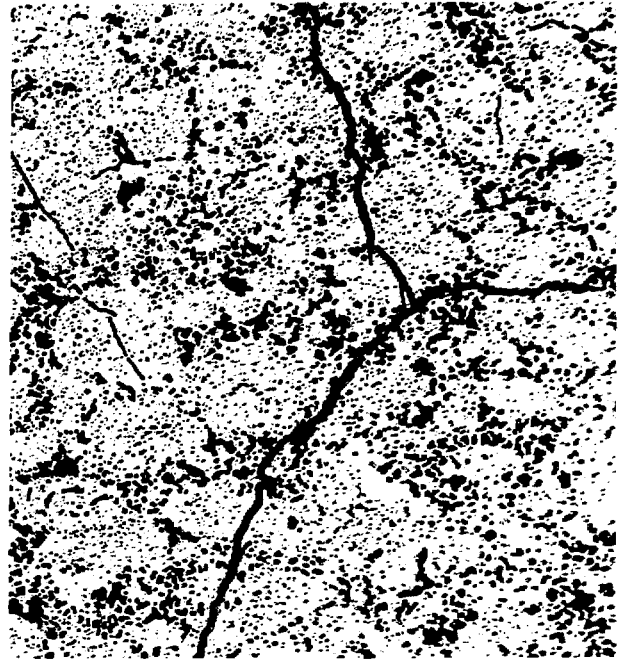
(Figs. 38 through 45) reveal that some degree of microstructural variation exists between pellets and from point to point within a given pellet. These slight variations apparently had little effect on the overall pellet performance, as the mechanical responses of all four pellets were essentially the same.

Fig. 38. Ceramographic specimen obtained from the central portion of fuel pellet SR-105. (a) Macrograph, as-polished, 10X; (b) micrograph, as-polished, 100X, and (c) etched, 100X.

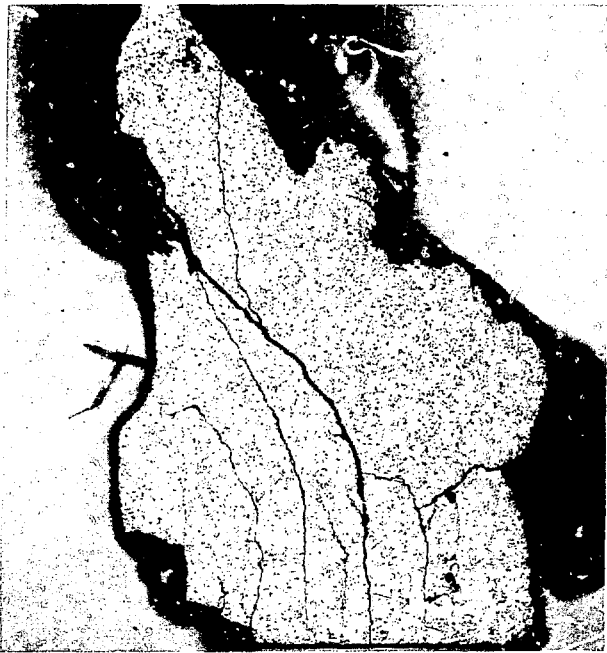
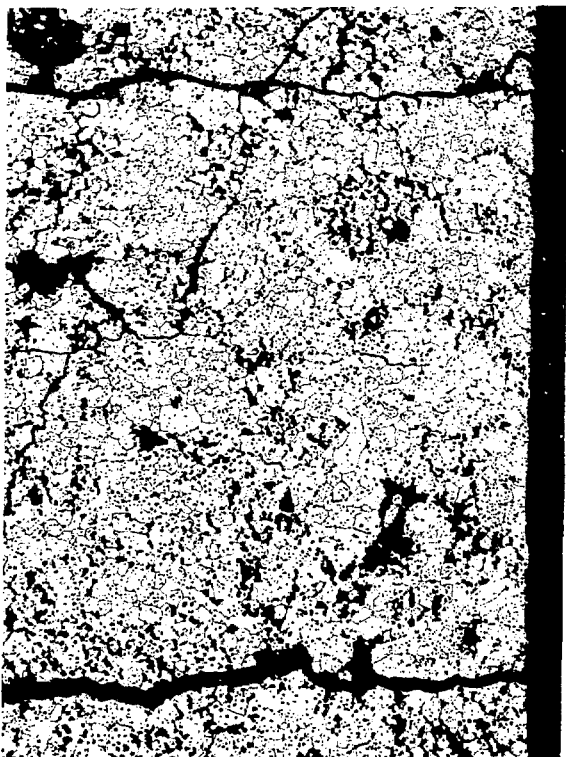
Fig. 39. Ceramographic specimen obtained from the external portion of SR-105. (a) Macrograph, as-polished, 9X; (b) micrograph, as-polished, 100X; and (c) etched, 100X.

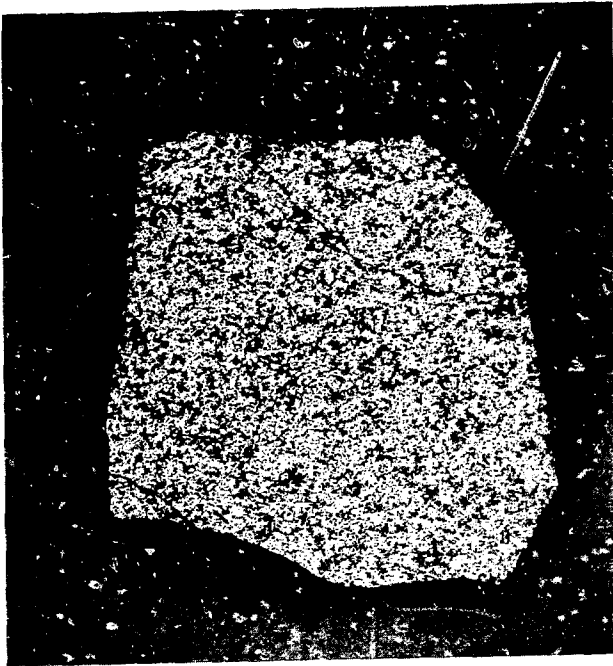
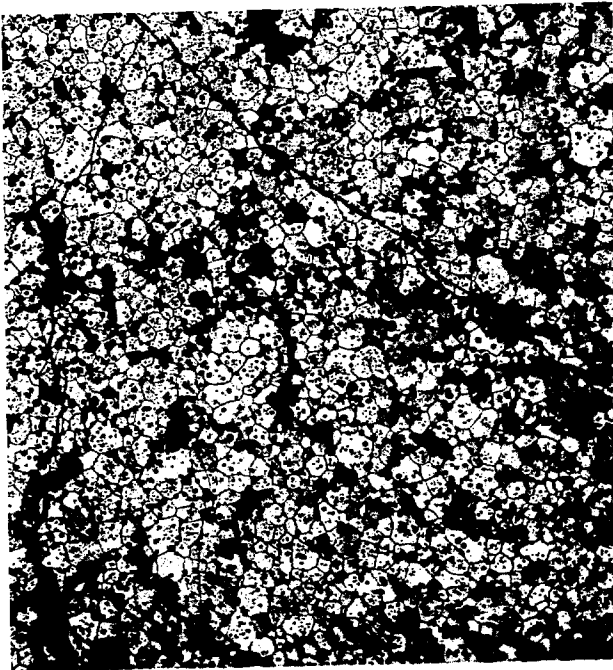
Fig. 40. Ceramographic specimen obtained from the central portion of fuel pellet SR-106. (a) Macrograph, as-polished, 10X; (b) as-polished, 100X; and (c) etched, 100X.

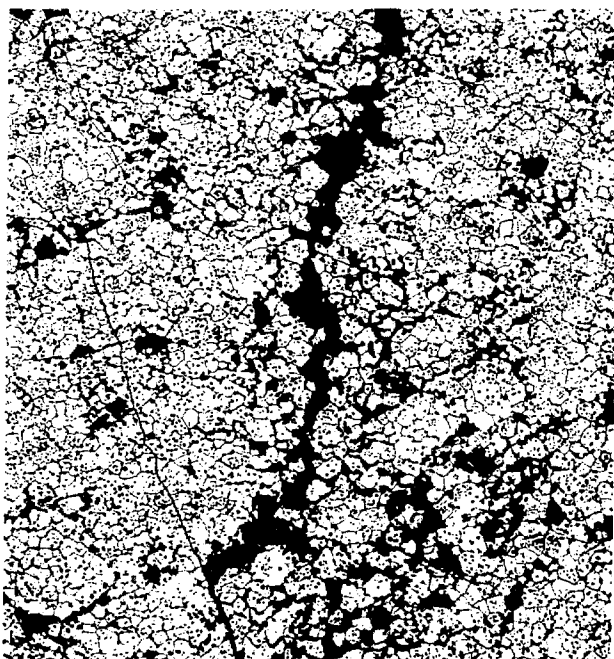
Fig. 41. Ceramographic specimen obtained from the external portion of SR-106. (a) Macrograph, as-polished, 10X; (b) micrograph, as-polished, 100X; and (c) etched, 100X.

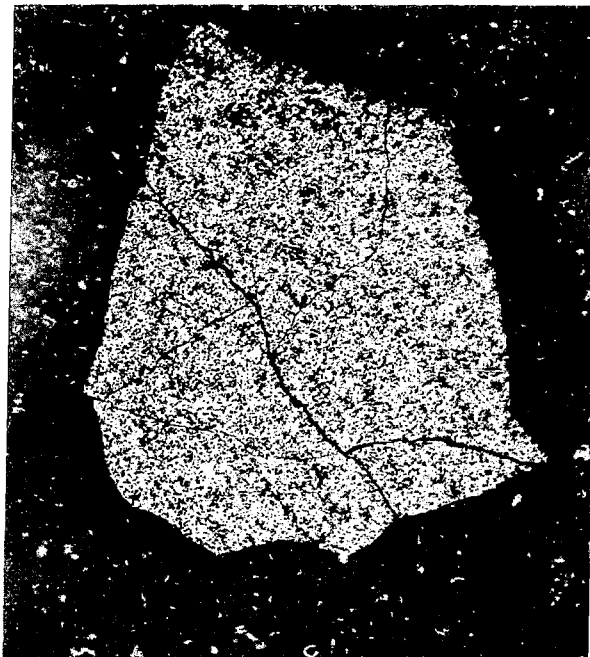
Fig. 42. Ceramographic specimen obtained from the central portion of fuel pellet SR-107. (a) Macrograph, as-polished, 10X; (b) micrograph, as-polished, 100X; and (c) etched, 100X.

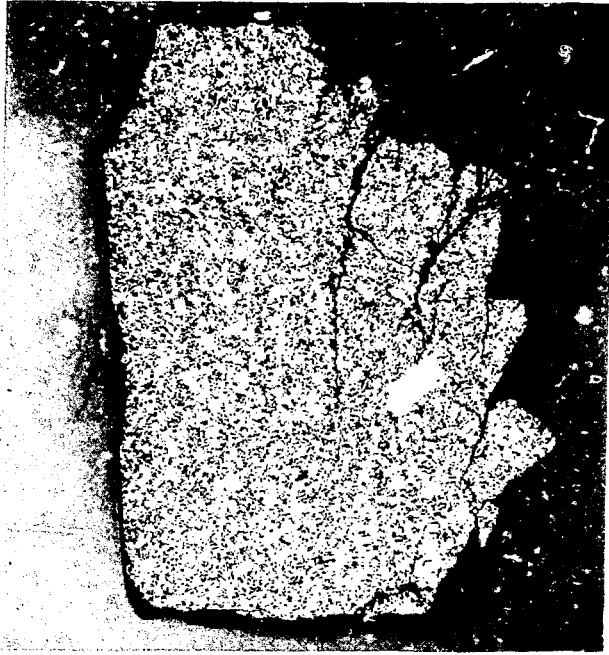
Fig. 43. Ceramographic specimen obtained from the external portion of SR-107. (a) Macrograph, as-polished, 10X; (b) micrograph, as-polished, 100X; and (c) etched, 100X.
