Assessment of Thermal Damage to Polymeric Materials by Hydrogen  
Deflagration in the Three Mile Island Unit 2 Reactor Building\*

N. J. Alvares\*\*  
Lawrence Livermore National Laboratory

UCRL--92721

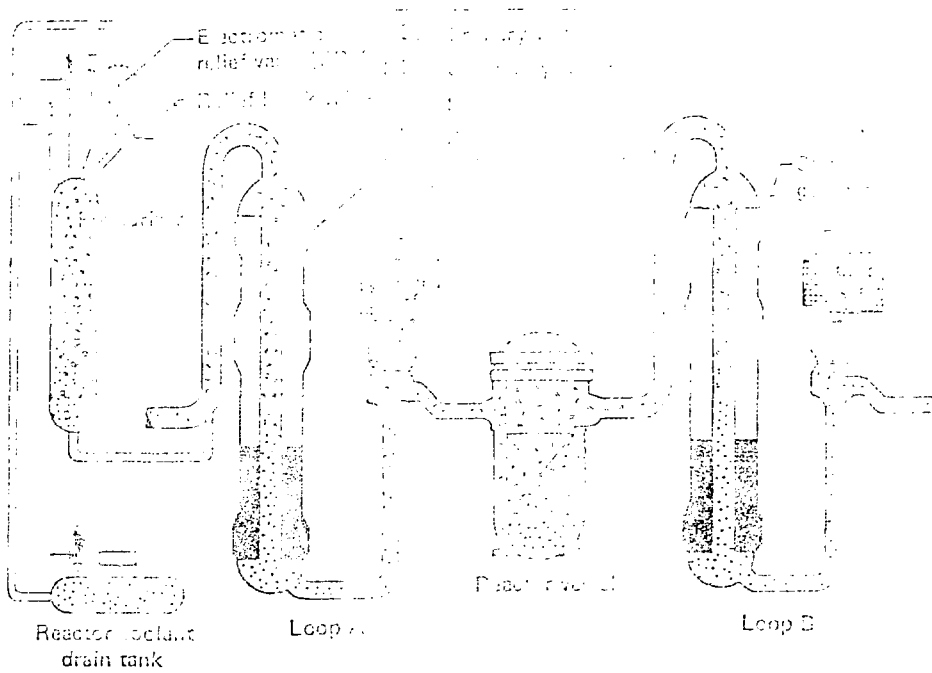
Fig. 1

Figure 1. Reactor coolant system schematic showing hydrogen release path through reactor coolant drain tank (1).

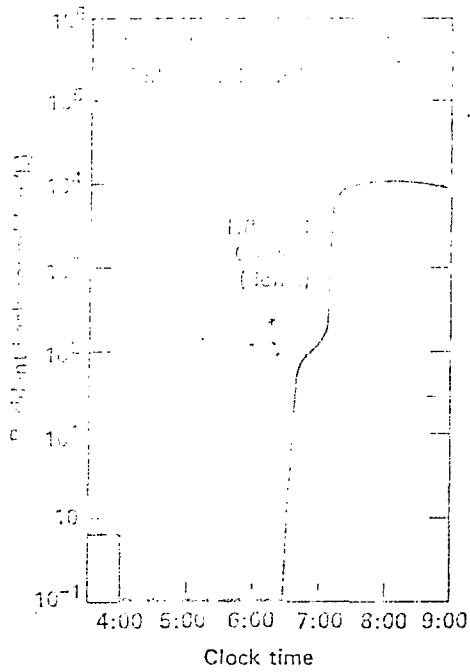
Fig. 2

Figure 2. Background activity as measured by sensor in dome (2).

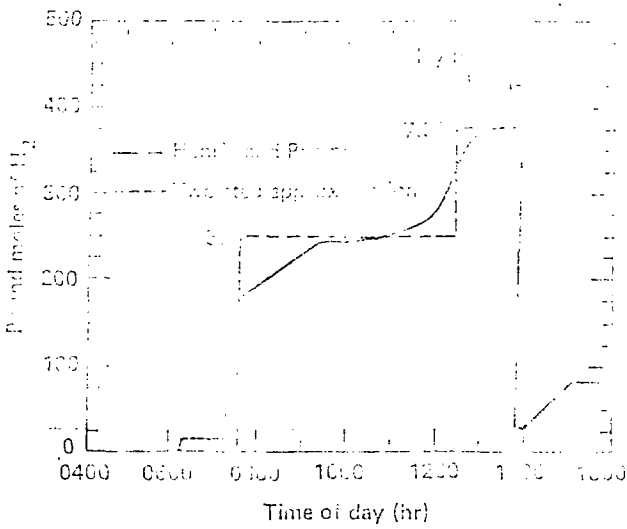
Fig. 3

Figure 3. Hydrogen production estimates based on analysis of pre- and post-burn core and reactor building indicators (3).

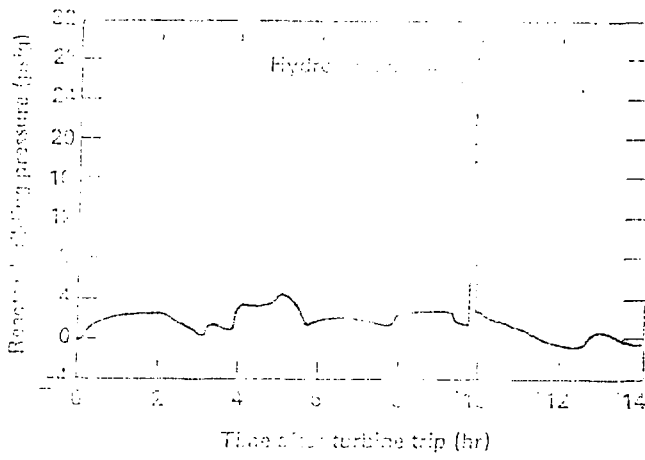
Fig. 4

Figure 4. Reactor building pressure record (1).

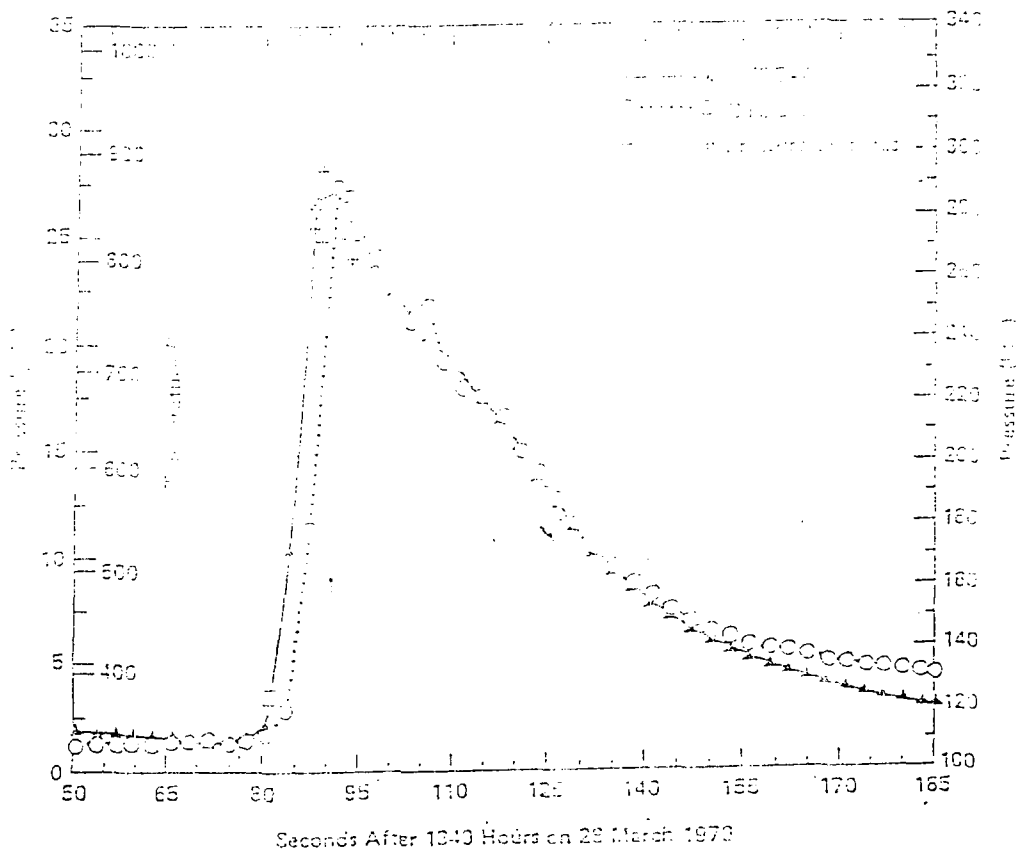
Figure 5. Pressures recorded during the burn from OTSG (once-through steam generator) pressure transmitters and pressure switch actuation times (1). Corresponding average temperature via procedure described in Ref.1 added to psig scale.

Fig. 5. Pressures recorded during the burn from OTDC pressure transmitters and pressure switch actuation times. Corresponding average temperature via procedure described in Ref. 1 added to psig scale.

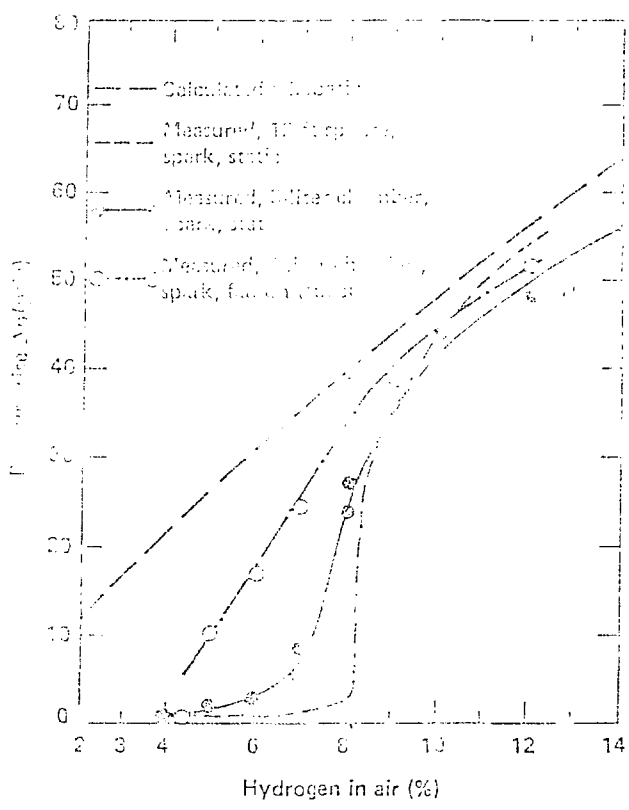
Fig. 6

Figure 6. Pressure rise ( $\Delta p$ ) produced by burning hydrogen ignited in constant volume chambers (4).

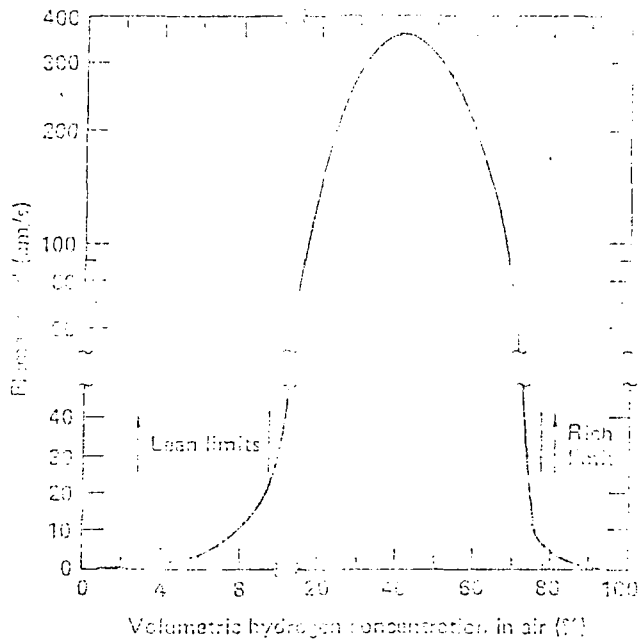
Fig. 7

Figure 7. Flame speed of varying hydrogen in air mixtures (4).

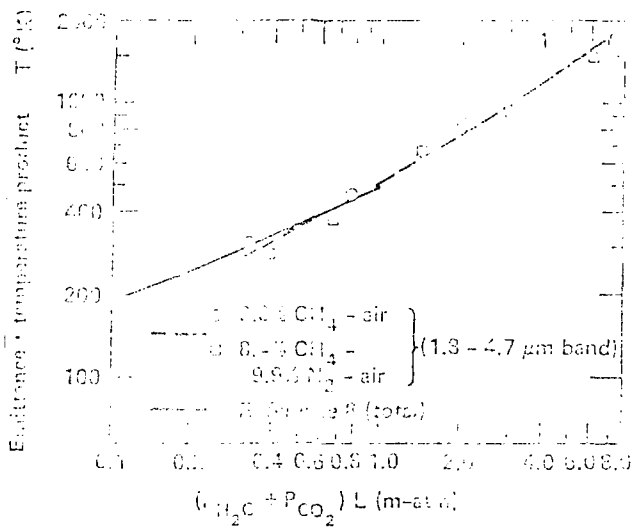
Fig. 13

This range is approximate because we assume values for combustion zone emittance ( $\epsilon$ ) at limits of the range  $0.2 < \epsilon < 0.8$ . It is quite possible that  $\epsilon$  could be larger for optically thick hydrogen combustion zones.(9) Figure 13 compares radiant emission from methane/air fires at various plume diameters. As zone volume increases, the product of emittance times absolute temperature correspondingly increases. Since plume temperature is essentially constant, their flame and hot gas emittance is shown to be directly

Figure 13. Emittance vs fire depth (9).
