Corrosion Monitoring in the UF₆ Cylinder Yards at the Oak Ridge K-25 Site: FY 1994 Report

Prepared by
Mukund Rao
Midwest Technical Inc.
Oak Ridge, Tennessee 37831
under subcontract 1BK-02268C with
Martin Marietta Energy Systems, Inc.

Ron Adamski
Jeff Broders
Alvin Ellis
David Freels
Don Kelley
Bonnie Phillips
K-25 Site Technical Division
OAK RIDGE K-25 SITE
Oak Ridge, Tennessee 37831

October 1994

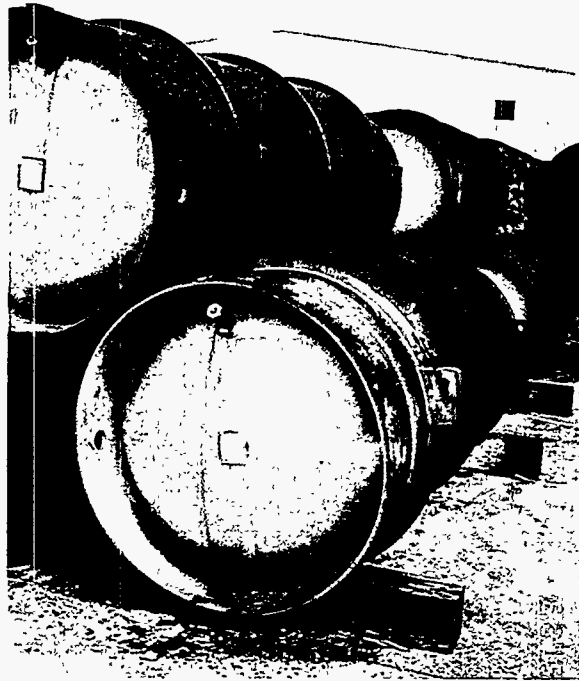
Most of the UF₆ cylinders are stored in two unprotected yards, designated as E-yard and K-yard. The UF₆ cylinders are stacked in two-high rows, with the bottom row of cylinders supported on contoured wooden saddles and the top row of cylinders resting in the valleys between the bottom row of cylinders. The wooden saddles are designed to keep the bottoms of cylinders 4 in. off the ground. Top- or bottom-row cylinders are typically spaced a few inches apart within a row (although they are often in contact), and cylinder rows are typically a few feet apart, allowing access for inspection and maintenance. The surface of E-yard is concrete; the surface of K-yard is part concrete and part compacted gravel. The concrete surface of E-yard is relatively even and intact, with good drainage of rainwater, whereas the concrete in K-yard is buckled and broken in several areas, leading to uneven drainage and water pooling. In some of these areas, cylinders have sunk into contact with the ground. The compacted gravel area is relatively well drained. Figure 1 shows a typical stacking arrangement of cylinders on the concrete pad in K-yard. Figure 2 shows examples of heavy corrosion scale and pitted surfaces on cylinders.

Fig. 1. Typical stacking arrangement of UF_6 cylinders in the storage yards at the Oak

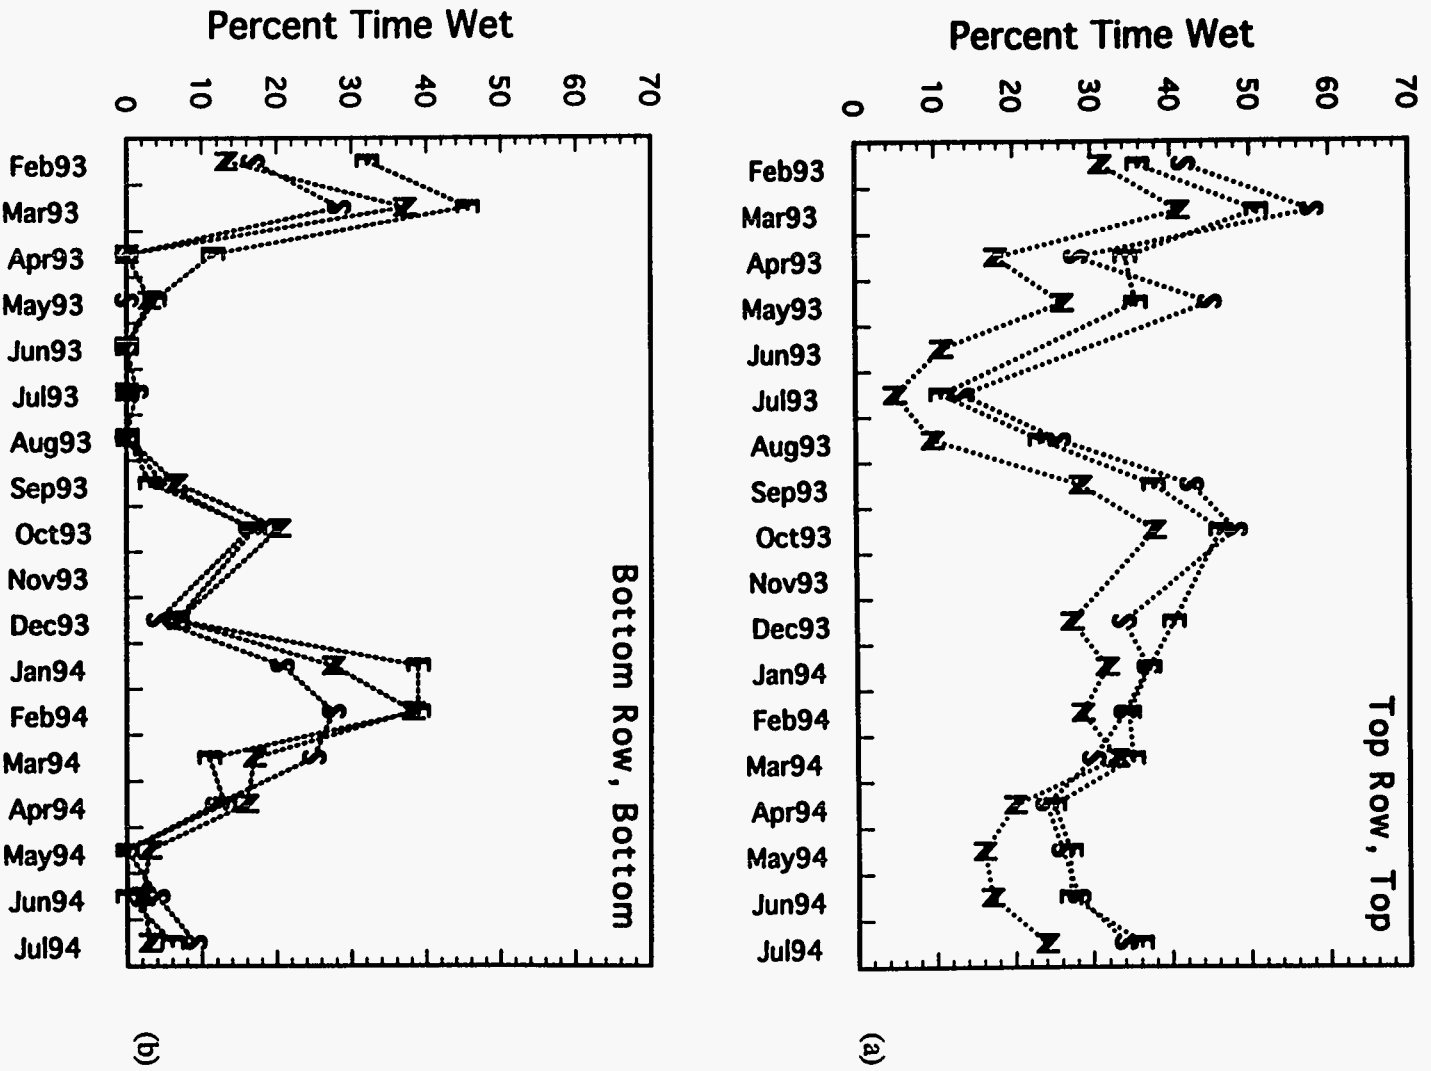
2. In general, no significant difference in wetness times was observed between the well-drained concrete surface in E yard and the poorly drained broken concrete (K-South) area in K-yard. One may expect BR, B regions at K-South to stay wetter than in other areas because of poor drainage. However, as seen in Fig. 4, this is clearly not the case, and, in fact, the reverse may be true. In addition, Fig. 4(a) shows that cylinder tops in the gravel area at K-North appear to stay consistently drier than the other locations.

Fig. 4. Percent wetness measured in (a) top row, top positions and (b) bottom row, bottom positions. E = E-yard, N = K-yard north (gravel) and S = K-yard south (concrete).

The potential trends in TOW data shown in Figs. 4 (a) and (b) are difficult to explain. There is no apparent physical reason why the TR, T position at K-North appears consistently less wet than other similar positions. The explanation may lie in a lower sensitivity of this sensor compared to the

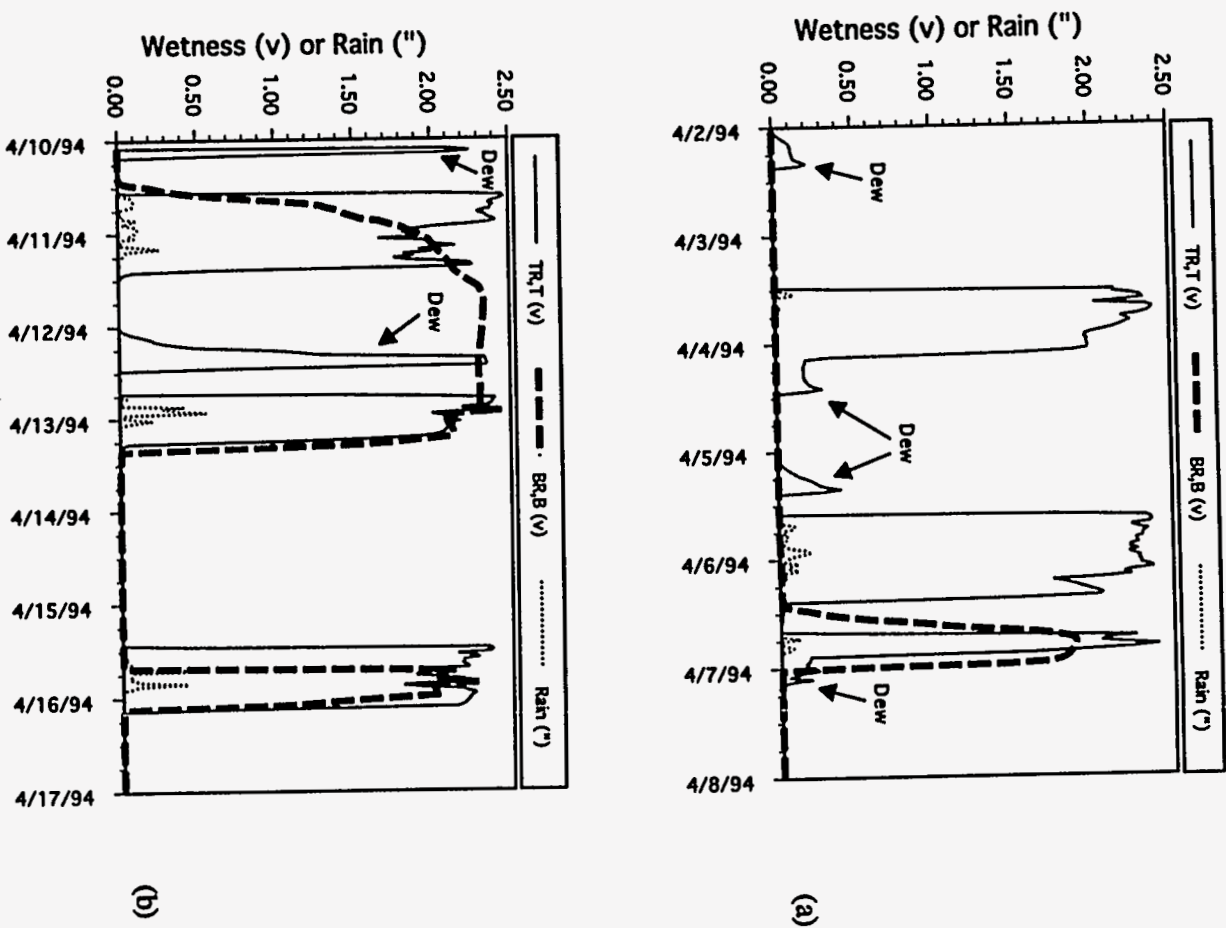
A detailed examination of the TOW results provides some clues to explain these observations. Figure 5 shows responses from TR, T and BR, B TOW sensors along with rainfall data collected during two time periods in April 1994 at the K-South location. The results are typical of all three locations. As can be seen, there are several instances when the TR, T sensor triggered a positive response over time periods with no rainfall. These include the early morning hours of April 2, 4, 5, 10, and 12. In each of these instances, the remaining three sensors at the installation did not trigger. The positive responses are apparently caused by dew formation on the sky-facing top surfaces during the early morning hours. Similar observations have been commonly reported in the

Fig. 5. (a) and (b) Wetness data from top row, top and bottom row, bottom sensors along with rainfall data collected during two time periods in April 1994 at the K-yard south location.

Figure 5 reflects the conclusion from Table 3 that cylinder tops stay significantly wetter than cylinder bottoms, but also provides further details. The rain events on April 4 and April 6 were insufficient to trigger the BR, B sensor: the sensor triggered only over the next rain period on April 7. It triggered again on the next rain on April 11, but this time the sensor stayed “on” for 3 days even though no rainfall was measured and the TR, T sensor switched off. These results suggest that cylinder bottoms stay dry even during rain periods, until a critical frequency and/or amount of rain

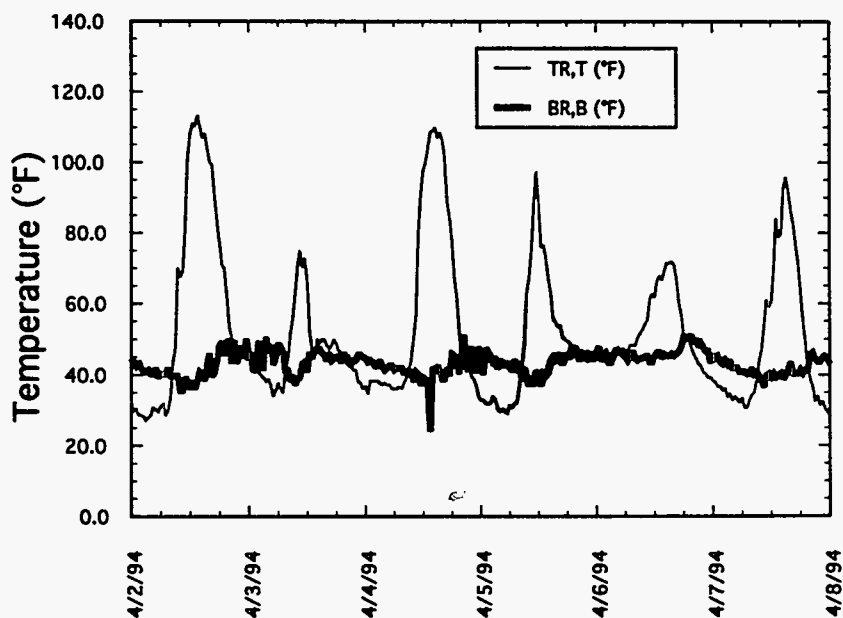
past,^{9,10,17,18} as has the fact that condensation can be the major contributor to total wetness times^{9,17} and often triggers a lower sensor response than rain,¹⁹ as observed here. The top surfaces undergo greater cooling due to radiative heat loss than bottom-facing surfaces, and surface temperatures are more likely to go below the dew point, leading to condensation. This is supported by thermocouple data from the cylinder surfaces. Data from the same time period as Fig. 5(a) from TR, T and BR, B surfaces at K-South are shown in Fig. 6. It is clear that the TR, T surface undergoes much greater temperature swings during a 24-hour period than the BR, B surface, which stays fairly close to ambient temperatures. The large fluctuations are due to a combination of radiative heating and cooling, the effects of which are magnified by an empty head space in the UF₆ cylinders, whereas temperature variations of bottom surfaces are moderated by the large heat mass of UF₆ in contact with these surfaces. During 1 day, both the highest and lowest temperatures are measured on cylinder tops, which evidently cool down below the dewpoint at night, causing condensation. Note that on April 3, there was no apparent dew formation [Fig. 5 (a)]. This condition can be related to significantly less cooling of the cylinder surface (Fig. 6), probably due to cloud cover before the rain later in the day [Fig. 5 (a)].

Fig. 6. Surface temperature data from TR,T and BR,B surfaces at K-yard south for the same time as Fig. 5(a) showing much greater temperature fluctuations on TR,T surfaces due to radiative heating and cooling.

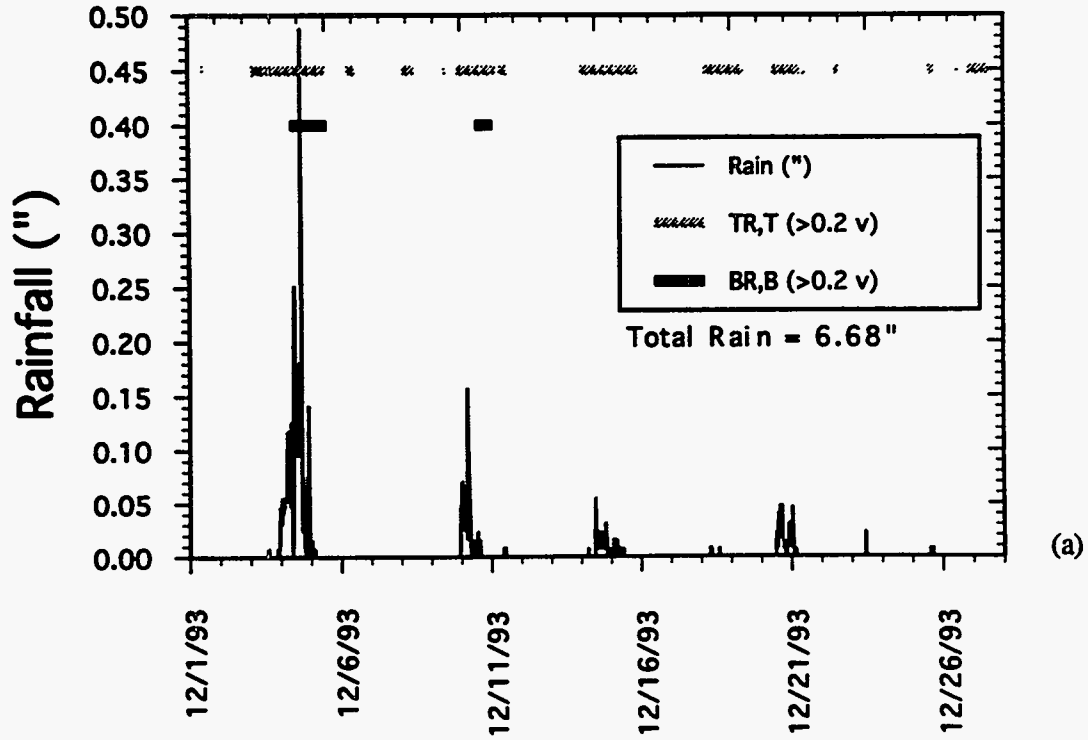
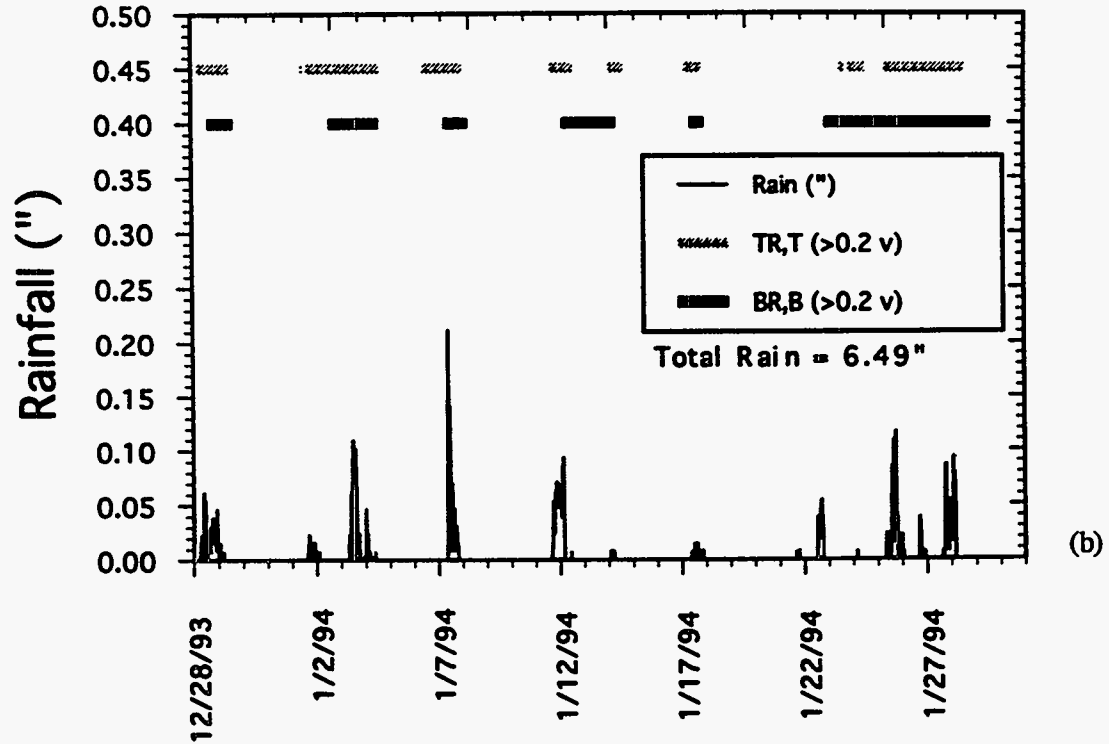
This view is supported by the data in Figs. 7 (a) and (b), which show rainfall data as well as periods when TR, T and BR, B TOW sensors were "on" during December 1993 and January 1994. (Some of the precipitation occurred in the form of ice or snow. However, sunshine and/or daytime temperatures typically melted the solid precipitation on contact or within a few hours. There was only one instance, toward the end of January, when solid precipitation was present for a period greater than 24 hours.) The time intervals shown, 27 days in Fig. 7(a) and 34 days in Fig. 7(b), experienced roughly equal amounts of total rain. In the period shown in Fig. 7(a), the BR, B sensor was triggered only over two time periods representing 6.8% of the time interval, compared to a 39.6% "on" time for the TR, T sensor. In contrast, for the period shown in Fig. 7(b), both TR, T and BR, B sensors stayed "on" for 38.3% of the time. It may be noted that the response of the TR, T sensor was very similar over the two time periods. The difference between Figs. 7(a) and 7(b) is that, in the first case, rain events were relatively heavy but few, typically occurring every 5 days. During the second time period, rain was less heavy but occurred more frequently. Note that, toward the end of January with several rain events over the last few days, the BR, B sensor stayed "on" for more than 1 week. This observation is similar to one made earlier with respect to Fig. 5(b). Note also that in both Figs. 7(a) and 7(b), the initial triggering of the BR, B sensor was always significantly after that of the TR, T sensor. These data support the conclusion that cylinder bottoms stay drier than cylinder tops because a significant amount of frequent precipitation is needed for the wetness to reach and cover these areas. The critical value of this precipitation is unknown but could perhaps be estimated from detailed analysis of a few months of data. This analysis has not yet been attempted.

Fig. 7. (a) and (b) Rainfall data and periods when TR,T and BR, B time-of-wetness sensors were "on" during December 1993 and January 1994 at the E-yard location.

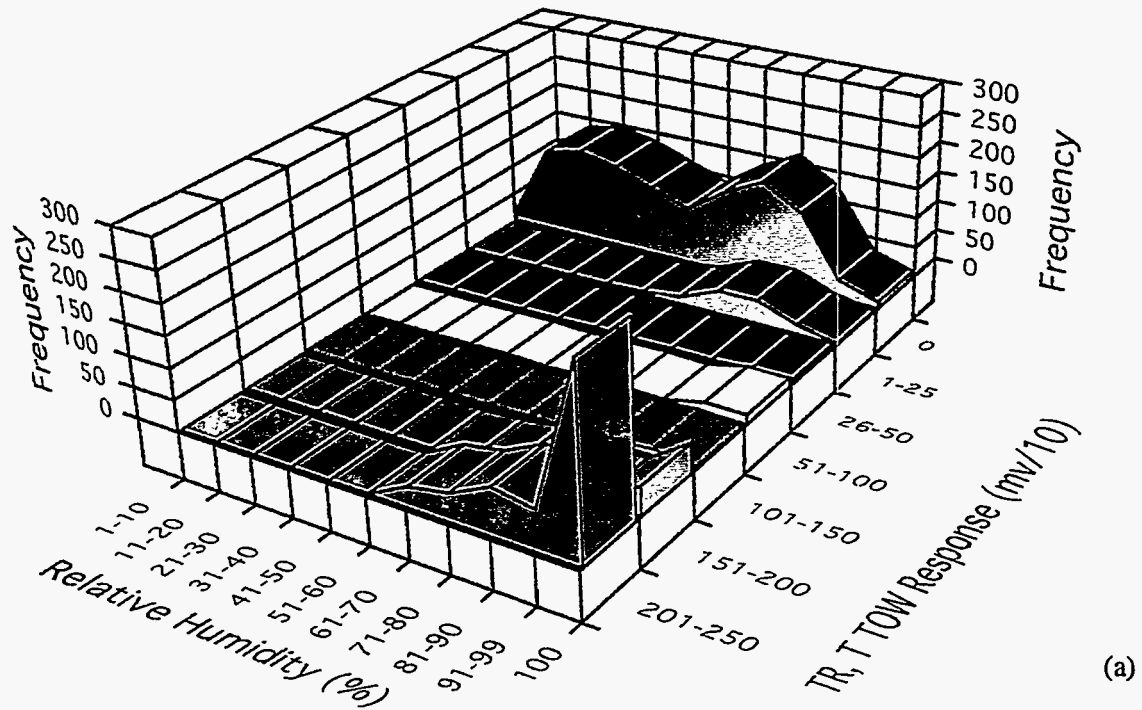
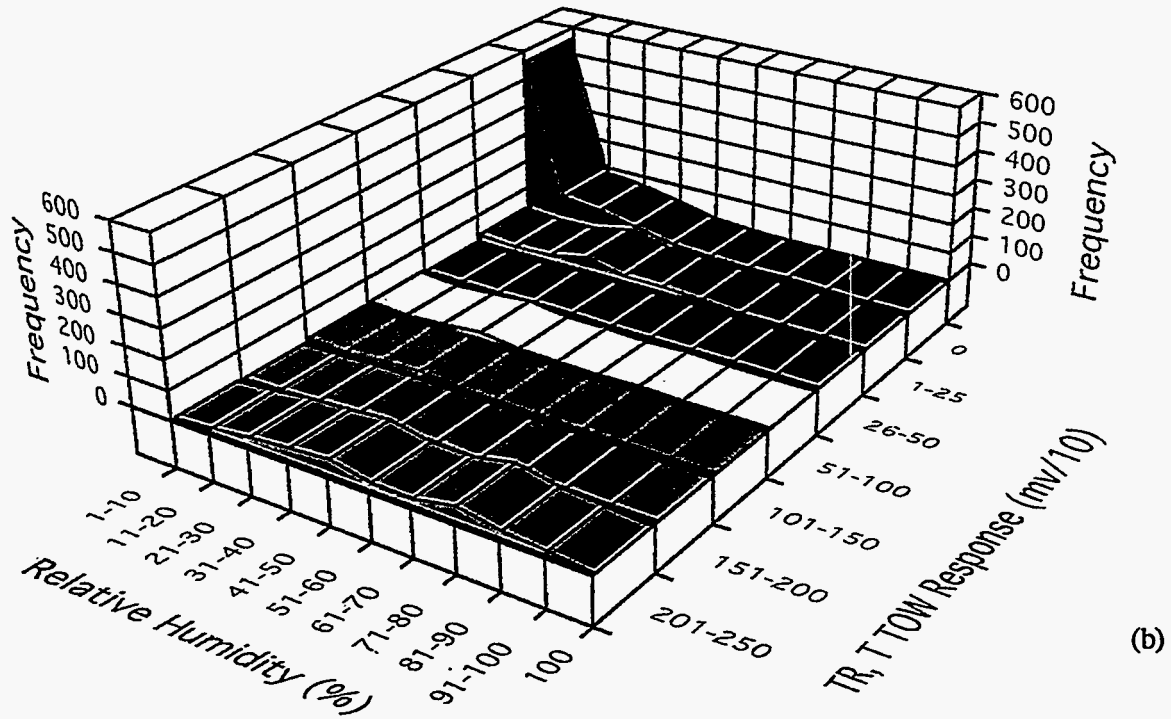
One relationship which could not be established conclusively was that between relative humidity and TOW. The relative humidity sensors typically broke down after 2-3 months, and practical considerations prevented immediate replacement of the sensors. Figure 8 presents summaries of relative humidity readings taken at the same time as TOW responses from the TR, T sensor in E-yard for the months of February 1993 (just after installation) and April 1993. In February 1993, almost all the nearly full-scale TOW responses corresponded to relative humidities greater than 50%, with a large fraction occurring at relative humidities of over 90% (mostly at 100%). In contrast, in the month of April 1993, the high TOW responses are distributed over the entire range of relative humidities, indicating that the humidity sensors were not responding consistently. The highest reading recorded was 92%, even during periods of rain. By the following month, maximum sensor response had dropped further, signifying sensor failure.

While the sensors were working, a fairly good correlation was shown between relative humidity and TOW readings. It appeared that the TOW sensors showed a positive reading only when relative humidity levels were over 50% and had readings over 200 mv (the "on" threshold) only at relative humidity readings greater than 60-70%. This agrees well with observations in the literature.^{5,9,10,15,17,19} Data were insufficient to do a rigorous correlation analysis over different seasonal periods. In addition, the relative humidity sensors were in the weatherheads, located a few feet away from the TOW sensors. Thus, local variations in relative humidity due to cylinder surface temperatures or ground conditions could not be determined. These variations could be significant⁴ and could lead to local differences in wetness and corrosion. Current plans call for installing relative humidity sensors next to the TOW sensors.

Fig. 8. Relative humidity and corresponding time-of-wetness sensor responses from E-yard for the months of (a) February 1993 and (b) April 1993.

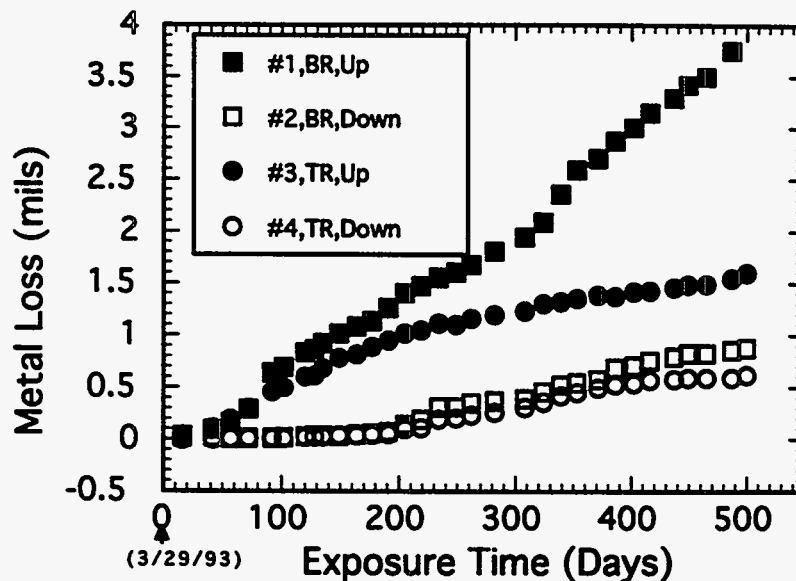
1. Probes exhibit an incubation period before the probe dial readings begin to increase (i.e., before measurable corrosion occurs). The incubation period is significantly longer on probes attached to bottom surfaces of cylinders.
2. Probes show similar trends depending on whether they are mounted on top or bottom surfaces, irrespective of whether the cylinder is in a top or a bottom row.
3. Significantly higher corrosion rates (measured after incubation) are observed from probes on cylinder tops than from probes on cylinder bottoms. However, these corrosion rates appear to moderate in some cases at later stages (e.g., Probe 3 in Fig. 9).

Fig. 9. Typical corrosion probe data, for Probes 1-4 mounted on cylinders at the K-yard north location.

Although the general behavior of top- and bottom-facing probes as two separate groups is similar, there are differences in individual probe behavior which are unexplained. An example is Probe 1 in Fig. 9. The lack of a transition to a lower corrosion rate is unusual and cannot be explained at present. Similarly, in Fig. 10(a), top-facing open Probes 34 and 37 appear to diverge significantly in behavior after showing similar responses for the first 150 days of exposure. In this set of probes, only Probe 34 among the "open" installations appears to show an interim transition to a lower corrosion rate. Further, the subsequent increase in corrosion rate in Probe 34 after 320 days is also unexplained. Some of these discrepancies must surely be related to seasonal changes and chemistry and morphology of the corrosion products developed on the probes. Recently, three of the probes (including Probe 1 in Fig. 9) reached the end of useful data collection life and "topped out," having undergone 4 mils of metal loss. These probes will be destructively analyzed, and it is hoped that corrosion product analysis and continuing data collection will help resolve some of the questions regarding probe behavior.

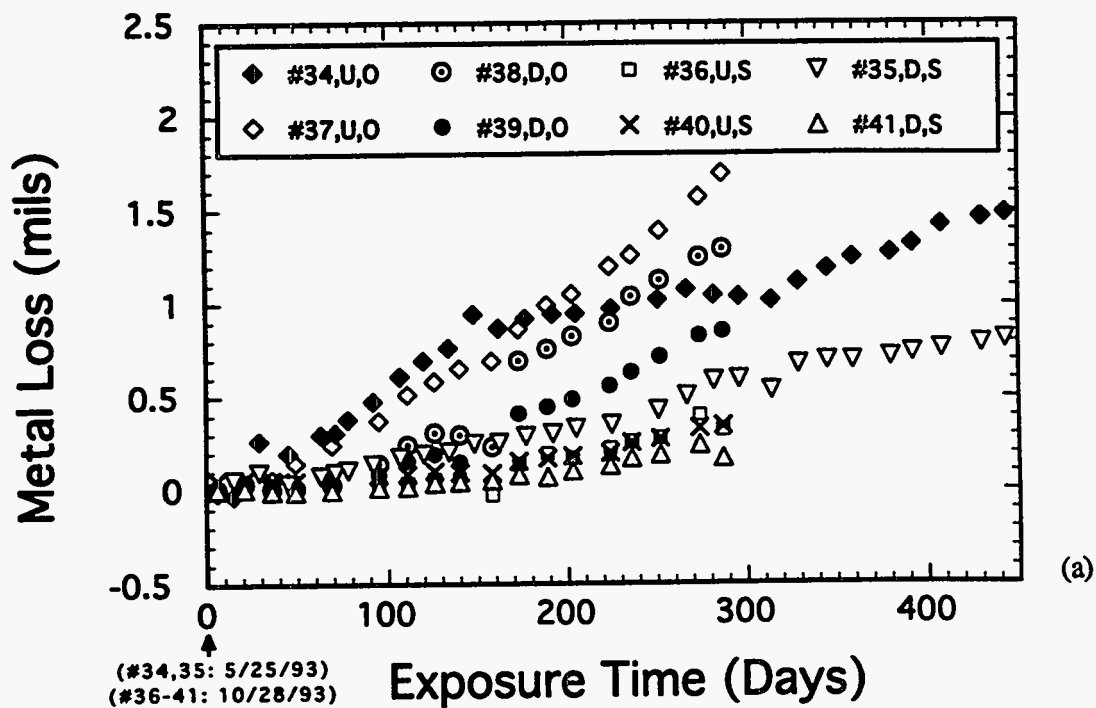
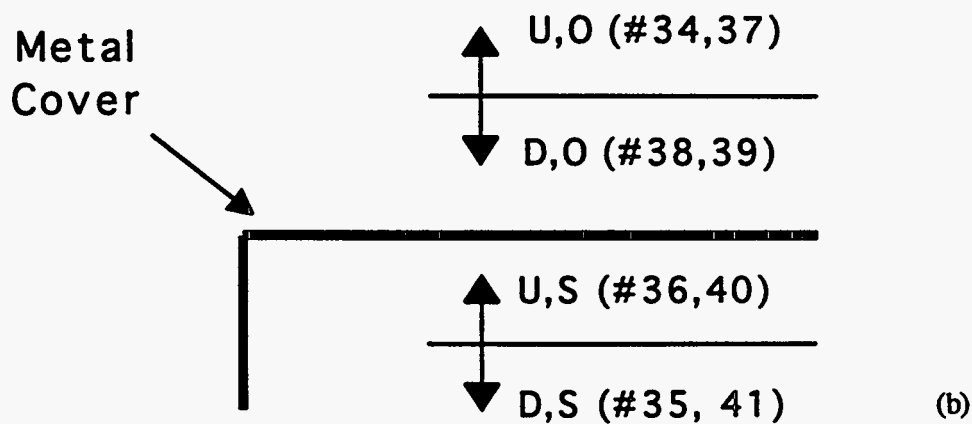
Figure 10(a) shows data from a set of probes attached to the corrosion coupon rack in K-yard. These probes were attached in orientations shown in Fig. 10(b), meant to replicate probes on cylinders. The trends seen in Fig. 10(a) are very similar to those seen in Fig. 9. Top-facing open probes (34 and 37) have shorter incubations and corrode faster, at least initially. The moderation in corrosion rates (change in slope) typically occurred after about 200 days of exposure for most top-facing probes (see also Fig. 9). Note that sets of probes were installed in late May and late October, yet show similar trends. This suggests that any seasonal effects on corrosion are minimal, although a careful analysis shows that they cannot be discounted. Metal loss vs time data for all the probes were examined, and 32 probes were identified, which showed a decrease in the slope (corrosion rate) in the post-incubation region. For example, such decreases in slope can be seen in Fig. 9 as occurring for Probe 3 after about 210 days and Probe 4 after 400 days. A clearer example can be seen in Fig. 10(a) for Probe 34 after 150 days. A tabulation of all the data showed that in 16 of the 32 cases, the decrease in slope was initiated in the months of November through January, suggesting a wintertime slowdown in corrosion rates. However, 14 of these 16 "slowdowns" occurred starting 150-230 days from initial exposure and 15 of the 16 probes were top-facing open probes, suggesting that the "slowdown" is more related to the time-dependent buildup of certain types of corrosion products. This issue is currently unresolved. It may also be noted that many probes showed an increase in corrosion rate after some period of "slowdown," typically from 60 to 90 days [see Fig. 10(a)].

Fig. 10. (a) Corrosion probe data from probes installed in various orientations on the coupon rack in K-yard. (b) Schematic showing the orientations of probes. The arrows point in the direction the probe is facing. (U, O = up; open; D, O = down, open; U, S = up, sheltered; D, S = down, sheltered.)

The long incubation periods and low corrosion rates associated with the down-facing probes (which include bottom-mounted probes on cylinders) are also seen in top-facing probes, which are sheltered [Fig. 10(a), Probes 36 and 40]. (This arrangement is not duplicated on the UF_6 cylinder surfaces, since all top-facing cylinder probes are open to the sky.) Top-facing sheltered probes evidence less corrosion than down-facing open probes (Probes 38 and 39). These results imply that surfaces protected from wetting undergo less corrosion, at least to the point that the onset of corrosion is delayed significantly. As a further check, three sets of probes were distributed in spaces between top-row cylinders in K-yard in the orientation shown in Fig. 10(b). The results are very similar to those observed in Fig. 10(a).

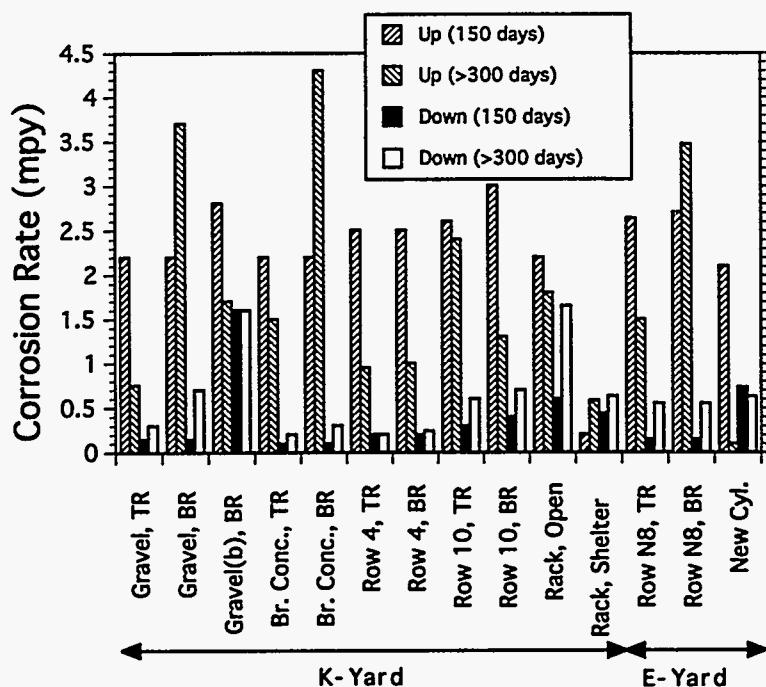
Figure 11 summarizes the corrosion probe data from several locations, including the three primary locations, the coupon rack and several other installations in K-yard. The data are presented as corrosion rates calculated from plots as in Figs. 8 and 9(a). As seen in these figures, the plots can often be divided into several linear segments having different slopes (i.e., different corrosion rates). Corrosion rates after "150 days" represent corrosion rates existing after 150 days exposure, which typically corresponds to post-incubation for top-facing probes but often still within incubation for down-facing probes. Data for ">300 days" for all probes represent the trend being observed in the last 100 days of data gathering. Total exposure periods range from approximately 300 to 500 days. Figure 11 shows that in most cases, corrosion rates of top-facing probes decreased significantly after initial incubation and a period of relatively high corrosion rate. The ">300 days" corrosion rates are often similar to those measured from down-facing probes, which typically show minimal corrosion for relatively long time periods before exhibiting a slight upward trend in corrosion rates. The data summarized in Fig. 11 show no obvious effects of poor or good drainage or of yard-to-yard differences.

Fig. 11. Corrosion rates calculated from data from corrosion probes.

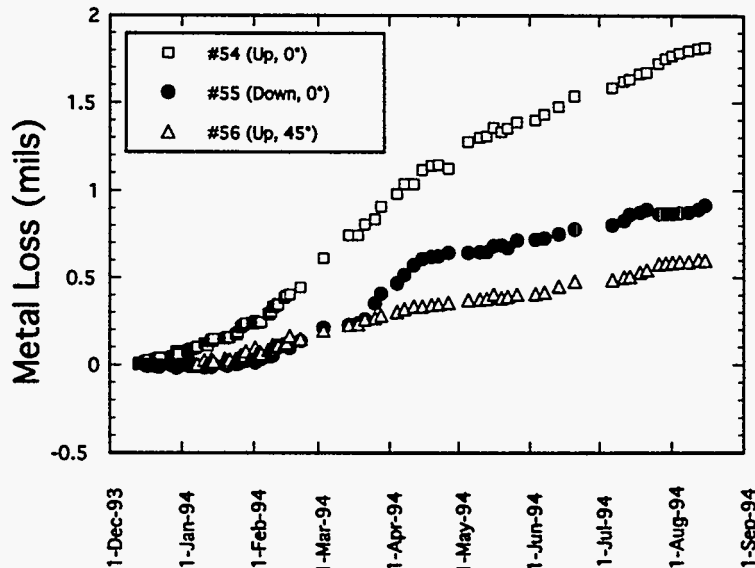
days later in early January 1994. The probes were monitored at least daily for the first few weeks of exposure. The data are summarized in Fig. 14. Again, the bottom facing probe (55) shows the longest incubation time, but shows a corrosion rate similar to the top facing Probe 54 once corrosion starts. Both Probes 54 and 55 undergo a significant drop in corrosion rates after about 120 days of exposure. Probe 56 does not show a well-defined incubation or any significant changes in slope over the data collection period. The corrosion product appears to be darker and thinner than on the other probes but has not been analyzed. In the final 30 to 50 days of data collection, the slopes in all three cases are fairly similar (though still higher for the top-facing Probe 54), indicating a narrowing of differences as reported above.

Visual inspections showed that Probe 54 quickly developed a rust layer on its surface (completely rust covered within 7 days) whereas Probe 55 had large rust-free areas even after 40 days of exposure. Probe 56 showed intermediate behavior while developing a thinner, darker, more adherent corrosion product. During rain events, Probes 54 and 56 were quickly wetted whereas Probe 55 stayed mostly dry, with occasional wetting from wicking action of water beads forming on the edges of the covering surface. Furthermore, Probe 54 stayed wet for significant periods (often on the order of 1 day) after rain ended, whereas Probe 56, inclined at 45°, dried off within a couple of hours. Figure 15 shows photographs of the two top facing probes following a rainfall event. The beads of water seen on the probes were typical of observation even after short periods of rain. The water drops overhanging the edge of Probe 54 occasionally wicked onto the surface of Probe 55 directly underneath, initiating corrosion.

Fig. 14. Data from corrosion probes mounted outside the laboratory area.

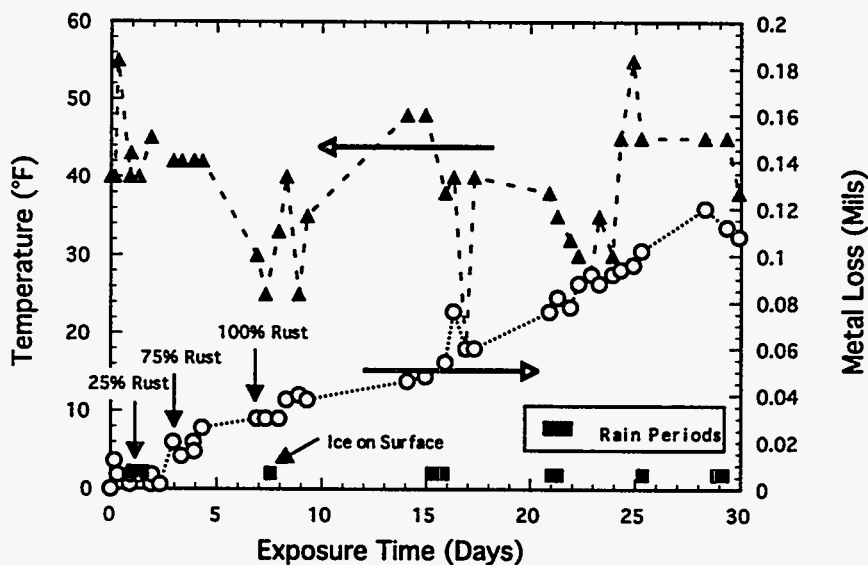
Figure 16 shows data from Probe 54 covering a few periods of precipitation. Corrosion is clearly associated with periods of wetness but appears to increase after the end of the rain, as the water bead evaporates. Such discrete jumps in metal loss were not seen in the other two probes, and this observation agrees with the model of atmospheric corrosion of iron's being dominated by corrosion during the drying stage of a moisture deposition/evaporation cycle.²⁰ Figure 16 also presents ambient temperature data showing that the corrosion process does not seem to be influenced by the temperature, at least in the range encountered.

Fig. 16. Data from Probe 54 (mounted facing up horizontally) showing relationship between probe readings and periods of precipitation.

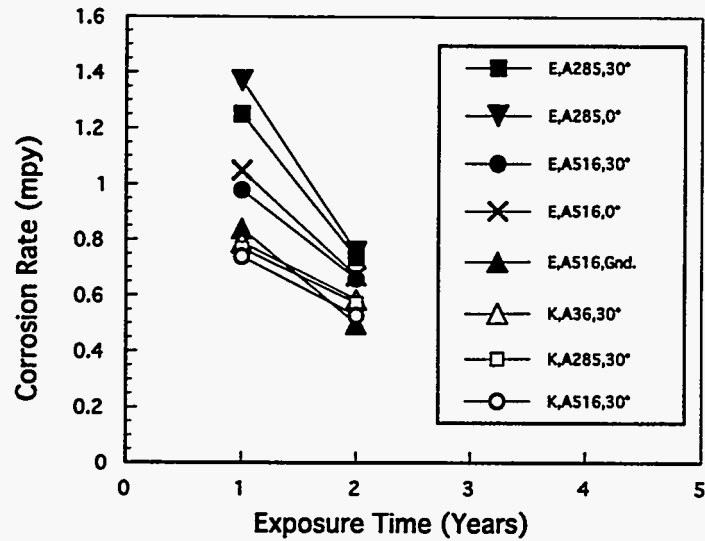
Data from 1- and 2-year exposures of ASTM G50 coupons are shown in Fig. 17. Higher corrosion rates were observed in the first year of exposure, as is typically observed in atmospheric exposures. In the second year, the corrosion rates drop off to 0.5-0.7 mpy, which is what may be expected in the rural or semi-rural atmosphere around Oak Ridge. One interesting trend which may be developing in Fig. 17 is the higher corrosion rates measured in E-yard. Compared to K-yard, the rates are at least 50% higher in the first year and about 30% higher in the second year. It is unclear whether the differences will narrow over the next set of retrievals.

Fig. 17. Corrosion rates measured after 1- and 2-year exposure from ASTM G50 type coupons mounted on coupon racks in E-yard and K-yard. Only average values are shown; the scatter in each data set was typically less than 10%.

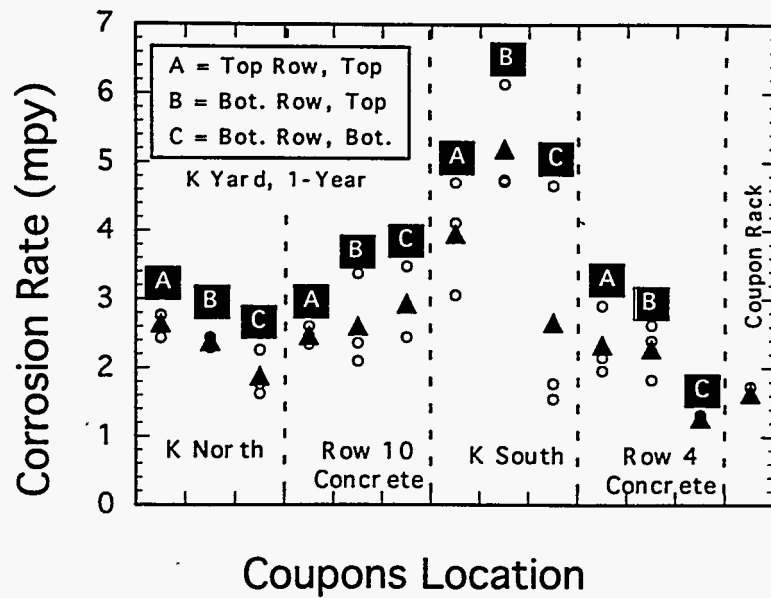
Figure 18 shows data from 1-year exposures of cylinder coupons. The corrosion rates measured from these single-sided coupons are significantly higher than those from the 2-sided ASTM G50 coupons. Part of the reason is undoubtedly due to the sheltering of bottom surfaces in the latter case.

Fig. 18. Corrosion rates measured after 1-year exposure from coupons mounted on cylinders in K-yard. (○ = individual data points and ▲ = average values.)

There may also have been contributions from undercutting around the taped edges of the cylinder coupons. This was clear in some of the coupons in which the tape had delaminated in places and may also contribute to the larger scatter seen in these data compared to Fig. 17. The data in Fig. 18 also indicate higher corrosion rates among the cylinder coupons compared to those on the coupon rack, with very high corrosion rates in the poorly drained K-South location and the highest corrosion rates among coupons on cylinder tops. However, these differences may narrow over the next sets of retrievals. Any conclusions drawn from this first set of data would be premature.

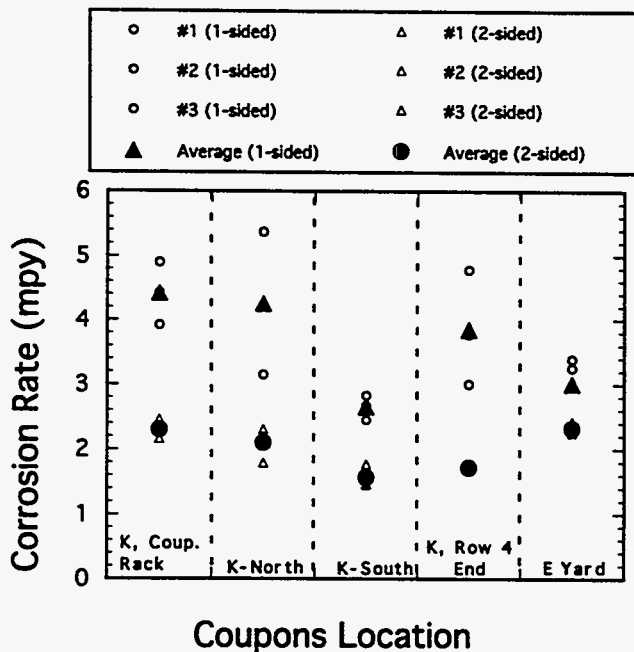
Early results from 6-month exposures of ground contact coupons are shown in Fig. 19. Again, the results are from too short a time to draw conclusions, especially with regard to the measured corrosion rates. However, it may be noted that one-sided coupons consistently showed higher corrosion losses than two-sided coupons. This supports the intuitive conclusion that ground-contact corrosion is worse than atmospheric corrosion since, for the two-sided coupons, the higher mass loss contribution from the ground contact side would be diluted by the lower mass losses from the skyward side, leading to an overall lower corrosion rate compared to ground-side-only exposed coupons.

Fig. 19. Corrosion rates measured after 6-month exposure from coupons in ground contact in E and K yards. Skyward faces of one-sided coupons are protected whereas those of two-sided coupons are open to the atmosphere.

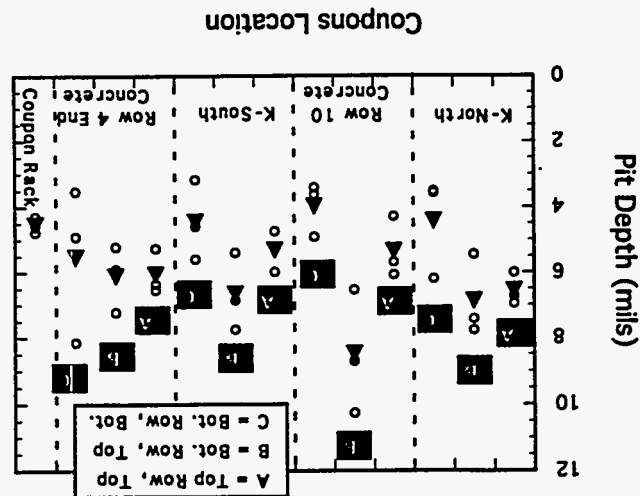
Examination of the cylinder coupons showed that top-facing coupons were also significantly more heavily pitted than bottom-facing coupons, which may contribute to their generally higher mass losses. Figure 20 shows the results of pit depth measurements on the 1-year cylinder coupons after the corrosion product had been rinsed off. Twenty of the deepest appearing pits were measured using an optical microscope with a calibrated focussing knob, and, of these, the fifteen highest

values were averaged for each data point. There is significant scatter in the data, but at each location pit depths on bottom row, bottom (BR, B) coupons are consistently lower than on the sky-facing coupons. Again it is too early to say whether pitting on bottom-facing coupons is fundamentally less or is merely delayed due to sheltering effects. Examination of two-sided ASTM G50 coupons exposed on the coupon rack for 2 years showed pits on both sides of the coupons, with no clear indication of whether the pits were deeper on any one side. This suggests that, with time, pitting on skyward faces becomes as severe as on sheltered surfaces. Unfortunately, none of the 1-year ASTM coupons were available for comparison to verify any aging effects.

Fig. 20. Results of pit depth measurements on cylinder coupons after 1-year exposure

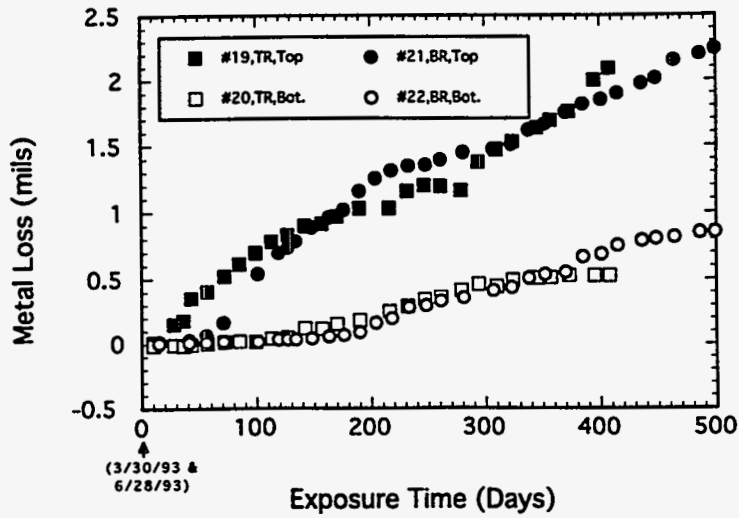
Fig. A5. Data from corrosion probes 19–22 on relatively heavily corroded TR and BR cylinders in K yard, row 10, concrete pad.

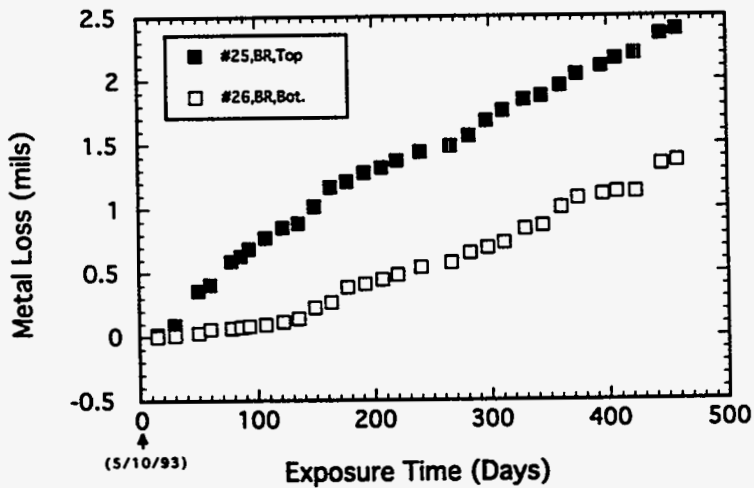
Fig. A6. Data from corrosion probes 25 and 26 on a relatively lightly corroded BR cylinder in K yard, row 14, gravel pad.

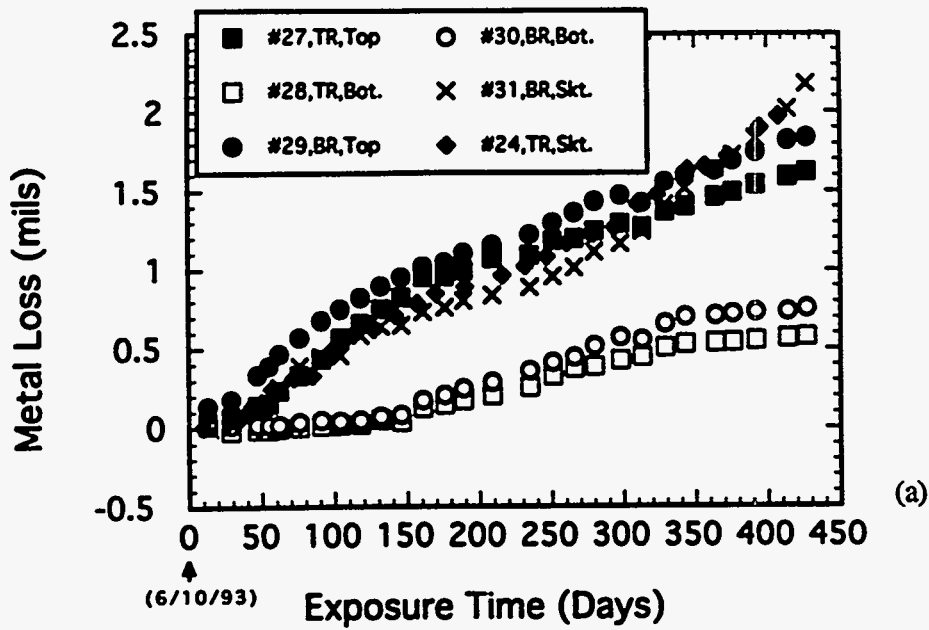
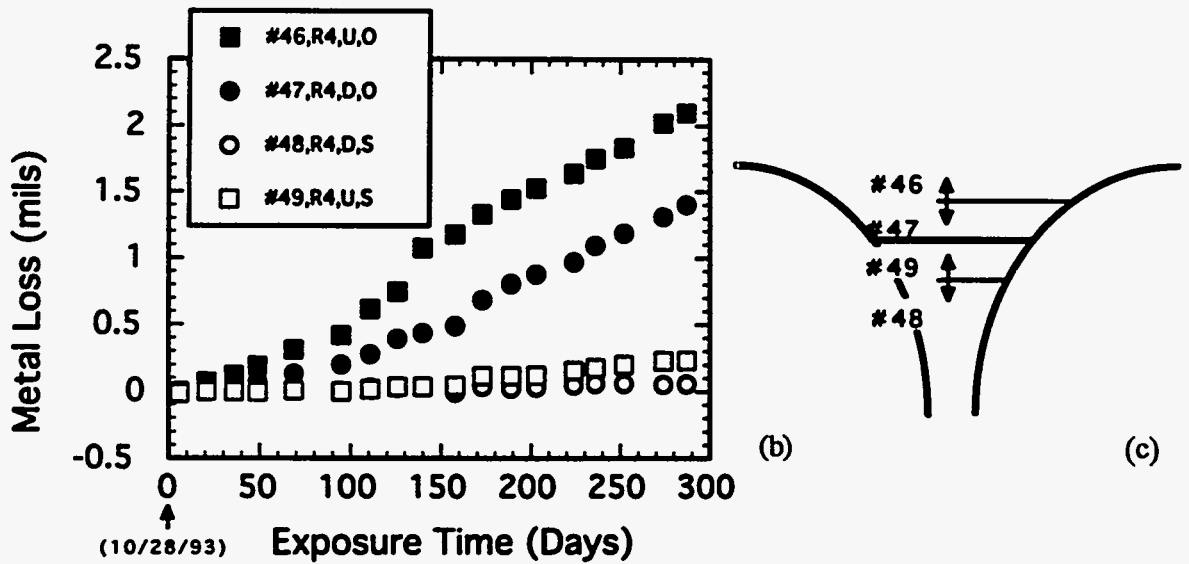
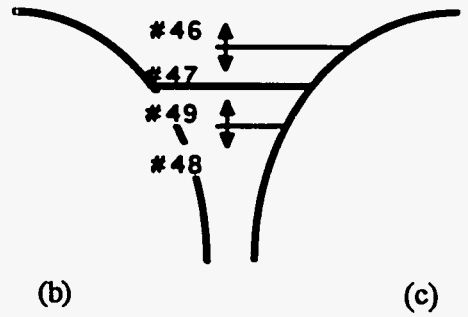
Fig. A7. Data from corrosion probes (a) 24, 27-31 (on cylinders) and (b) 46-49 (between top row cylinders) on relatively lightly corroded cylinders in K-yard, row 4, concrete pad. The sketch (c) shows the orientation of probes 46-49.

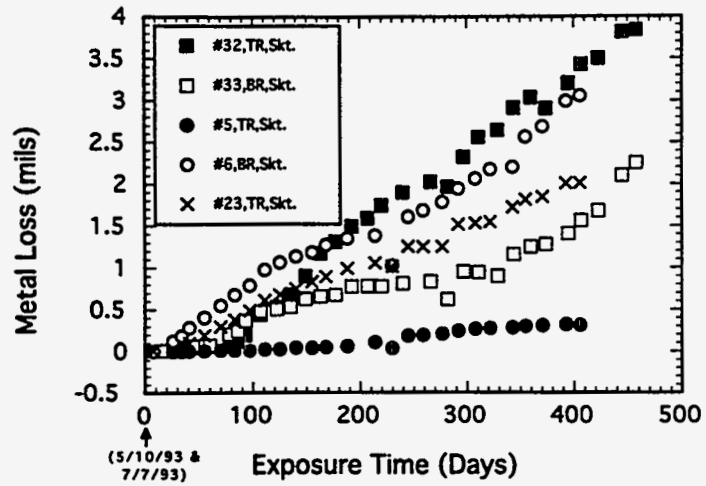
Fig. A8. Data from corrosion probes 5, 6, 23, and 33 on relatively heavily corroded TR and BR cylinders in K-yard, row 3, concrete pad.
