## LIFE TESTING OF A LOW VOLTAGE AIR CIRCUIT BREAKER\*

Mano Subudhi  
Department of Nuclear Energy  
Brookhaven National Laboratory  
Upton, New York 11973

BNL-NUREG--47471

Satish Aggarwal  
U.S. Nuclear Regulatory Commission  
Washington, D.C. 20555

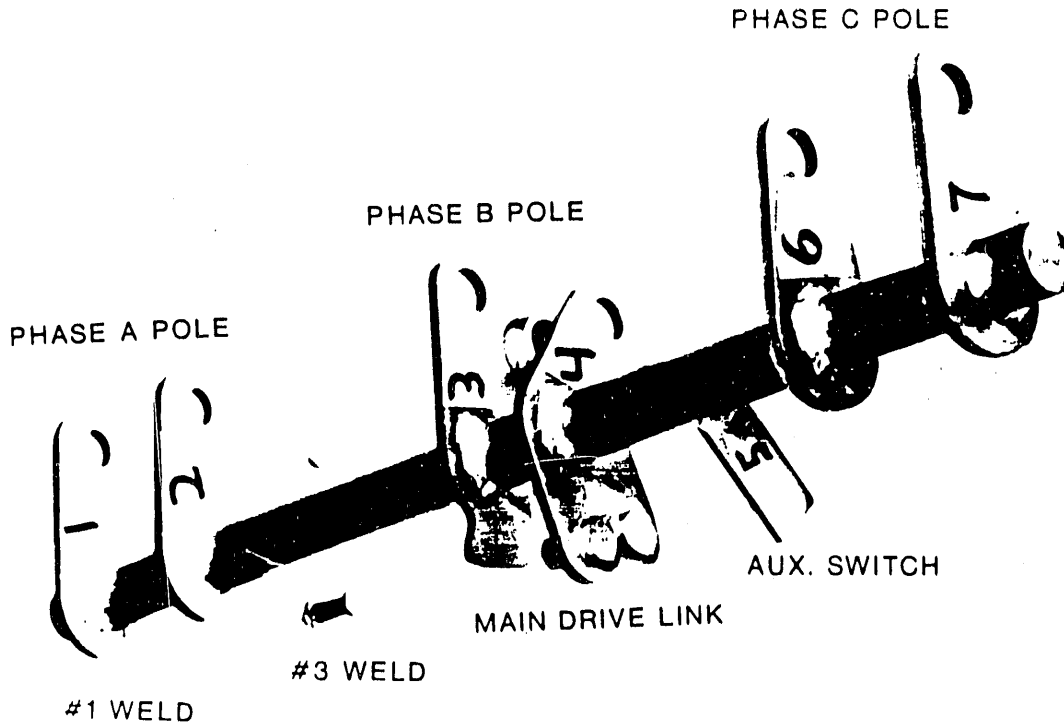
Figure 4. Pole shaft with pole levers

environment of a breaker in a nuclear power plant is relatively benign,\* it has a minimal effect on the degradation of the breaker's components. The operating cycles, however, induce degradation attributed to heating generated by full load operation, and arcing associated with the closing and opening (or tripping) of the breaker. Problems stemming from this heating are typically associated with the burning and erosion of contact surfaces and arc chutes. From the various maintenance recommendations found in industry standards or in manufacturers' manuals, it is evident that these problems are better understood by the utilities. In addition, the cycling itself imposes various aging degradation in the power-operated mechanism and the pole shaft. Review of operating experience data from the NPRDS revealed that aging of various parts within the power-operated mechanism, including the pole shaft, had dominated the recent breaker failures. The current inspection, monitoring, and testing activities failed to identify degradation of these subcomponents at their incipient stages. Since the failure of substandard pole lever welds on a reactor trip breaker at the McGuire nuclear power station in 1987 prompted this research, this testing was limited to mechanical cycling to assess the adequacy of the inspection program delineated in NRC Bulletin 88-01 for verifying the structural integrity of all seven welds on the pole shaft, as shown in Figure 4.

The high force/torque on the #3 pole lever weld is the critical reason why a crack in this weld developed first in the pole shaft with 60-degree weld; as shown in Figure 7. The #3 lever was completely detached from the shaft before transferring any load to other welds. Up until 2000 cycles, the effect of the crack in this weld was not noticed. For the next 1000 cycles, however, several problems associated with the operating mechanism were observed, including jamming of the trip mechanism, failure of the breaker to lock in or trip, and sluggish operation.
