An application of AcciMap to identify and analyse the causes of the Eastern Star and Sewol casualties

Yanning Jiang

**AN APPLICATION OF ACCIMAP TO IDENTIFY
AND ANALYSE THE CAUSES OF THE EASTERN
STAR AND SEWOL CASUALTIES**

2016

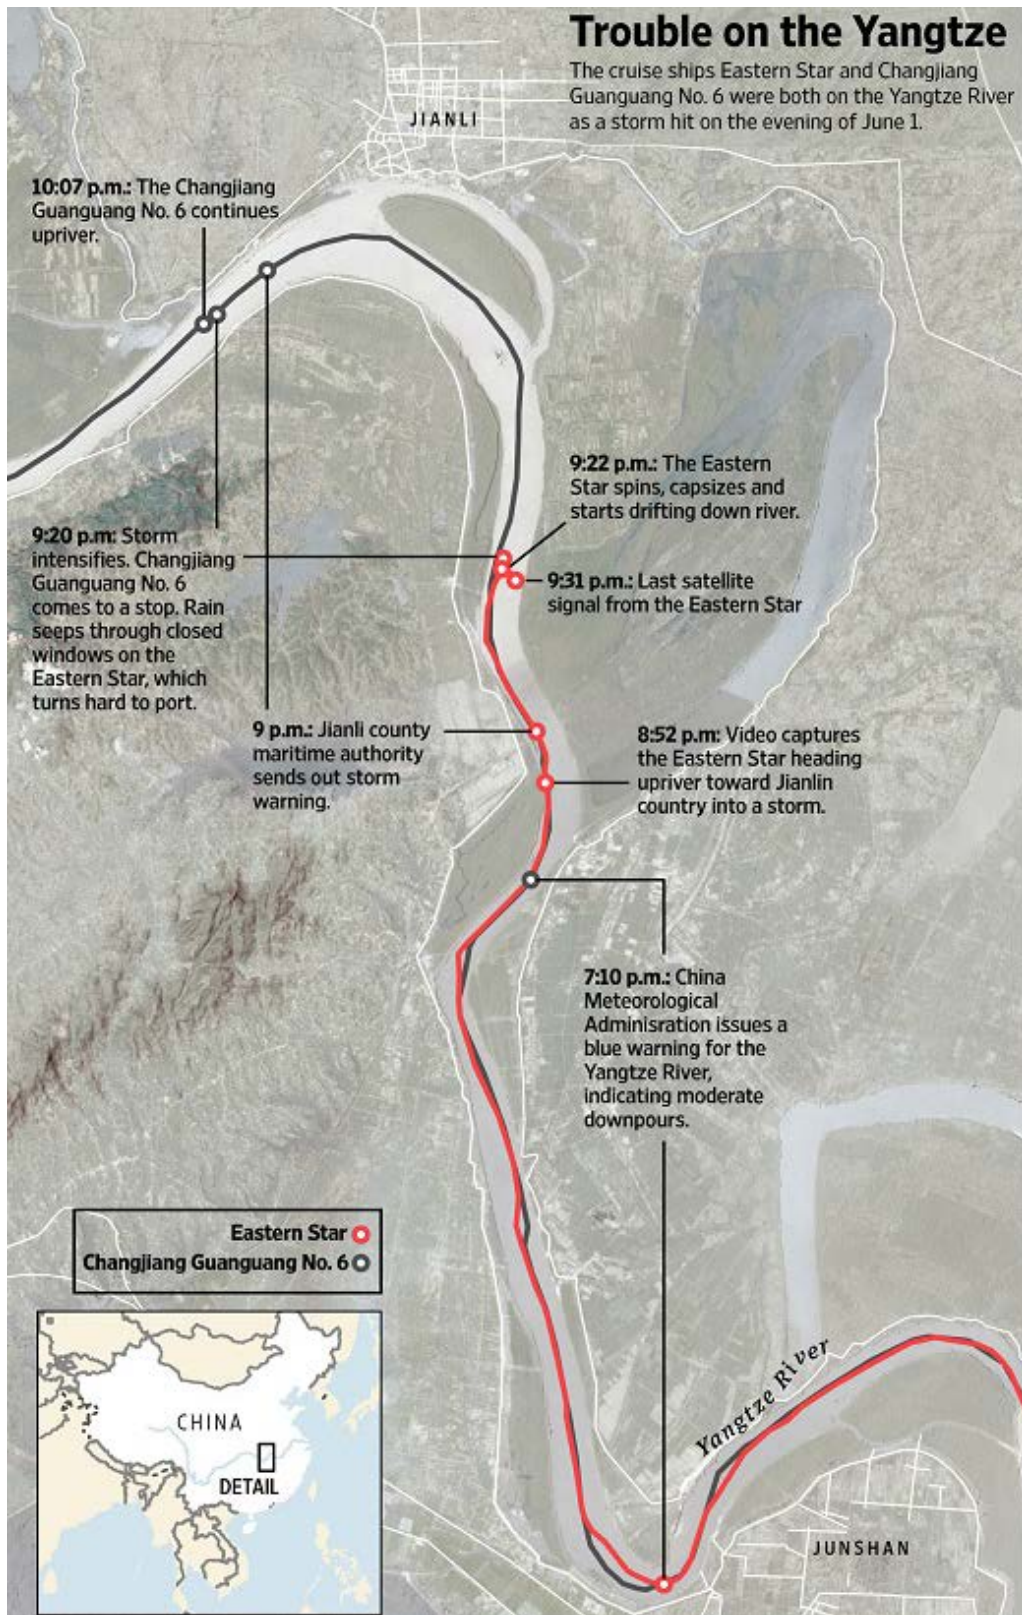
Figure 6. The sinking timeline of Eastern star

Time	Event
2103	Navigated to the water area around “No.1 Buoy of Tianzi”. Ship speed 14 km/h. Lighting and drizzling.
2121	Maximum wind speed 24.6 m/s (Bf 10). Low visibility. Captain ordered to Chief Officer (C/O) to slow down speed, altered small rudder angle to port, and intended to anchor in the water area near the starboard side of the river. Ship speed 12.0 km/h.
2123	Ship speed 2.2km/h, and gradually reduced to 0.
2124	Ship started to go astern due to the influence of strong wind. Ship speed 4.0 km/h astern.
2125	Ship speed 5.6km/h astern. Captain ordered C/O to increase the engine speed.
2126	Ship speed reduced to 5.0 km/h astern. Suddenly encountered downburst storm, the maximum wind speed increased to 32-38m/s (Bf 12-13).
2129	Ship speed reduced to 4.0 km/h astern by the effects of the engine and rudder.
2130	Ship started to turn and wind angle increased under the effect of the strong storm. The ship was not under control. Ship speed increased to 6 km/h astern. Later on, the ship suddenly listed to starboard and started to flood.

2131	Main engine stopped. Heavily listed to starboard.
2132	The Eastern Star Capsized. AIS and GPS signals disappeared.

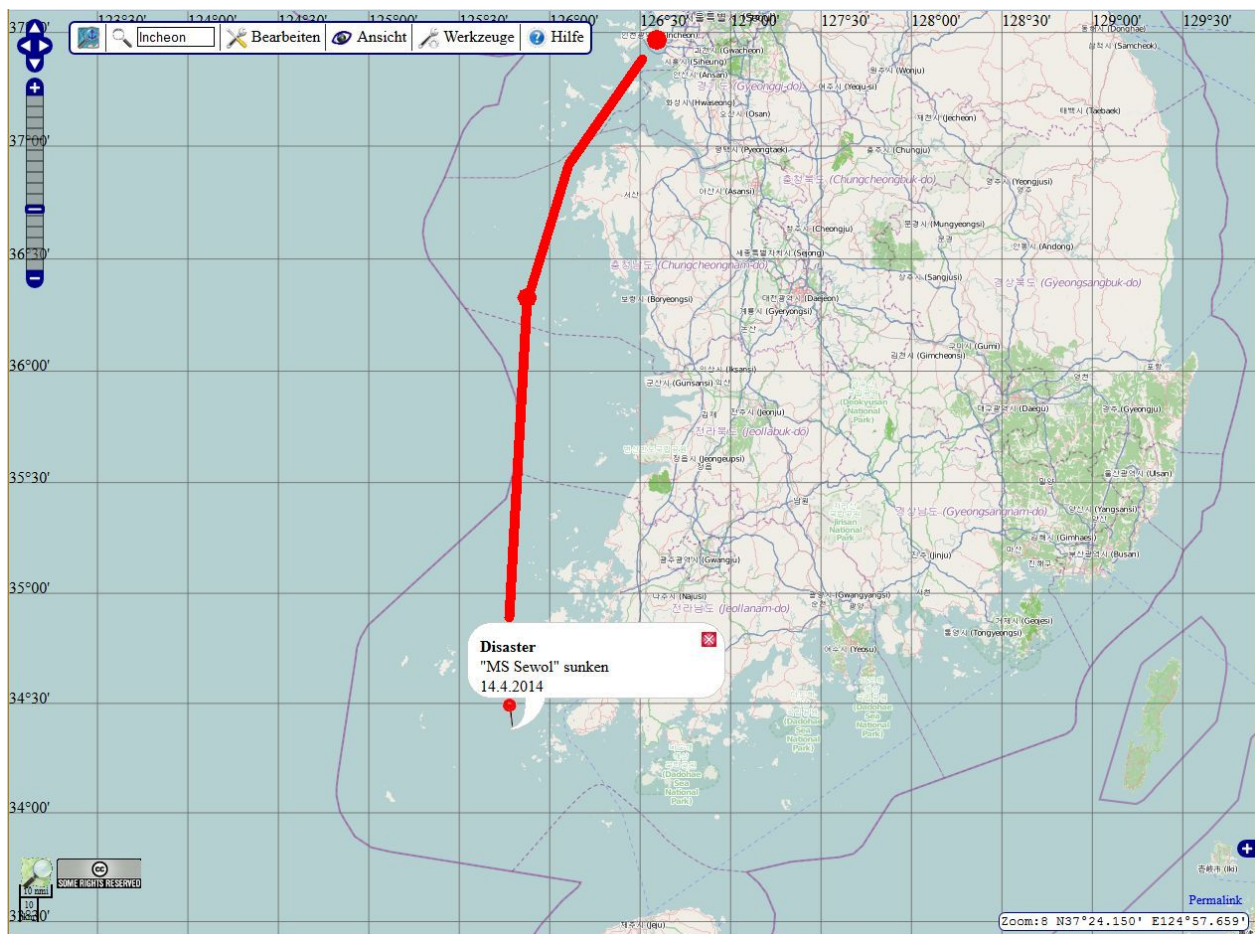
Figure. 8 The route of Sewol ferry (Source: Wikipedia)

Time	Event
0800	The 25-year-old third mate, Park Han-gyeol, began her scheduled four-hour shift on the bridge.
08:48	Right before 8:48 a.m., Cho steered the ship on a course of 135 degrees, or southeast. At 8:48, Third Mate Park, who was monitoring the radar and radio in the ship, came to conclusion that there was another ship approaching on a collision course and therefore ordered to Helmsman Cho to turn the ship, initially by 5 degrees to 140 degrees and then to 145 degrees. Cho reacted to Park's orders and turned to starboard to 145 degrees.
0849	The second turn to course 145 (10 degrees) in one second, from 8:49:12 to 8:49:13, is contemplated to be sharp in the context that generally large passenger ships would take two minutes to make a five-degree turn. When the chief engineer was enquired about the situation, Cho replied that the "steering gear was not working." Due to the imbalance, Park ordered Cho to balance the ship to "Port," but this order was misheard as a Korean word meaning to 'turn in the opposite direction,' a mishearing that did not affect the meaning. The chief engineer testified that the ship commenced tilting precisely after Park's last order.

0850	The chief engineer ordered an evacuation of the engine room through a call to the assistant engineer. With the engines off, Sewol became unable to change directions and began drifting sideways.
0852	Choi Duk-ha, a Danwon high school student aboard the ferry at 8:52 a.m., made the first emergency call; he called the national emergency service number and reported to the Jeollanam-do fire station that Sewol was capsizing.
0855	At 8:55 a.m., Sewol's crew made their first distress call to the Jeju vessel traffic service requesting them to notify the Coast Guard since the ferry was rolling and in danger.
0930	Around 9:30 a.m., the captain ordered to abandon the ship, though the order may not have been relayed to all the passengers.
1118	At 1118 hours approximately, the bow of the ship was submerged, with a section of the hull about 2 meters (6 ft. 7 in) high and 20 to 30 meters (66 to 98 ft.) long showing above the water.

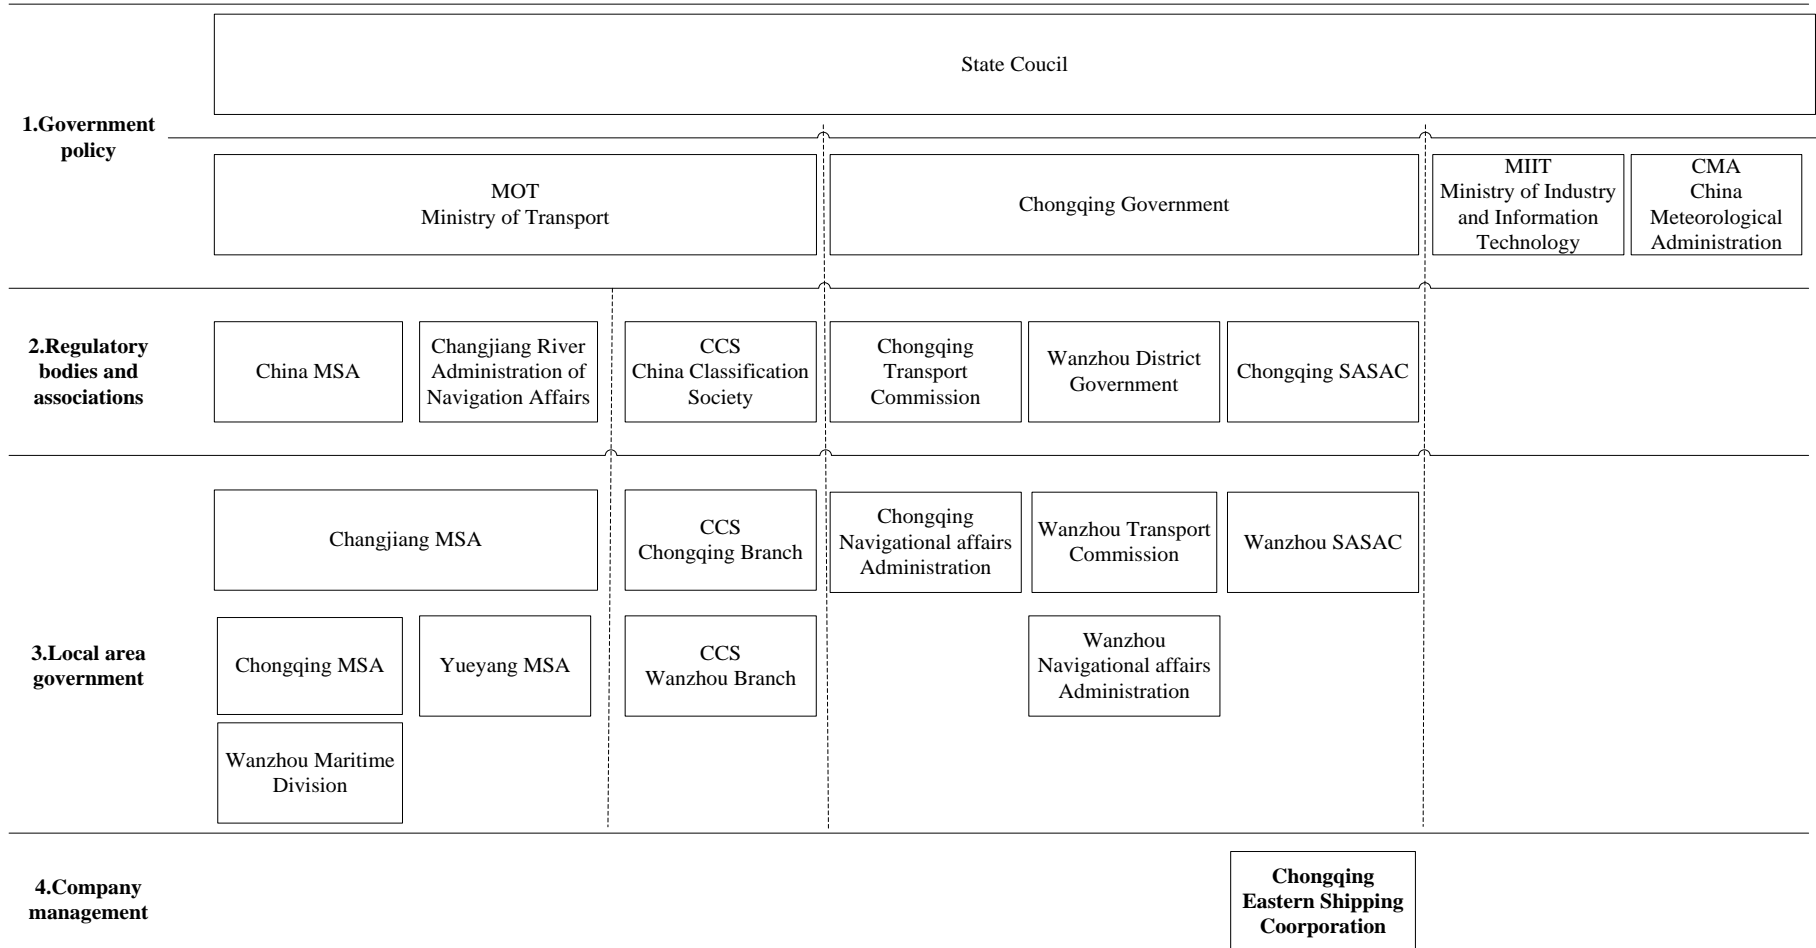
Figure 10. ActorMap of Eastern Star casualty

For the case of the Eastern Star, according to the investigation report, actors can be identified as in the map shown in Figure 10.

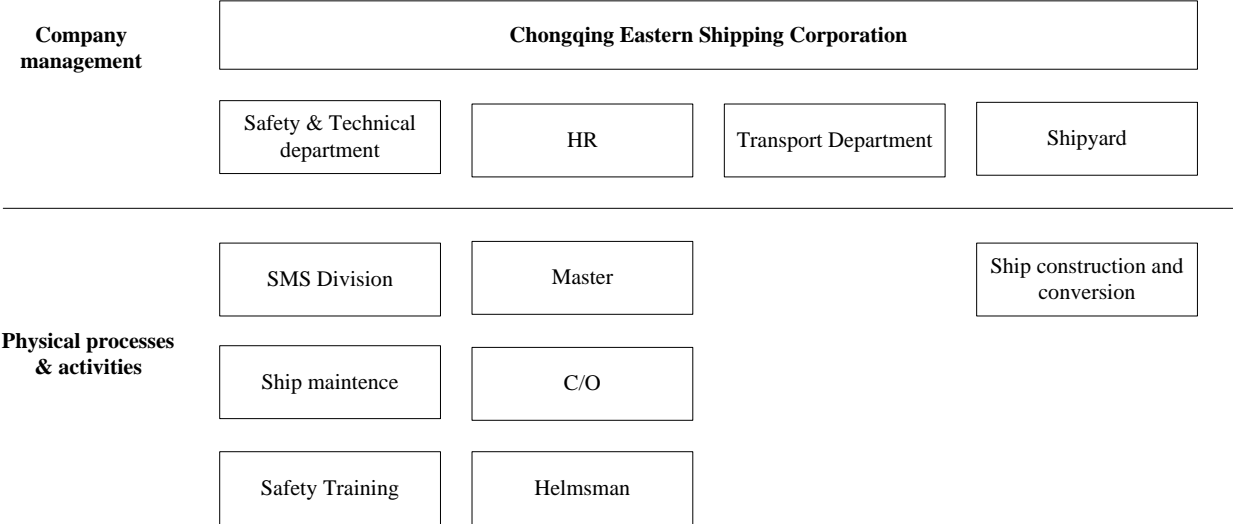
Figure 11. ActorMap of Chongqing Eastern Shipping Corporation

At the company level, Chongqing Eastern Shipping Corporation takes direct responsibility for the incident. In detail, the Technical & SMS Department, HR, the Transport Department and the company-owned shipyard took the liability for the incident. (See Figure 11)

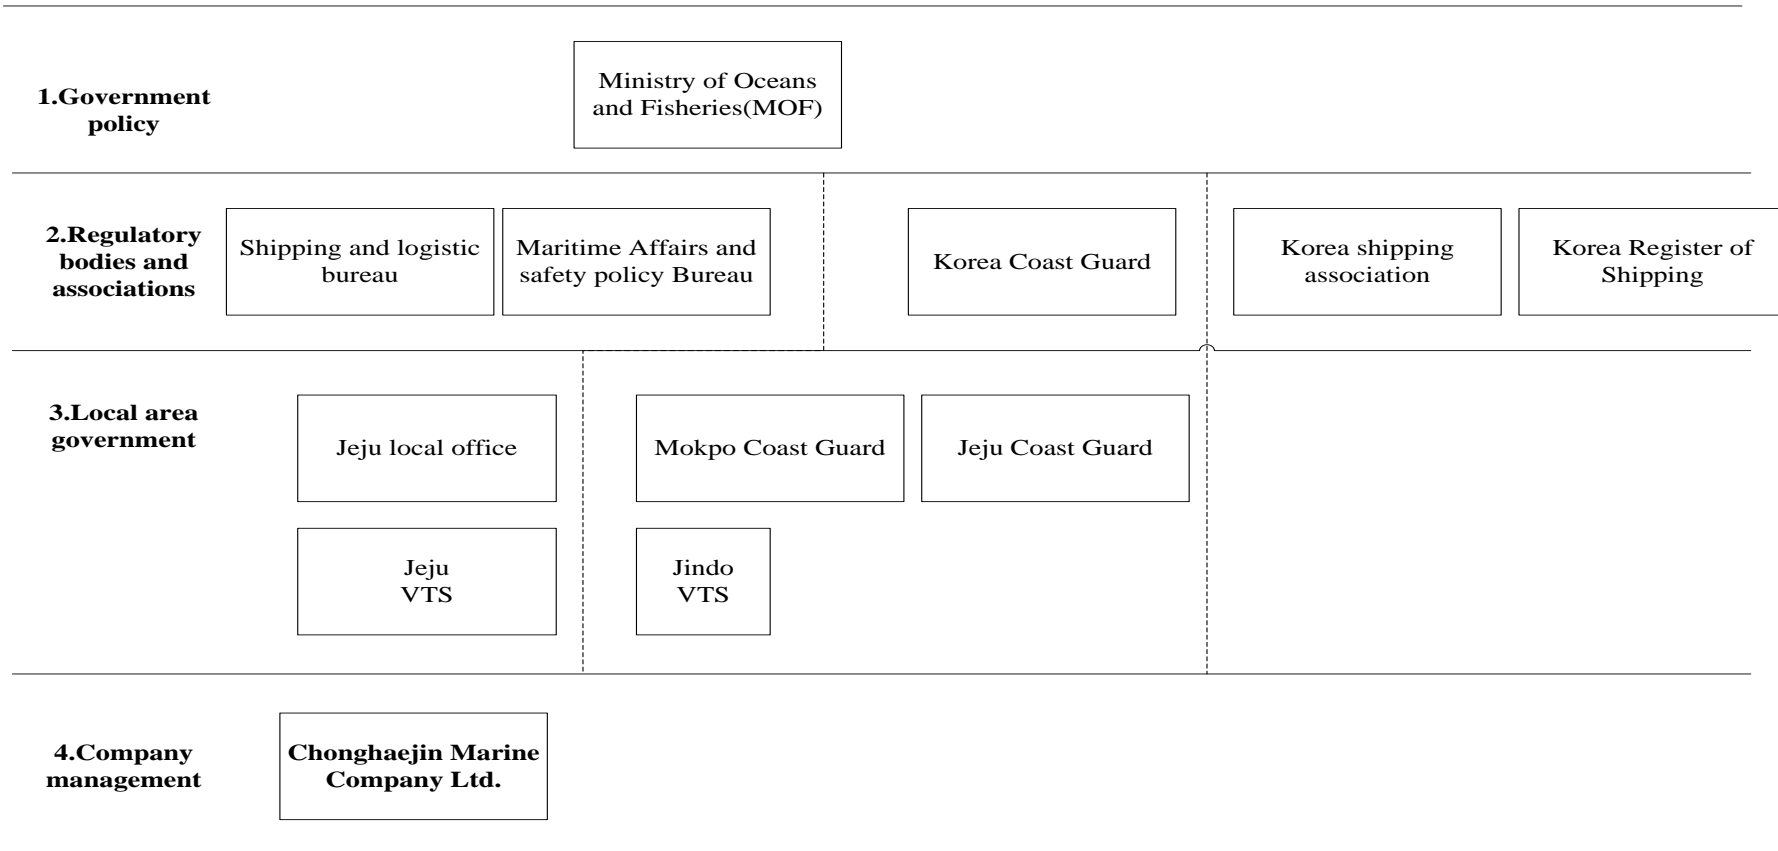
Figure 13 ActorMap of the Sewol casualty

According to the investigation report into the Sewol accident, an ActorMap is drafted as shown in Figure 13.
