XVIII SCIENTIFIC - EXPERT CONFERENCE ON RAILWAYS RAILCON '18

METHODOLOGY FOR STATISTICAL ANALYSIS OF SQUAT RAIL DEFECTS

Milica VILOTIJEVIĆ¹
Ljiljana BRAJOVIĆ²
Andrey P. PUSTOVGAR³

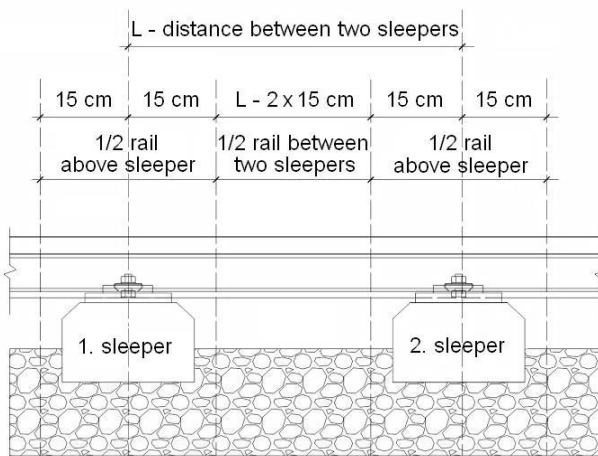
Fig.7. Zones of squat occurrence above and between sleepers

Based on the defined zones of defect occurrence (Figure 7), around 63% of all squat rail defects were detected in the zone above the sleeper, while 37% of squat defects were detected in the zone between two sleepers. Thus, the correlation of the defect location and the rail support stiffness was confirmed. In addition, larger number of defects above the sleepers was detected in the case of decreased distance between sleepers ($L < 60$ cm). Therefore, it could be concluded that the distance between sleepers affects the occurrence of squat rail defects. The continuous occurrence of squat rail defects is observed in the zones with smallest sleeper distance (higher vertical stiffness of rail support).
