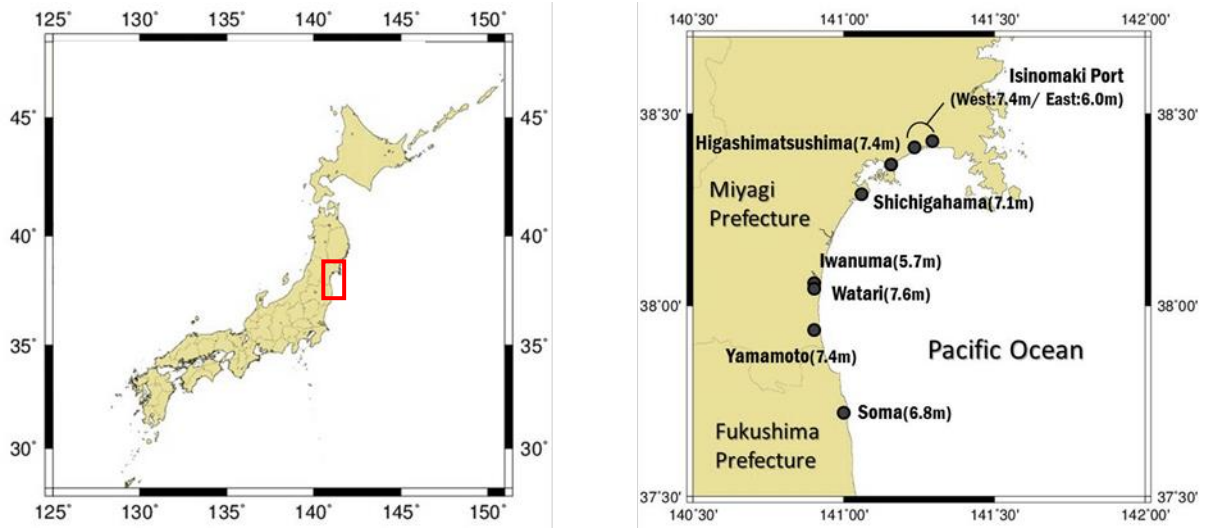
Figure 1. Surveyed locations in Miyagi and Fukushima prefectures after the 2011 Tohoku tsunami with inundation heights.

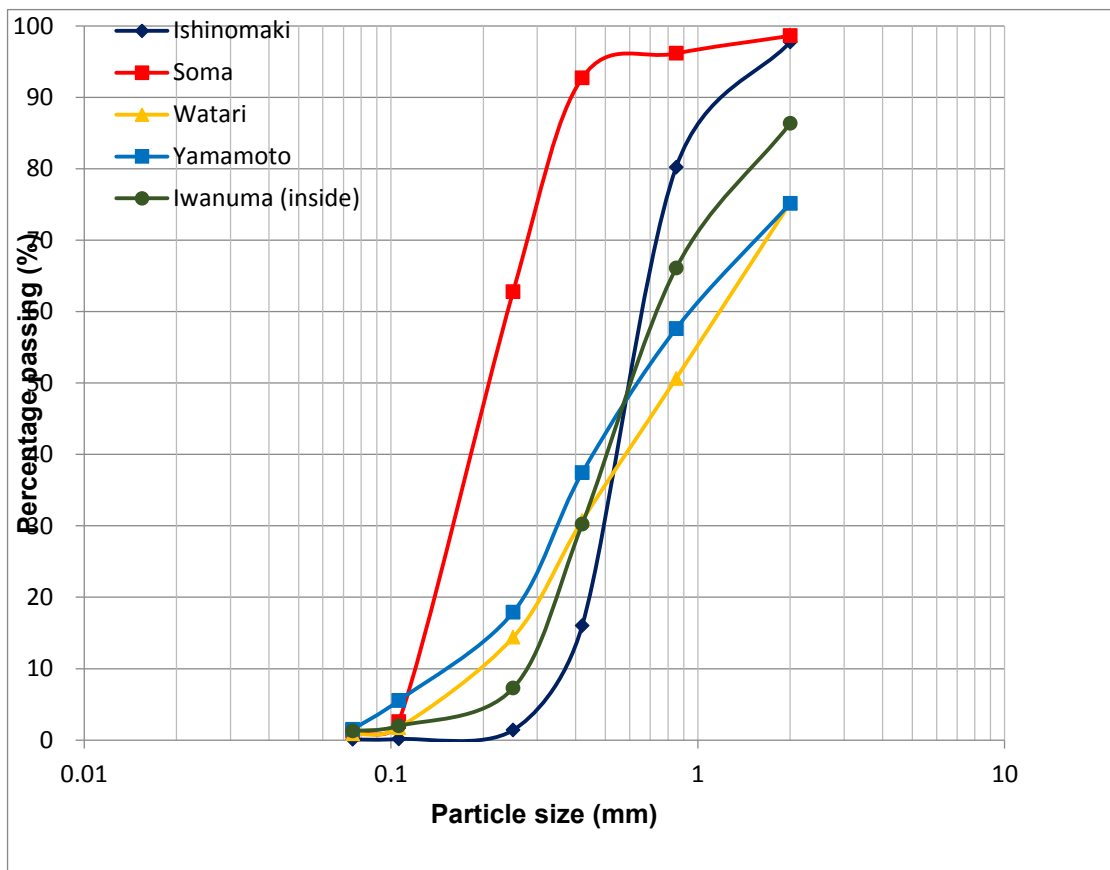
Figure 11. Particle size distribution curves for scour holes at different locations in Miyagi and Fukushima prefectures.

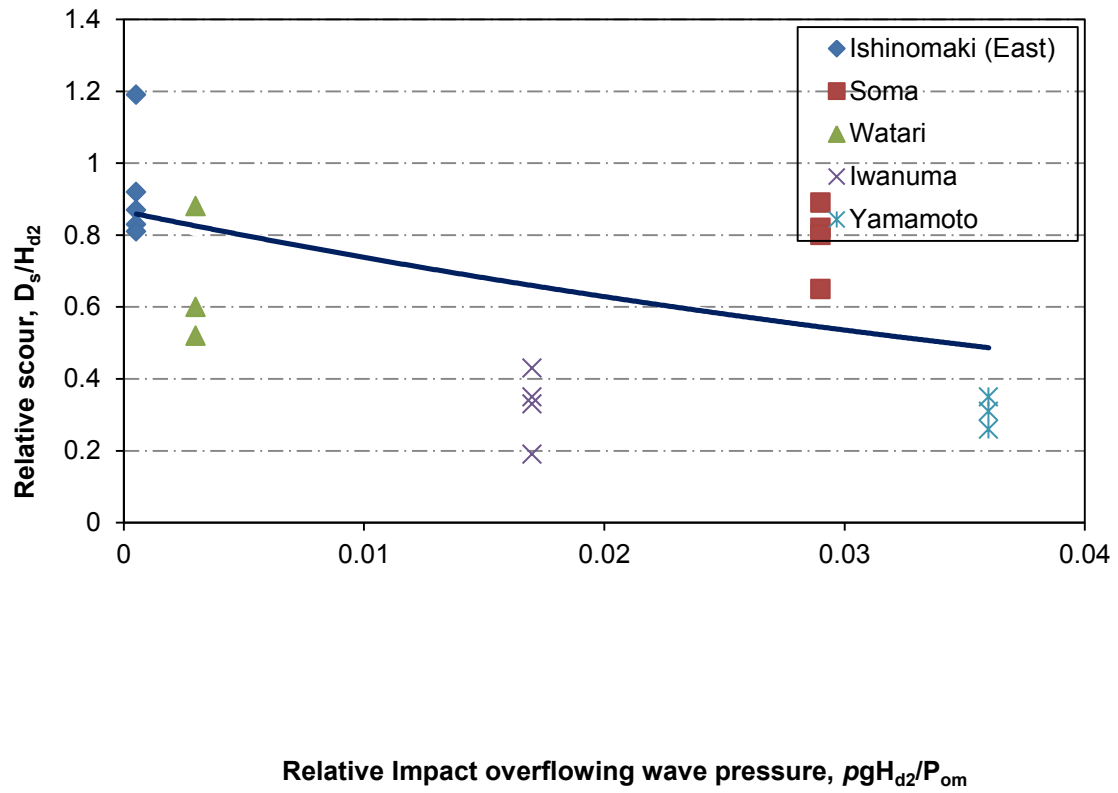
Figure 12. Relationship between relative scour depth and impact overflowing wave pressure

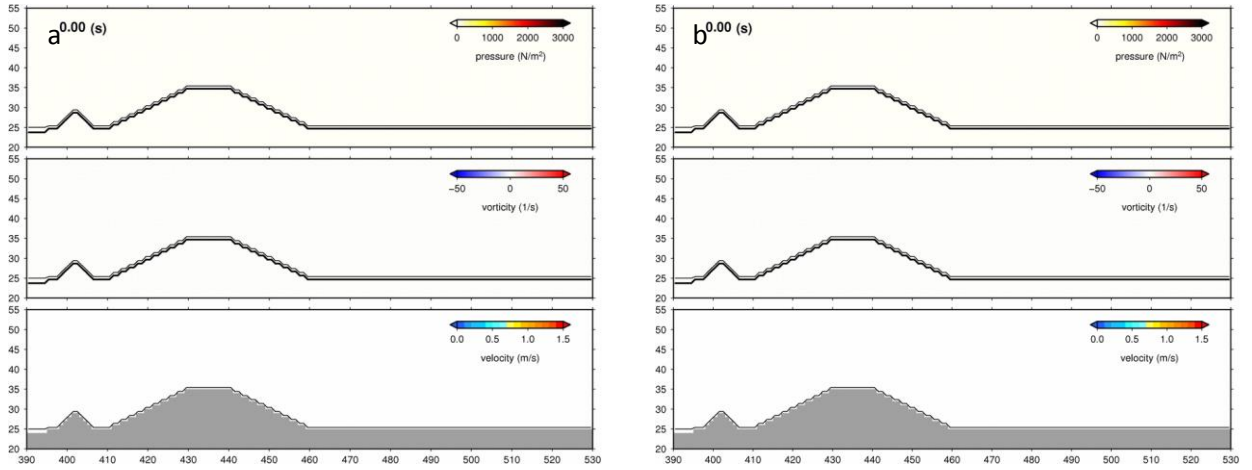
Figure 13. (a) Typical coastal dike with wave wall (Laboratory scale) found in Miyagi and Fukushima prefectures, and (b) Improved coastal dike section with placing artificial armour units in front of seaward slope.

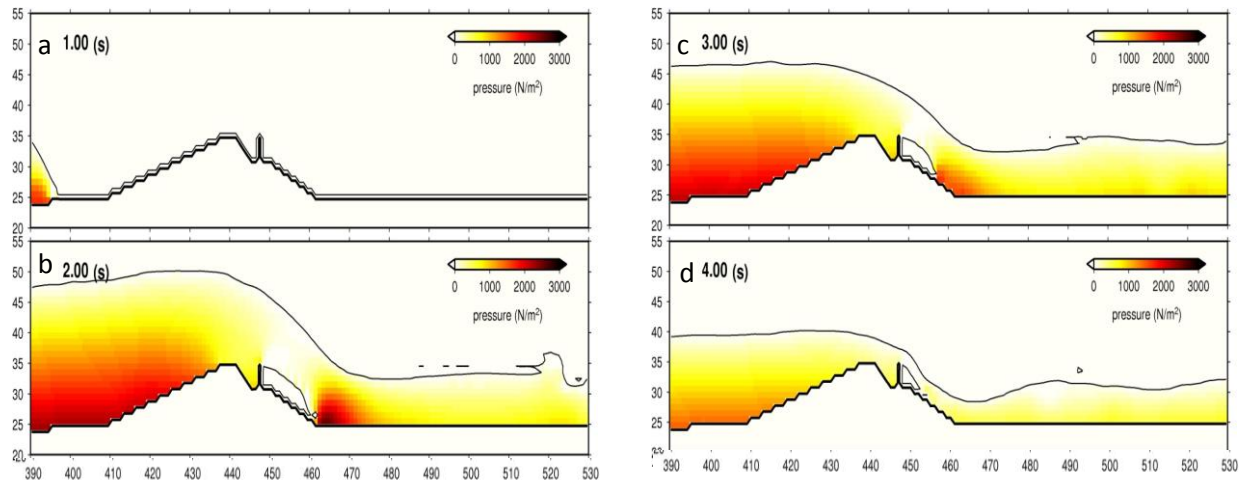
Figure 14. Time variation of overflowing wave pressure around a typical coastal dike with wave wall (Laboratory scale) found in Miyagi and Fukushima prefectures ($t=1.0-4.0$ s).

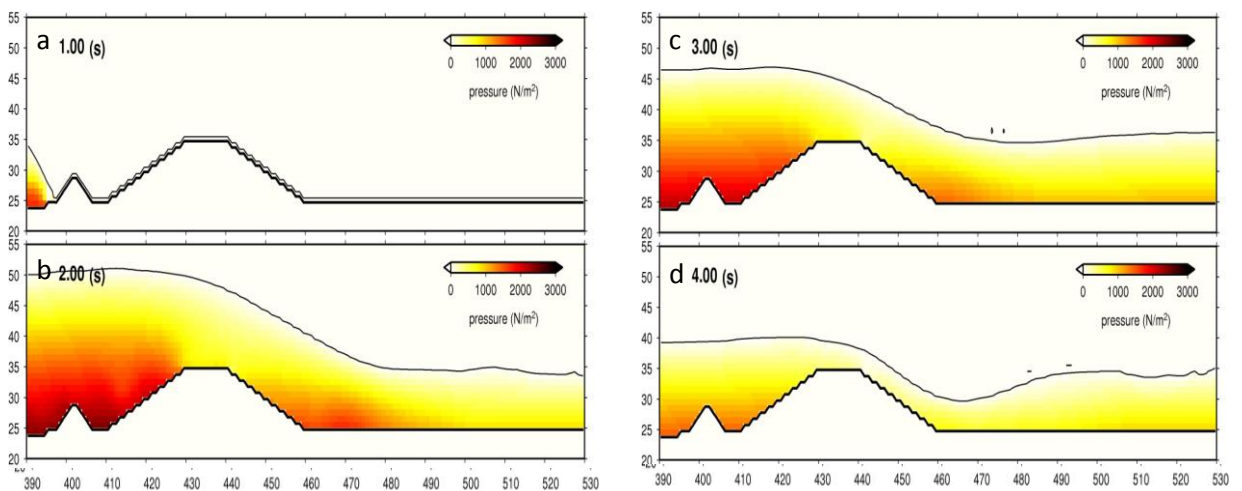
Figure 15. Time variation of overflowing pressures around an improved coastal dike section with artificial armour units placing in front of seaward slope (Laboratory scale) ($t=1.0-4.0$ s).

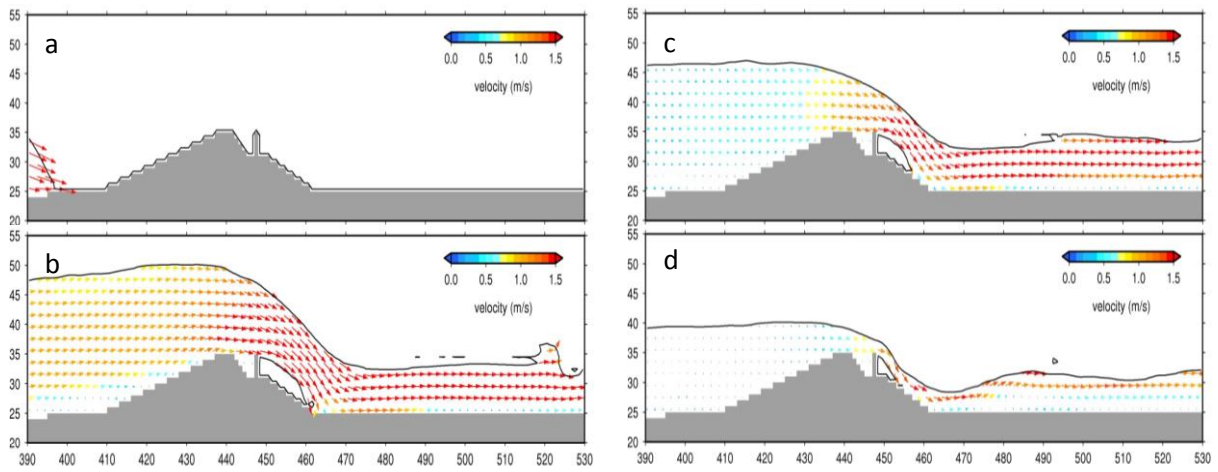
Figure 16. Time variation of velocities around a typical coastal dike with wave wall (Laboratory scale) found in Miyagi and Fukushima prefectures ($t=1.0-4.0$ s).

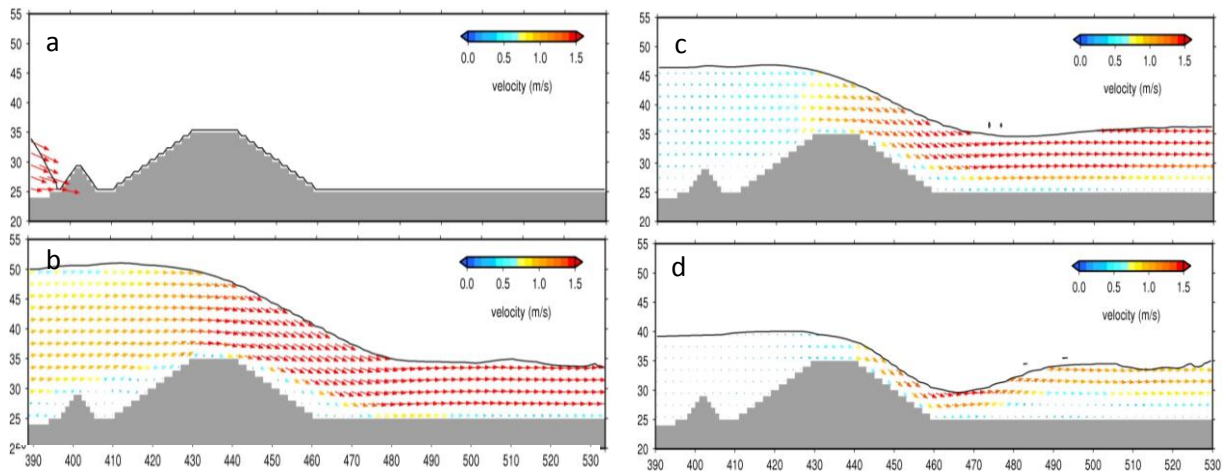
Figure 17. Time variation of velocities around an improved coastal dike section with artificial armour units placing in front of seaward slope (Laboratory scale) ($t=1.0-4.0$ s).
