A Framework for Risk Analysis and Vulnerability Assessment of the Rubble Masonry at Tuzigoot National Monument

A FRAMEWORK FOR RISK ANALYSIS AND VULNERABILITY ASSESSMENT
OF THE RUBBLE MASONRY WALLS AT TUZIGOOT NATIONAL
MONUMENT

Advisor and Program Chair
Frank G. Matero
Professor

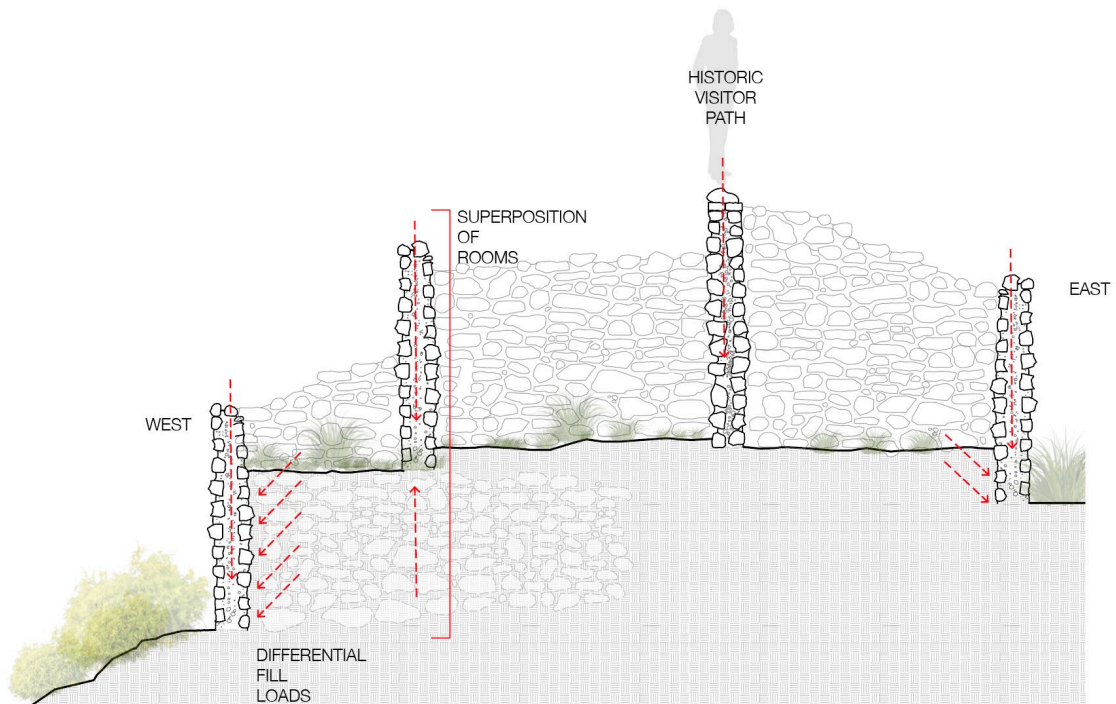
Figure 25 / *Diagram showing the current differential fill and room superposition.*

In summary, the original rubble masonry at Tuzigoot was not a structurally robust system. First, as previously discussed in the technical section, both the rounded shape of the stones and their random positioning contributes to a nonuniform distribution of loads causing localized stress concentrations resulting in failure in the form of cracking, and material loss and a short life. Second, the disconnection between wythes and between intersecting walls also makes the walls prone to vertical separation, displacement, and collapse. And third, the surrounding conditions of the walls such as differential fill and the super positioning of the walls might be slowly contributing to the structural failure of some of the walls at Tuzigoot.

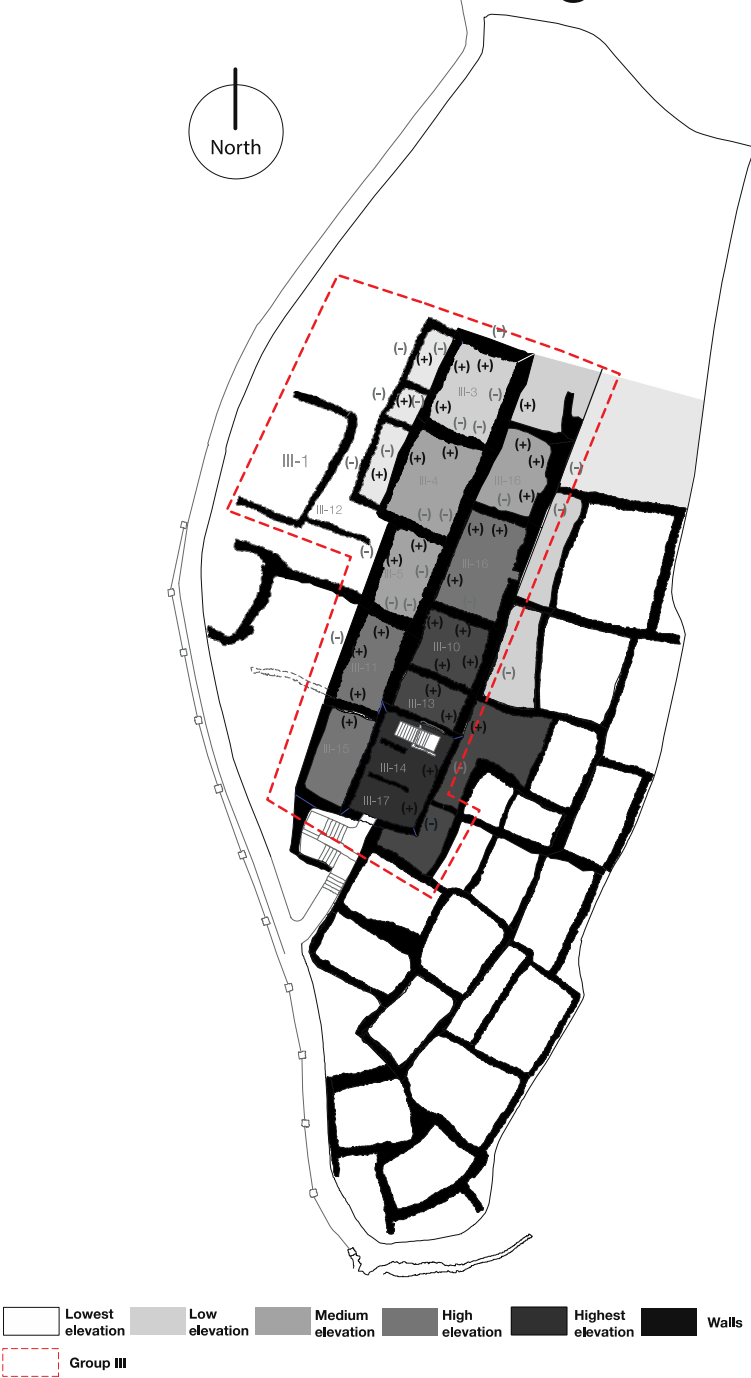
Differential fill was depicted in the site plan (Figure 30) to show the relationships between the ground height on both sides of the walls. This diagram was used to compare and contrast conditions that might be affected by differential fill.

Figure 30 / Differential Fill diagram

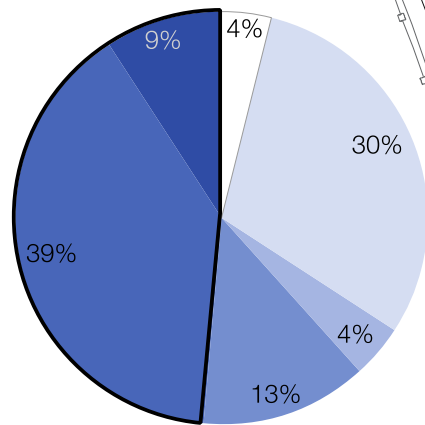
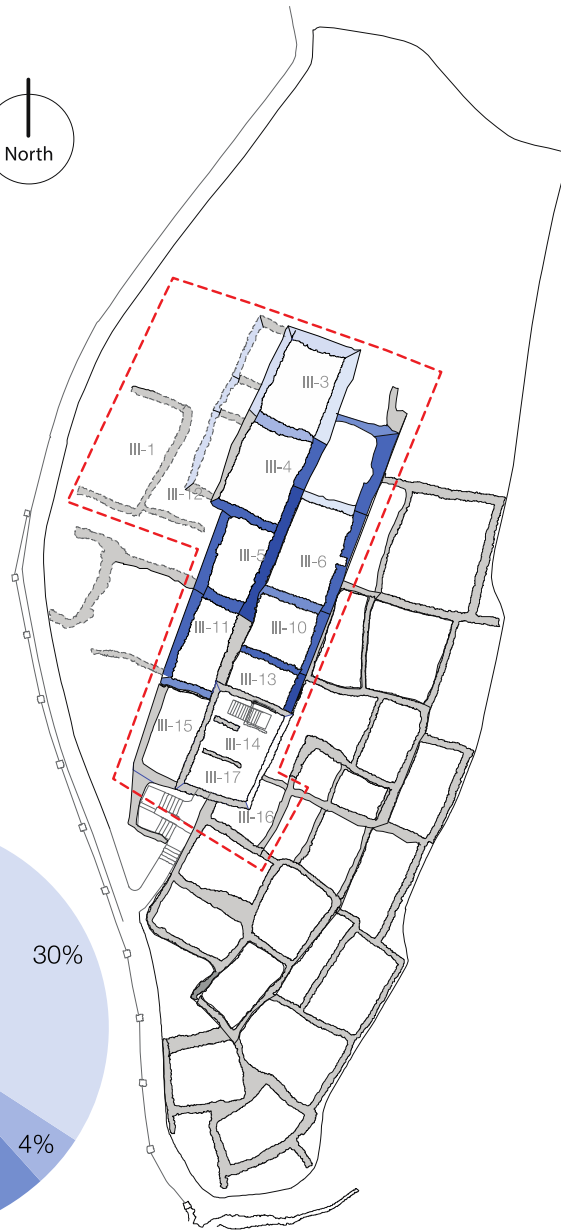
In general, wall cap deterioration, bulging and animal burrowing were the most recurrent conditions found on site, where more than 80% of the evaluated walls had some level of each condition. Cap Deterioration (Figure 31) occurred in 96% of the walls and 48% of the evaluated walls had a high level of deterioration of 4 or 5. This condition was observed in both, north-south and east-west oriented walls. This confirms that wall orientation does not influence cap deterioration of walls. The only wall that did not show any signs of cap deterioration was one that is accessible to the public and is regularly maintained.

96%
of walls have some degree
of cap deterioration

48%
high level of
deterioration

Figure 31/ Wall Cap deterioration Diagram

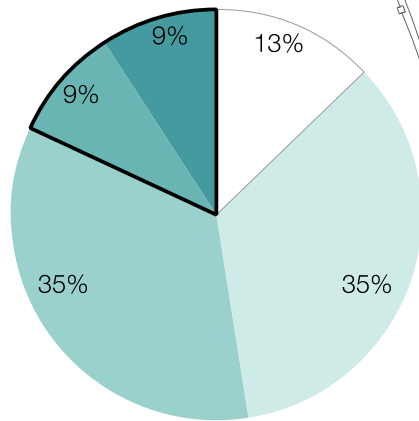
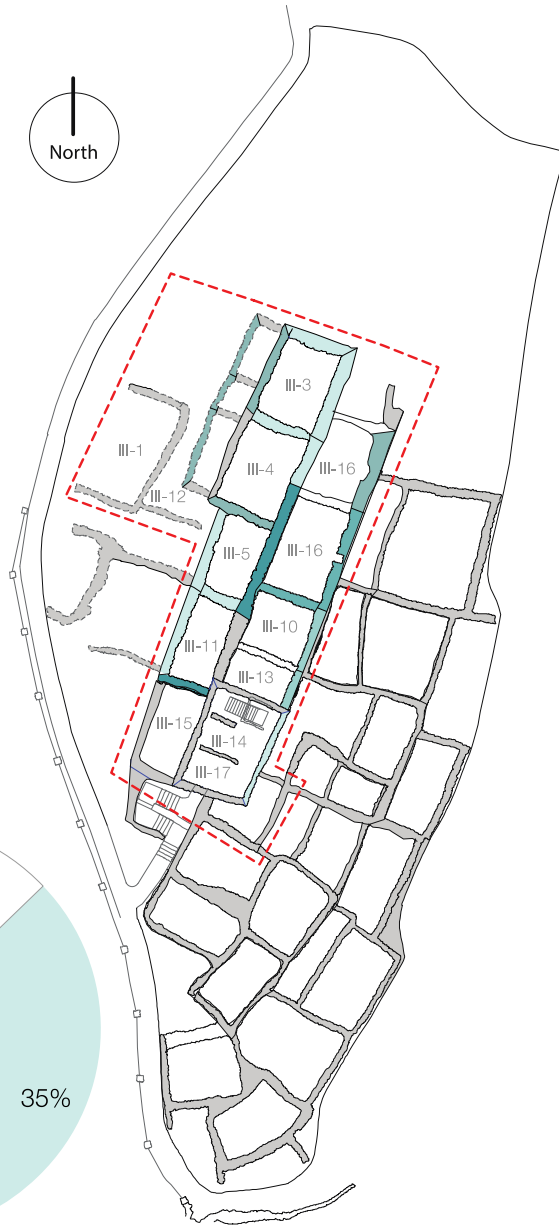
87%
of walls have some
degree of bulging

18%
high level of
deterioration

Figure 32 / Bulging Diagram

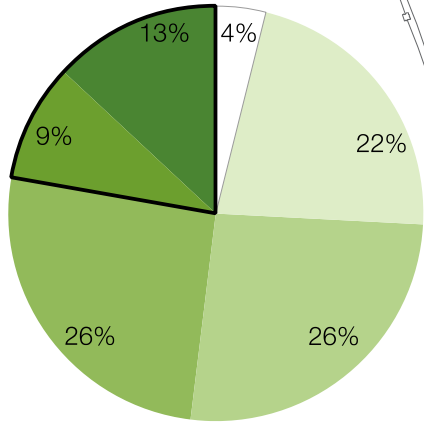
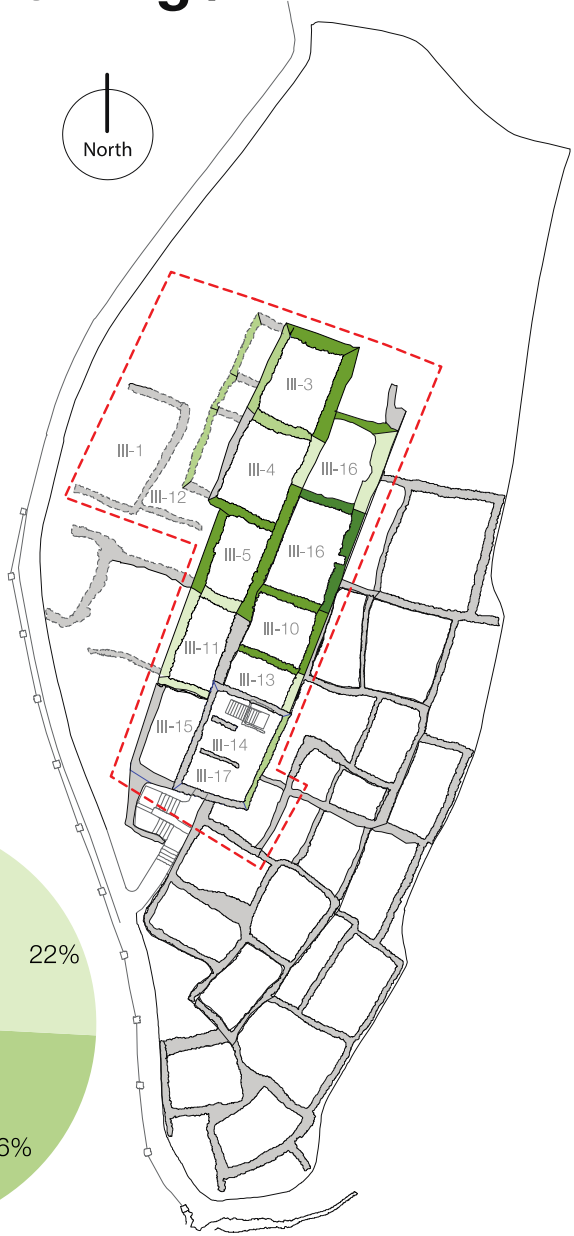
96%
of walls have some
degree of animal
burrowing or vegetation

22%
High level of
deterioration

Figure 33 / Animal Burrowing and Vegetation

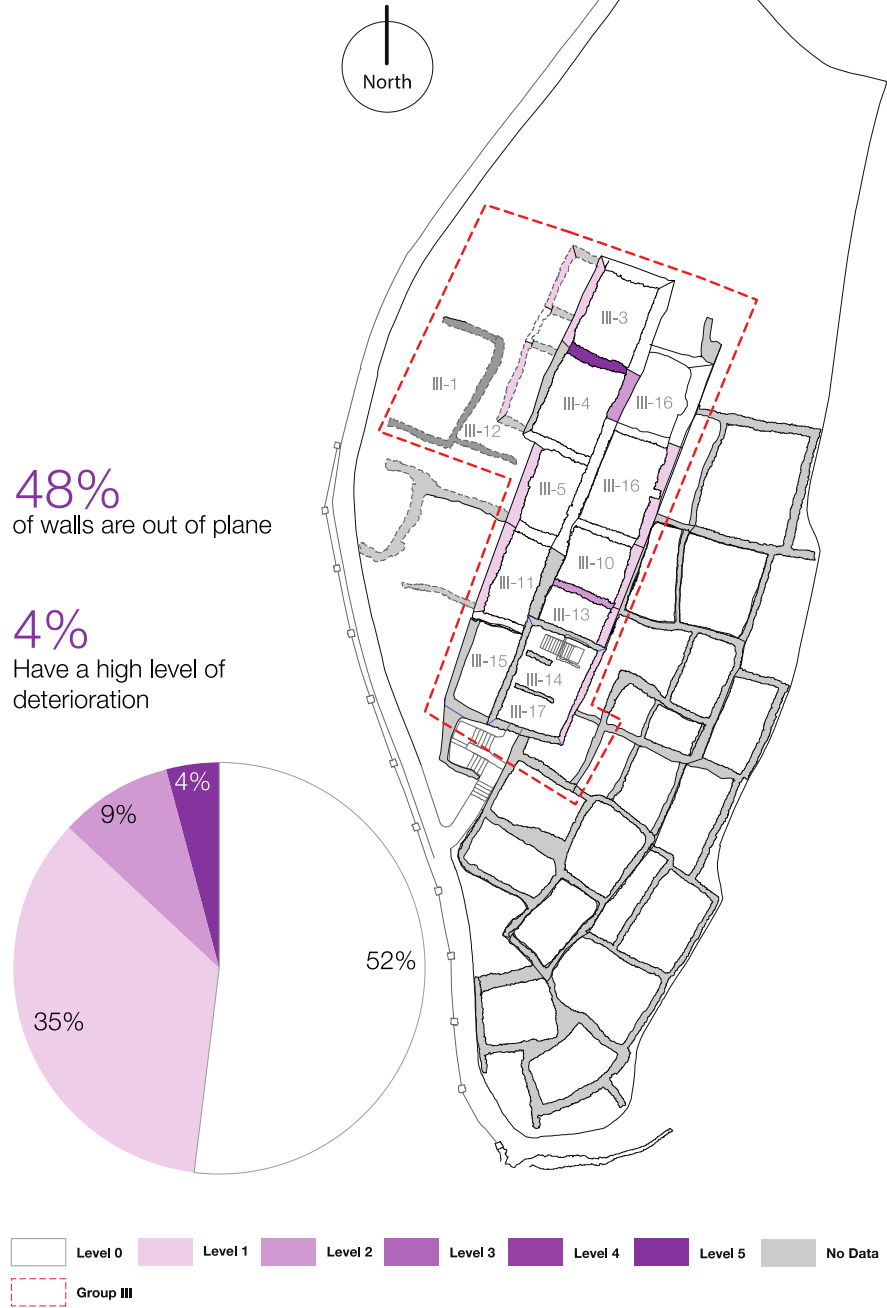
Out of plane, structural crack and structural cracks at wall junctions had an intermediate recurrence. Out of plane (Figure 34) was only observed in 48% of the walls, with 96% of the walls scoring low levels (level 1 and level 2) for this condition. The only wall that scored a level 5 was the interior division wall of the rooms that superimposed earlier construction. In this case the superimposed wall is not perfectly aligned with the buried wall underneath causing the upper wall to be unsupported and lean out of plane. Neither wall orientation nor location were found to influence structural cracking (Figure 35) or structural cracking at wall junction (Figure 36).

Figure 34 | Out of Plane Diagram

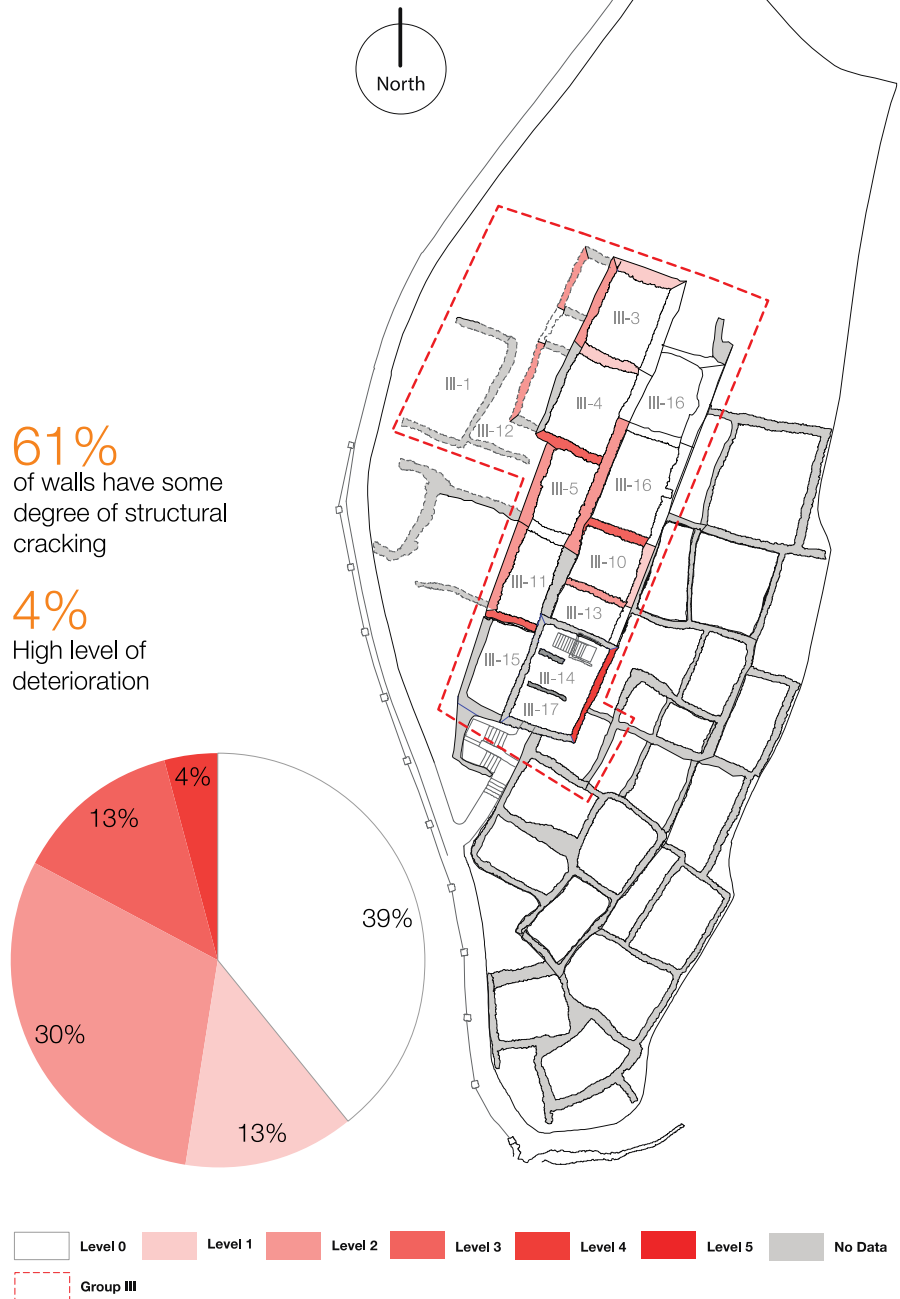
Figure 35 / Structural Cracks Diagram

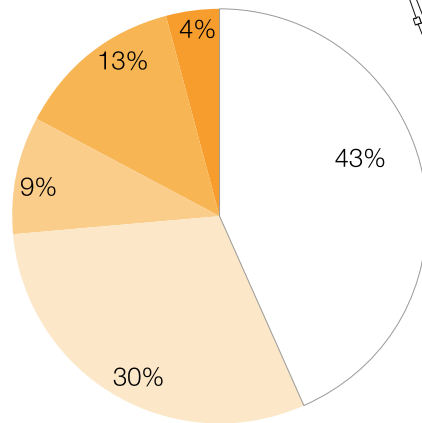
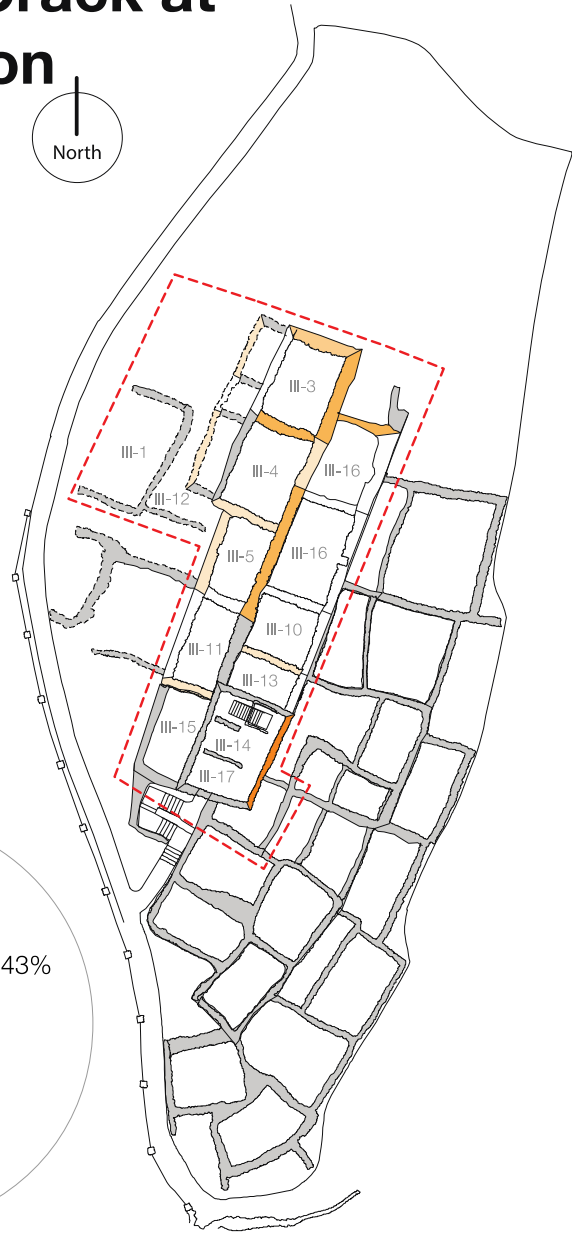
57%
of walls have some
degree of structural
cracks at wall junction

4%
High level of
deterioration

Figure 36 / Structural Cracks at Wall Junction

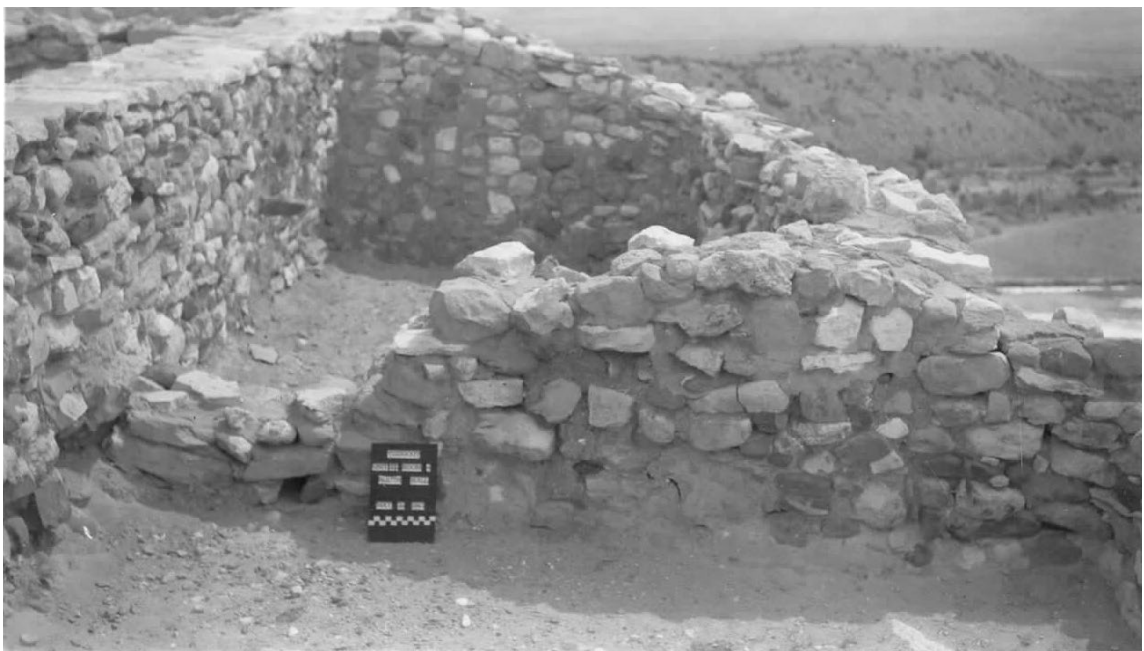
Figure 38 / Photo taken from north looking at Room III-5. Note the flat profile wall caps on the left wall (wall segment 4C). Source: 1942 Jack Cotter's photograph collection from the digital archives of Tuzigoot National Monument.

After excavation this wall segment was part of a historic visitor trail that was built using a flat flagstone limestone cap on top of the center wall of the pueblo (Figure 38)¹³⁹ It was submitted to pedestrian traffic loads for 28 years, causing noted damage to the masonry, until 1962 when Shiner replaced the wall caps.¹⁴⁰ In 1944-45 an abnormal rainfall event that caused some damage to the ruins was reported in the area, but due to WWII the wall did not receive any maintenance or stabilization until 1947 when minor repointing was completed.¹⁴¹ During that period of abandonment the walls were exposed and vulnerable to deterioration where material loss had occurred.¹⁴² The combination of both, previous weakening caused by live loading from visitor traffic, and the vulnerability of the wall to the weather, could have caused irreparable damage that was only redressed by the 1947 repointing campaign.¹⁴³

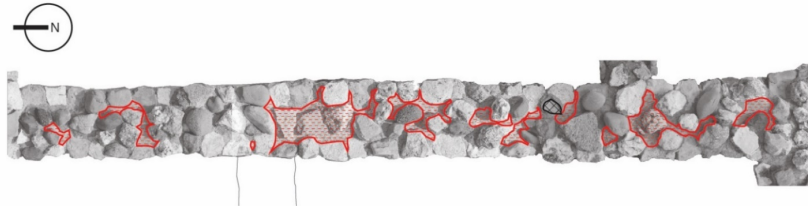
EAST ELEVATION OF WALL 4C

In general, the west elevation is in a more advanced state of deterioration than the east elevation of wall segment 4C. The west side exhibits two instances of extreme bulging. Basal erosion is present in the majority of the wall and structural cracking surrounds the areas with bulging. The east elevation only displays some structural cracking, but animal burrowing and vegetation conditions are recurrent conditions in this side. Although no cracks are visible on the caps, the wall was given a high score due to the pronounced level of erosion and some masonry loss, revealing a core clay material, possibly dating from historic 1930's excavation repairs.

Figure 43/ Comprehensive Condition Assessment of wall 4C completed on top of Ortho-rectified Photography. The west elevation displays an advanced level of bulging, basal erosion, and structural cracking. Some stone loss, where basal erosion has occurred. Refer to Figure 17 (next page) for details (D-1 & D2) and notes (1,2,3,4). For larger drawings refer to Appendix X.

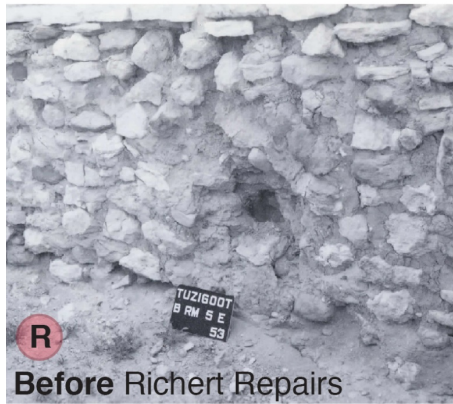
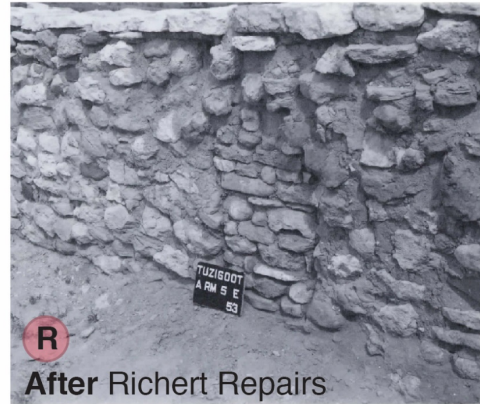
Wall was grouted with cement and finished with soil cement tinted mortar.

Figure 44 / Detail and historic photos referred to Conditions Assessment annotations.

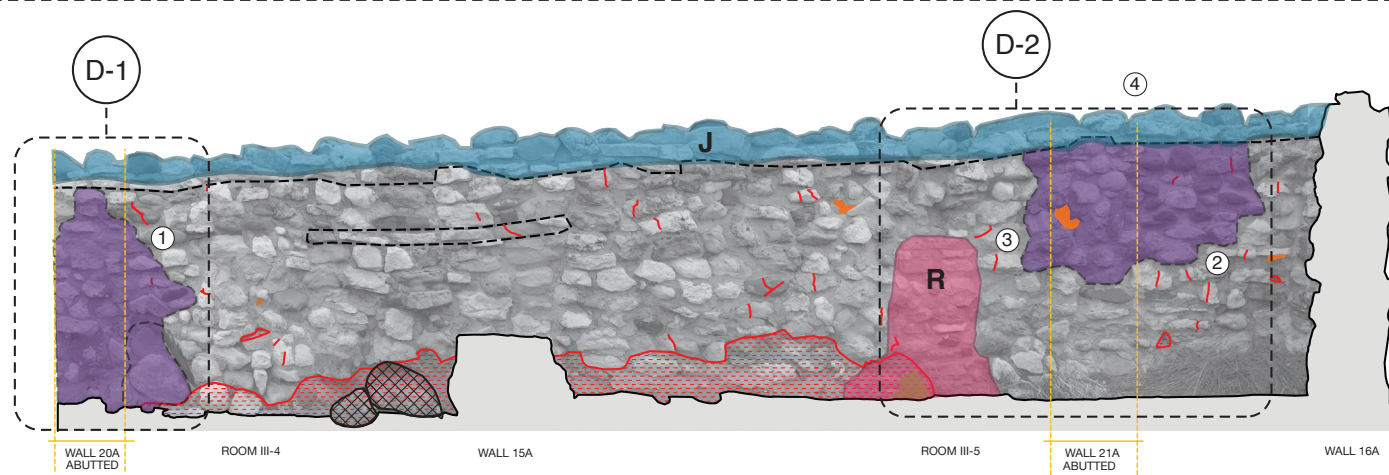
WEST ELEVATION OF WALL 4C

Both instances where bulging is evident are located on the west elevation of the wall where perpendicular walls abut on the opposite side. Structural cracks occur in areas where the wall is bulging or in areas surrounding it, but never in the space where a wall is abutted. According to excavation records, the abutted walls are not interlocked to this wall. The cracking in the masonry shows there is or has been movement in the masonry, disrupting the original load path and causing structural cracking. A more comprehensive assessment of the walls abutted to this wall segment, would aid in determining the pathologies of these walls and why are they pushing and causing damage to wall 4C.

1. **Structural cracks** surrounding the northmost bulging on west wall support the fact that loads, probably from wall abutted behind is causing displacement.
2. Appearance of **structural cracks** surrounding the bulge, only in adjacent areas to abutted wall.
3. **Structural cracks** are visible between bulge, abutted wall and Richard's cement grouting repair.
4. Mortar on **caps** has eroded to the point where a more clay-ish, silt-like material is visible. Caps might be susceptible to water intrusion.
