Dellingr: Reliability lessons learned from on-orbit

Larry Kepko, Luis Santos, Chuck Clagett, Behnam Azimi, Dean Chai, Alan Cudmore, Scott Starin, James Marshall,
John Lucas
NASA Goddard Space Flight Center
Space Weather Laboratory, Greenbelt, MD, 20771; 301-286-2728
Larry.kepko@nasa.gov

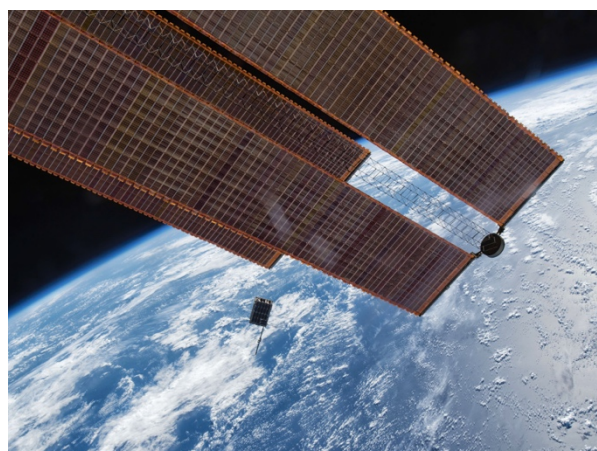
Even with the low resolution live feed it was quickly apparent that Dellinger had experienced the first anomaly of on-orbit operations, just seconds into the mission: The magnetometer boom and UHF antenna deployed immediately upon ejection, despite a 30-minute built-in delay timer. Figure 1 shows a high-resolution image of Dellinger deployment. The magnetometer boom is seen clearly pointed to the lower part of the picture, as are the UHF antenna.

Figure 1. Photographs of Dellinger’s deployment confirmed that both the magnetometer boom and the antenna deployed immediately upon ejection from the NanoRacks deployer.

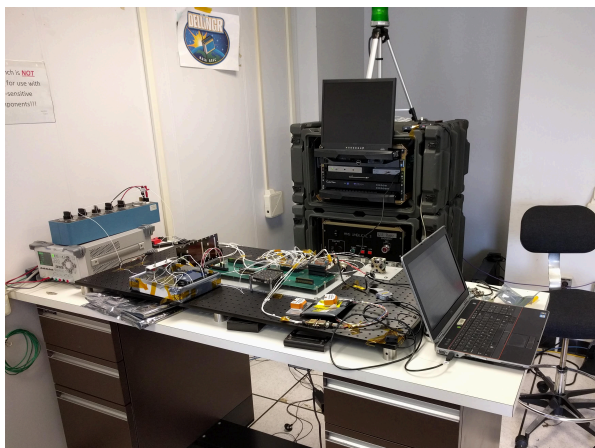
Figure 7. Dellinger flatsat

We have attempted to recreate the issue on the ground through use of a flatsat (Figure 7). The flatsat has been assembled from engineering units and spare parts. It is based around a custom backplane for PC-104 connectors which allows components to be added and removed with ease. One thing we are lacking is a spare Cadet radio. Instead, we are using a Cadet simulator program developed by NASA's Independent Verification and Validation (IV&V) Facility. This allows us to complete the loop between the flight software and ground control software to view the telemetry in real-time. Despite

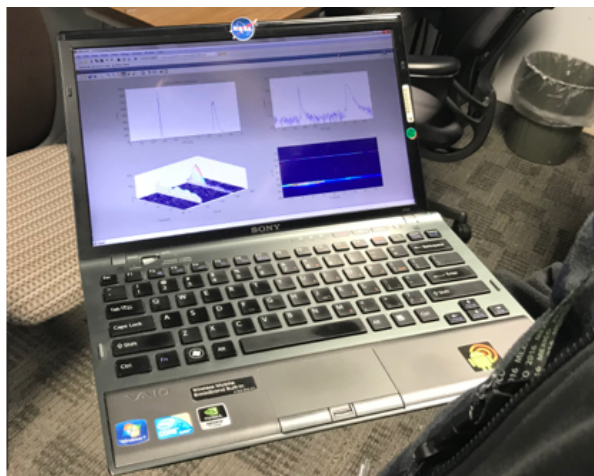
By turning off the wheels, we had removed the resets completely. But without wheel control the spacecraft could no longer maintain a sun pointing orientation. Still, we were finally able to turn on the INMS, and a few days later, on February 9th, we had spectra (Figure 10). Validating the INMS instrument was a key goal of the mission, and the team rightly celebrated the recovery.

Figure 10. The first ion spectra from Dellinger.

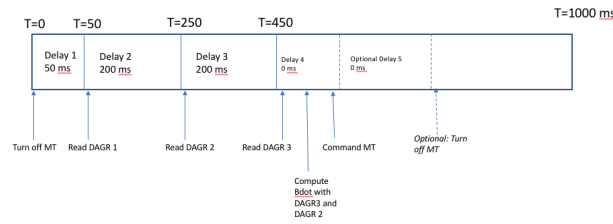
following the timing diagram in Figure 12.

Dellinger was successfully despun over the weekend of May 19-20, 2018.

Figure 12. Timing diagram of the final B-dot algorithm.
