Steel Bridge Research, Inspection, Training, and Engineering (S-BRITE) Center

October 2015

# Member-Level Redundancy of Built-Up Steel Girders Subjected to Flexure

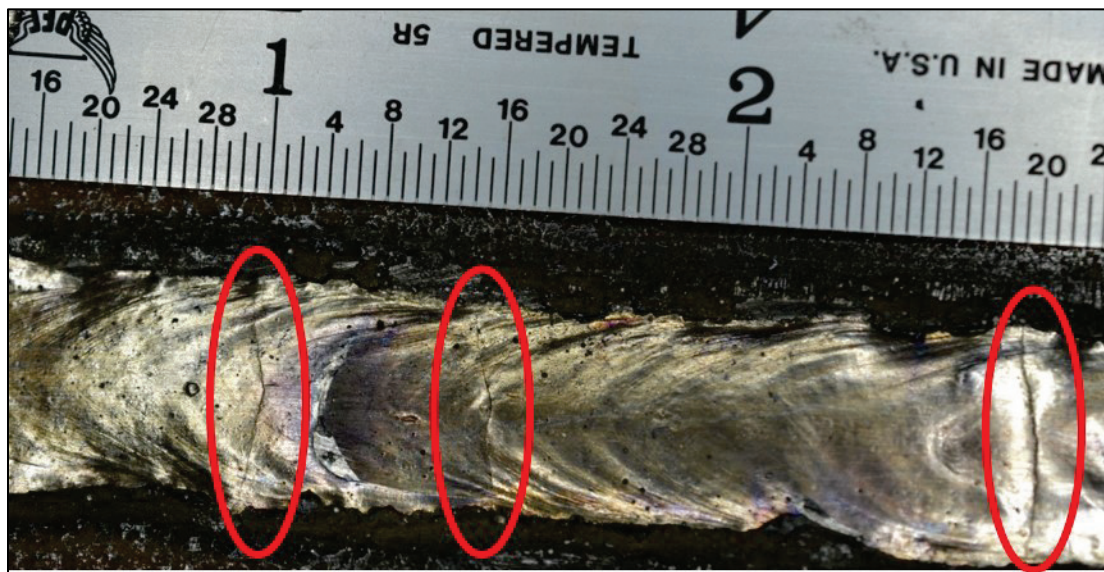
Hardfacing welding rod, used to build up wearing faces typically found in heavy machinery, was investigated due to its brittle behavior. Lincoln Electric's Wearshield ME is a heavily alloyed hardfacing rod specifically designed for heavy abrasion. The weld material has a Rockwell C hardness of up to 59 when deposited in multiple layers (The Lincoln Electric Company, 2012). The weld metal is designed to cross crack (transverse to the direction of the weld axis) in order to relieve stresses and minimize distortion (The Lincoln Electric Company, 2014) as shown in Figure 3-23. The Wearshield ME welding rod was investigated as a source for creating sharp crack tips in specimens due to the cross cracking.

**Figure 3-23 Transverse cracks in Wearshield ME weld metal**

Many small scale specimens were created to investigate different methods of welding with the hardfacing welding rod to create cracks. It was found that the cracks would pop into the weld as the weld cooled. In some cases it was observed that the crack had some penetration into the base metal. The crack tips created from these welds were

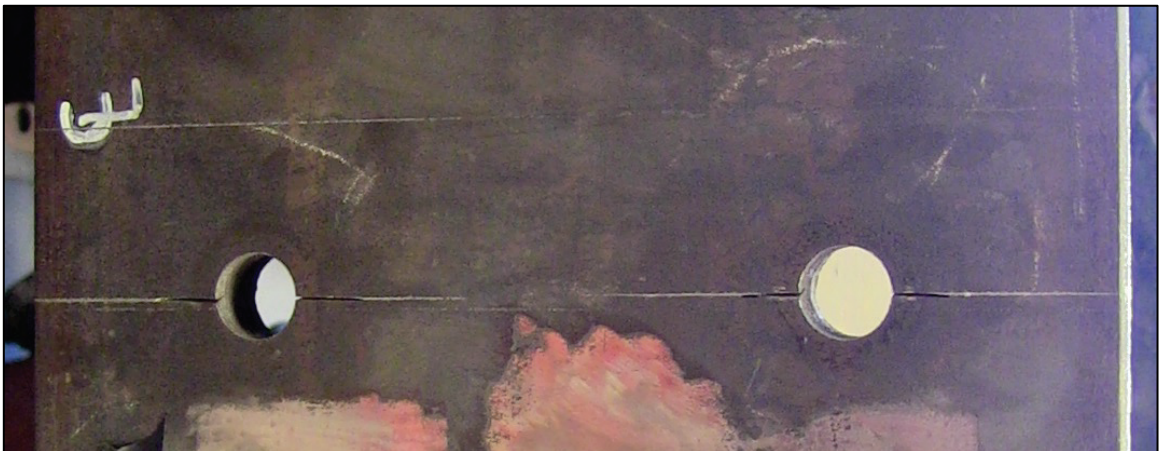
**Figure 3-30 Specimen 23-1 hole notches**

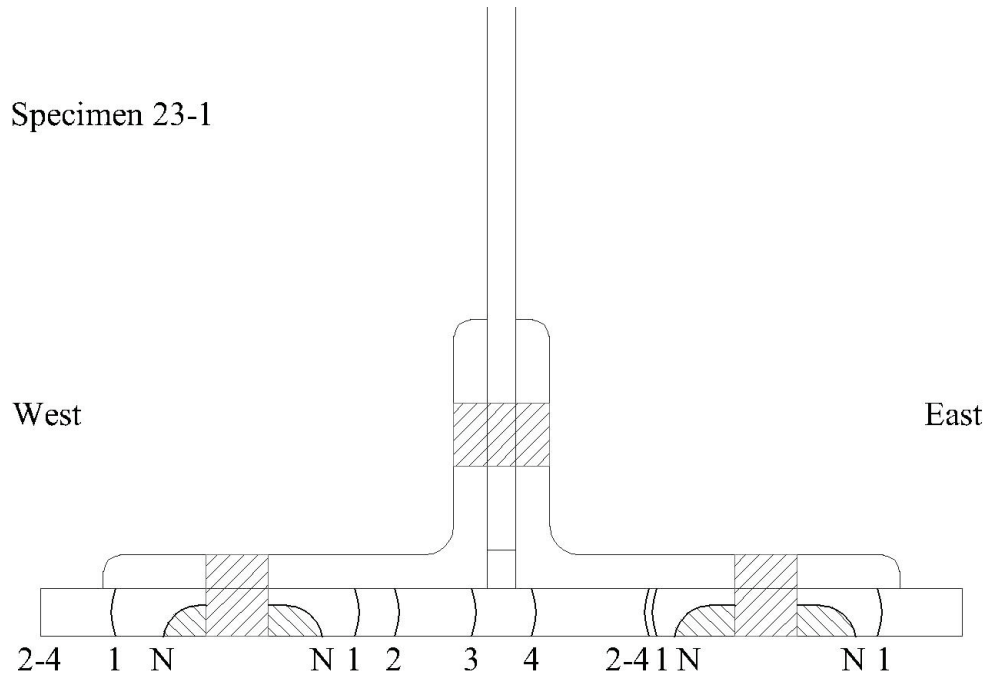
At 1.85 Million cycles the cracks in the notches were measured to be at 1.18", 1.12", 1.01", and 1.05" (from west-to-east) measured from the edge of the hole to the tip of the crack. Using an assumed fracture toughness (as material testing had not been performed at this stage) the cracks were near the critical crack length. Later, material testing showed that the critical crack length for the plates was approximately 0.8" in length based on linear elastic fracture mechanics and the stress intensity factor found per Newman (1971). An attempt was made to fracture the specimen using the protocol described in Section 3.3.3 at a bottom flange temperature of -66° F, however no fracture occurred. The specimen was allowed to warm back up to ambient temperature and then cycled further to extend the crack lengths. Three more attempts were made to fracture the bottom cover plate at increasing crack lengths. The temperature at the three additional fracture attempts was -79° F, -75° F, and -11° F (due to a depletion of the

liquid nitrogen). Figure 3-31 shows the notch lengths and crack lengths at each of the four fracture attempts. In the image, 'N' represents the original notch length, and each of the numbers (1-4) represent the crack length at each fracture attempt. During the fatigue cycling of the specimen, after the fourth fracture attempt, the cover plate failed. The total number of cycles applied to the specimen was 2.14 million cycles.

**Figure 3-31 Specimen 23-1 cover plate crack growth**

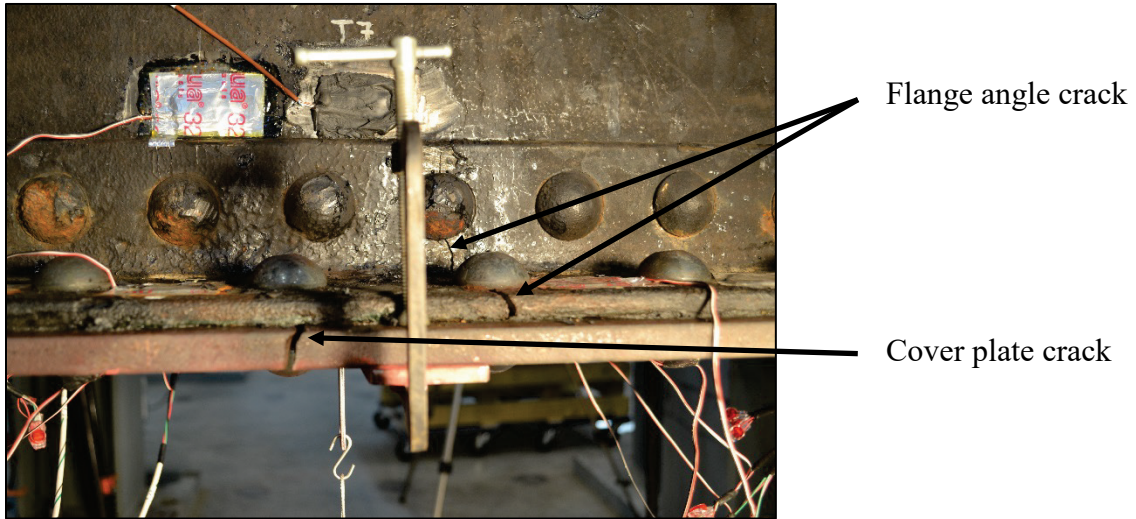
of the net section after the failure of the cover plate. The calculated net section stress range of the remaining net section was 25.6 ksi. After cycling for 355,000 cycles, the east flange angle failed (one hole north of the crack in the failed cover plate) and the test was stopped (see Figure 3-32). The fatigue data can be seen plotted with other test results in Section 3.5.2.

**Figure 3-32 Specimen 23-1 failed flange angle and cover plate**

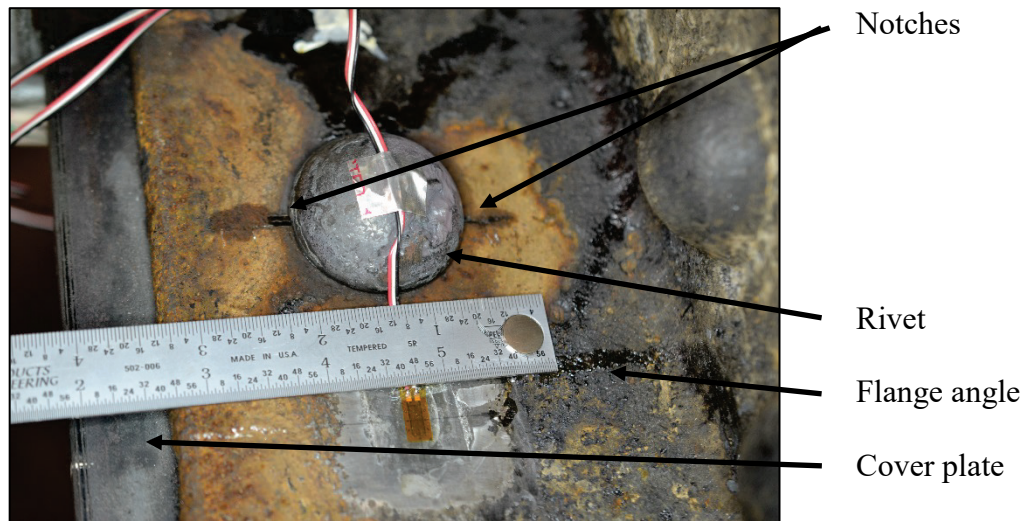
The east flange angle of Specimen 23-2 was notched at a rivet hole (see Figure 3-33) to investigate the behavior of a beam when the cross section was asymmetrical resulting from a component failure. A 12"×½" A36 steel cover plate was attached to the bottom flange of the specimen with hot driven rivets. The cover plate was covered with a thin layer of packing grease prior to the installation in order to minimize the friction contribution to stress transfer between the components. The material properties of each component are reported in APPENDIX D. The notches were cut prior to the addition of

the cover plate and were cut from the bottom and the top of the angle giving each notch a quarter circle shape at each face of the angle leg.

**Figure 3-33 Specimen 23-2 hole notches**

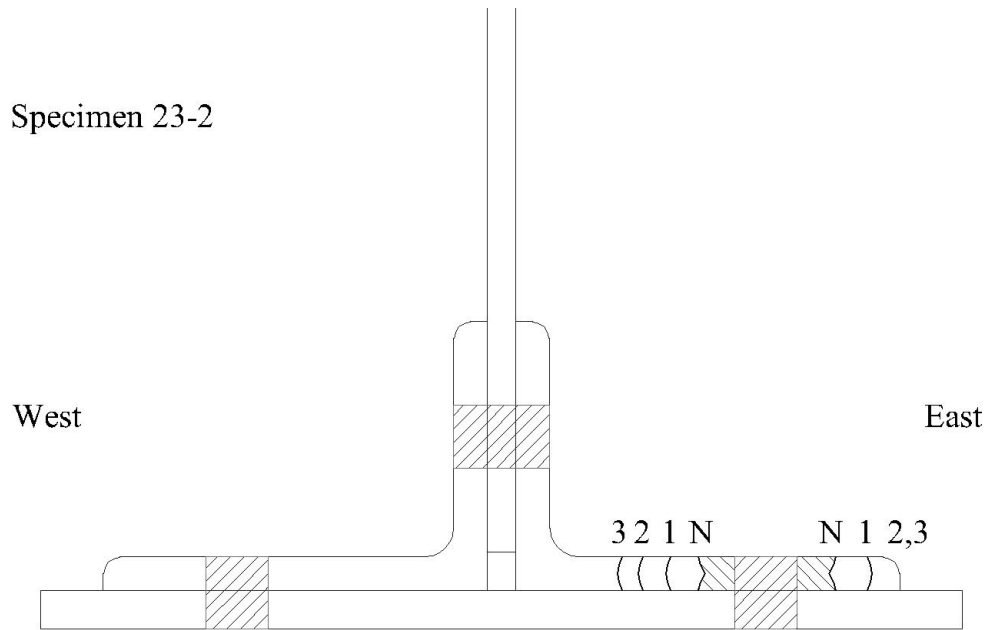
The calculated critical crack length for Specimen 23-2 was 0.25", less than the original notch lengths. However, in order to create a sharp crack tip at each notch the cracks were grown in fatigue. After 319,000 cycles, cracks had grown from the notches on both sides of the rivet hole in the east flange angle. The specimen was cooled in the temperature chamber to  $-74^{\circ}$  F and an attempt was made to fracture the flange angle. Since the specimen did not fracture, it was allowed to warm and cycled in fatigue to increase the length of the crack. The specimen was tested for fracture two additional times at temperatures of  $-66^{\circ}$  F and  $-64^{\circ}$  F (see Figure 3-34 for crack lengths at different attempts) with no fracture occurring in the flange angle.

**Figure 3-34 Specimen 23-2 crack growth in east flange angle**
