# Recent structural interventions to the eighteenth-century Greatham Bridge, UK.

## **ABSTRACT**

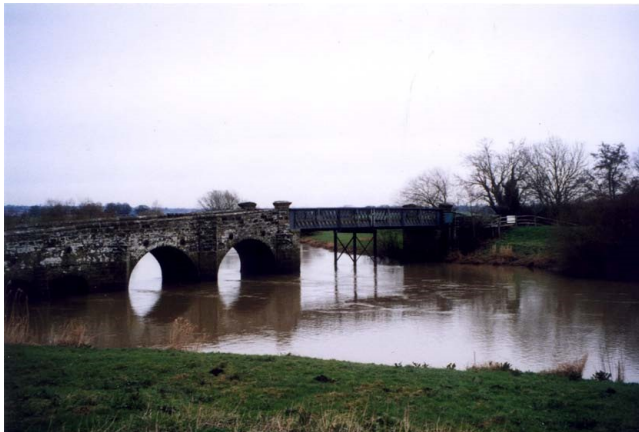
Fig 1 View of Greatham Bridge from South West prior to works being carried out.

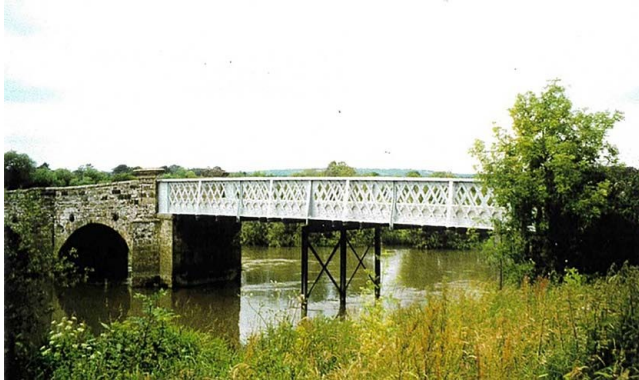
Fig 11 Greatham Bridge in 2003 after strengthening works completed

The bridge was strengthened and upgraded sympathetically enough to be awarded a commendation at the ICE Historic Bridge and Infrastructure Awards (HBIA) in 2003. Judges commented that it was “a very good repair, carried out extremely well” (NCE, 2003).

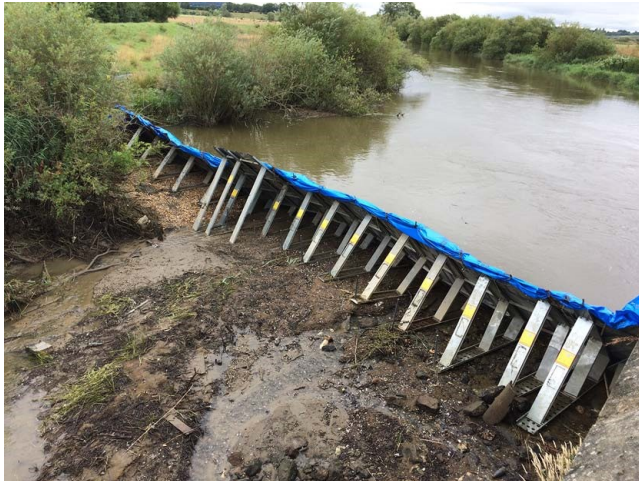
Fig 15 Temporary dam used in the early stages of the refurbishment

The original budget for the works was £300,000 but the final cost was only £200,742.17. The main reason for this big difference was the eventual non-use of a temporary dam (see figure

15). Where work at, or below, the water line was necessary, the work was planned to be completed while the river was held back by the hire of a temporary dam (at a cost of £90,000). It was originally planned to use the temporary dam system (to provide a dry work zone) to restrict flow through one or two arches at a time in order to minimise water flow restriction under the bridge i.e. staged work. In reality, the dam failed after 3 weeks and was then abandoned as the contractor (rightly) refused to allow operatives to work behind it after its failure. This meant that the work was carried out only during low-water conditions. The River Arun is still tidal at Greatham Bridge (in fact it is tidal for a length of 41km upstream from the sea at Littlehampton). Figure 16 shows the scaffolding arrangements required to give access to the faces of the arches.

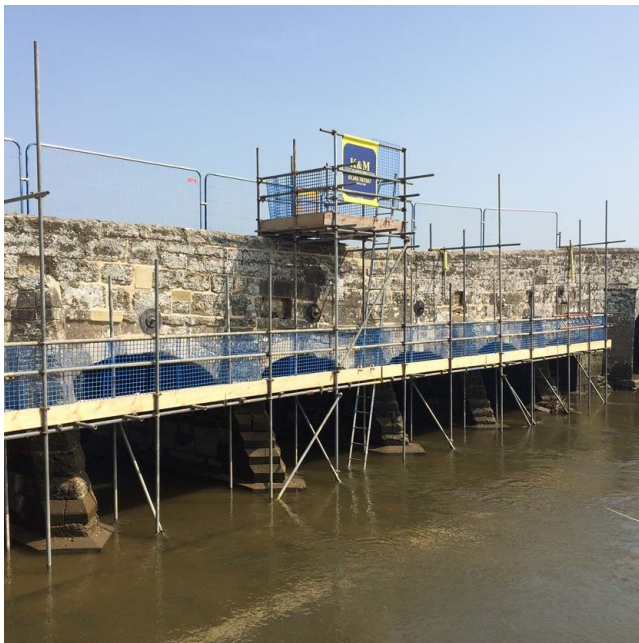
Fig 16 Refurbishment temporary works for access to arch faces
