Increased Span Length for the MGS Long-Span Guardrail System Part III: Failure Analysis

INCREASED SPAN LENGTH FOR THE MGS LONG-SPAN GUARDRAIL SYSTEM PART III: FAILURE ANALYSIS

1. Report No. TRP-03-362-17	2.	3. Recipient's Accession No.	
4. Title and Subtitle Increased Span Length for the MGS Long-Span Guardrail System Part III: Failure Analysis		5. Report Date September 29, 2017

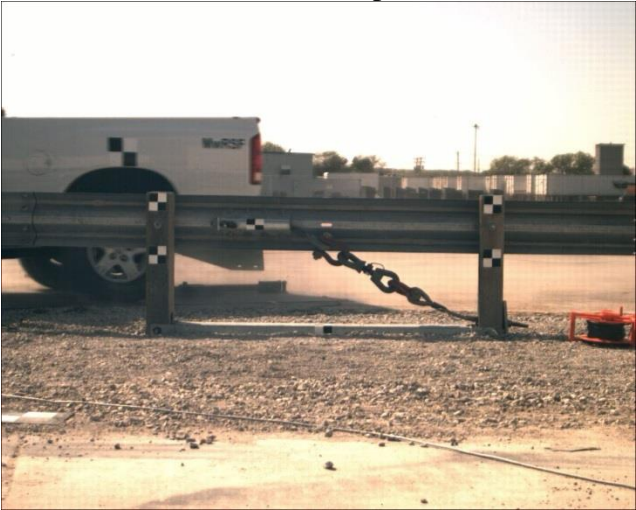
Figure 10. End Anchorage Sequential View Comparison of MGS Tests

Analysis of the anchor failure began with a comparison the load and deflection of the downstream end anchorage in test no. MGSLS-2 with other available data from tests of similar end anchorages. Figures 11 through 18 show a sequential comparison between the loading and deflection of the downstream end anchorage in test no. MGSLS-2 and other similar anchorages under full-scale testing impacts with 2270P vehicles, including the upstream end anchorages from test nos. MGSLS-2, MGSMP-1, and MGSMIN-1 and the downstream end anchorage from MGSLS-1. Review of the sequential images found that all of the anchorages displayed similar deflection behavior in terms of deflection downstream due to the tensile loading of the W-beam rail. The vertical splitting of post no. 24 in test no. MGSLS-2 was not a singular event as test nos. MGSLS-2 and MGSMP-1 demonstrated similar behavior on the upstream anchors, but did not fail. Motion of the cable end plate was also reviewed for all of the tests and no abnormal deflection or rotation of the cable end plate was noted in test no. MGSLS-2 prior to the anchorage failure as compared to the other tests.

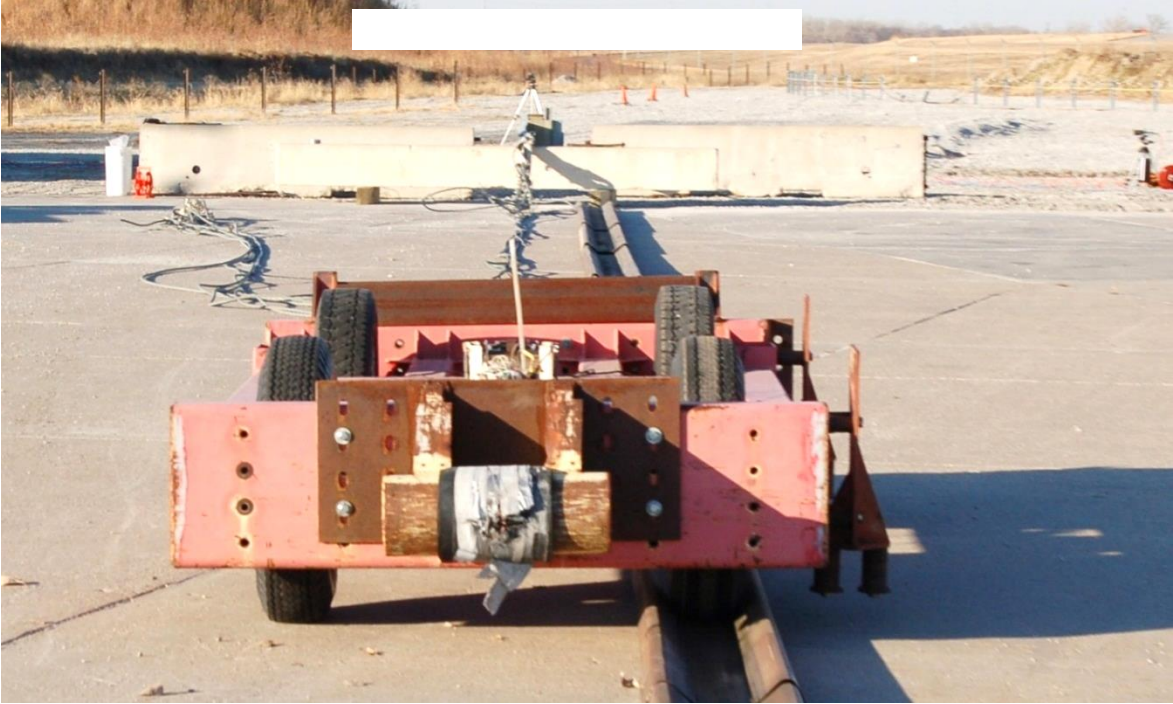
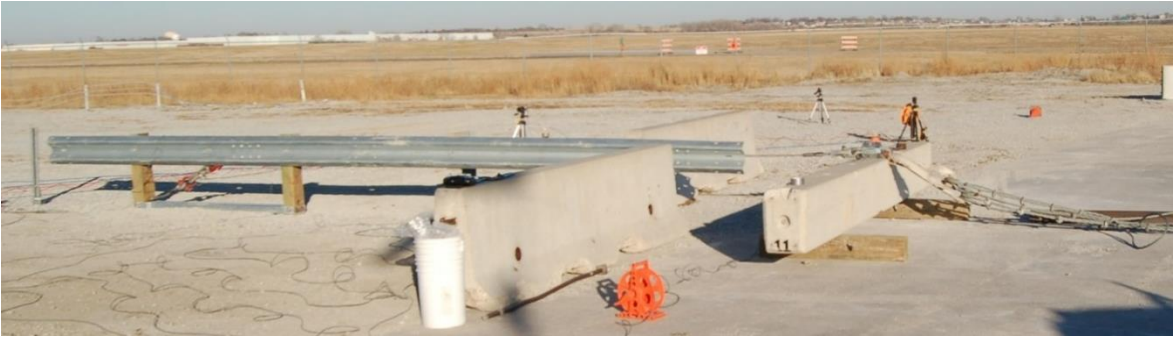
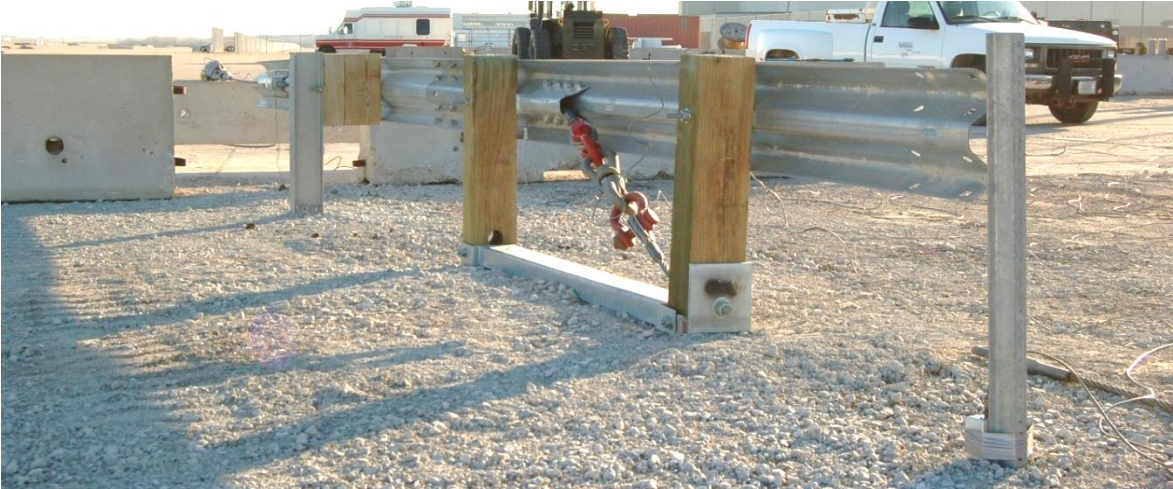
Figure 21. Anchor Load Vs. Deflection, Test No. MGSL-2

Comparison of the downstream end anchorage load versus deflection data from test nos. MGSL-1, MGSMIN-1, and MGSL-2 showed similar trends. The stiffness or slope of the load versus deflection curves were similar for each of the three tests with available data. Additionally, test no. MGSL-1 developed a peak load in the downstream end anchor of 30.9 kips (137.5 kN) without failure, which was 12.3% higher than the measured peak load in the downstream end anchorage that failed in test no. MGSL-2.

Analysis and comparison of the end anchorage load and deflection from test no. MGSL-2 and other comparable tests did not identify a potential source of the end anchorage failure observed in test no. MGSL-2. The peak load recorded in the failed anchorage did not appear to be excessive when compared with similar full-scale crash tests and did not exceed previous dynamic load testing of similar anchorages. The deflection and stiffness of the failed end anchorage did not suggest any significant departure from previous anchor testing. Finally, no behaviors were noted during loading of the end anchorage that were different from those observed in other end anchorages.

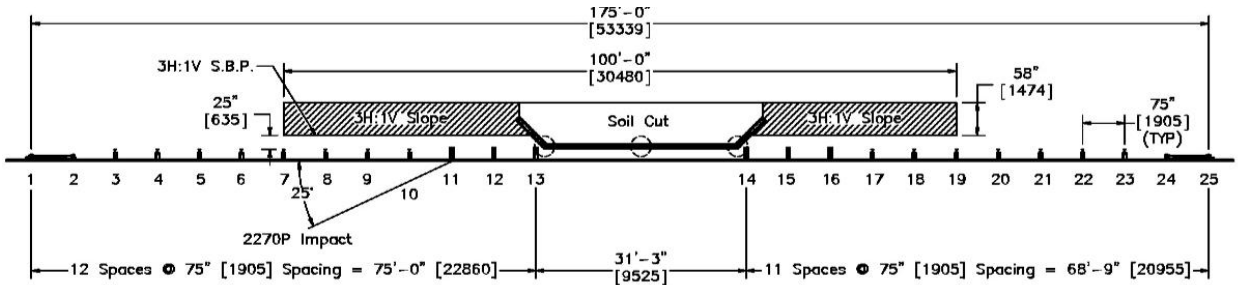
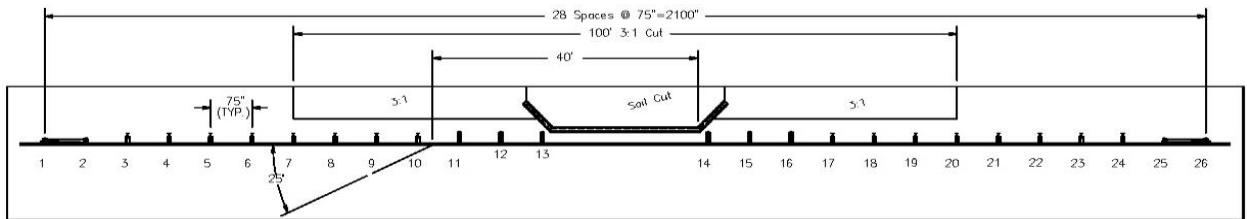
Figure 27. Impact Point for Test Nos. MGSL-2, LSC-1, MGSL-1, and LSC-2

Review of the data found that the impact point for test no. MGSLS-2 fell into the mid-range with respect to distance to the first post downstream of impact, which suggested that the impact point with respect to the first impacted post likely had little effect on loading of the end anchorage. However, rail pocketing caused by the impact location relative to a post may have increased anchor loads, as noted previously. Similarly, the distance from the impact point to the first splice downstream for test no. MGSLS-2 fell into the mid-range of the comparable systems. It was noted that in test no. MGSLS-2 the impact was closer to the downstream end anchorage than in previous long span guardrail tests and was closer to the end of the guardrail system than all comparable tests except test nos. WIDA-1 and MGSMIN-1. Test no. LSC-1 was impacted farther from the first post downstream of the unsupported span than test no. MGSLS-2, but no concerns with anchor failure were associated with the former test. Test no. WIDA-1 evaluated an impact near the end of the redirective length of the MGS with a trailing end terminal. In this test, the end anchor failed, but it did not release until the 2270P vehicle had nearly reached the end of the barrier system, and high lateral and longitudinal loads were imparted on the trailing end anchorage. Thus, the failure mode was not similar to the failure under longitudinal loading observed in test no. MGSLS-2. Test no. MGSMIN-1 evaluated a 75-ft (22.9-m) long MGS and impacted 56 ft-3 in. (17.1 m) from the end anchorage. However, the 2270P vehicle was safely redirected and no failure of the end anchorage occurred as a result of the impact closer to the downstream end anchorage. Thus, while the impact point for test no. MGSLS-2 was different as compared to previous tests of the MGS and MGS long span, no evidence was found that suggested the impact point directly contributed to the anchor failure.

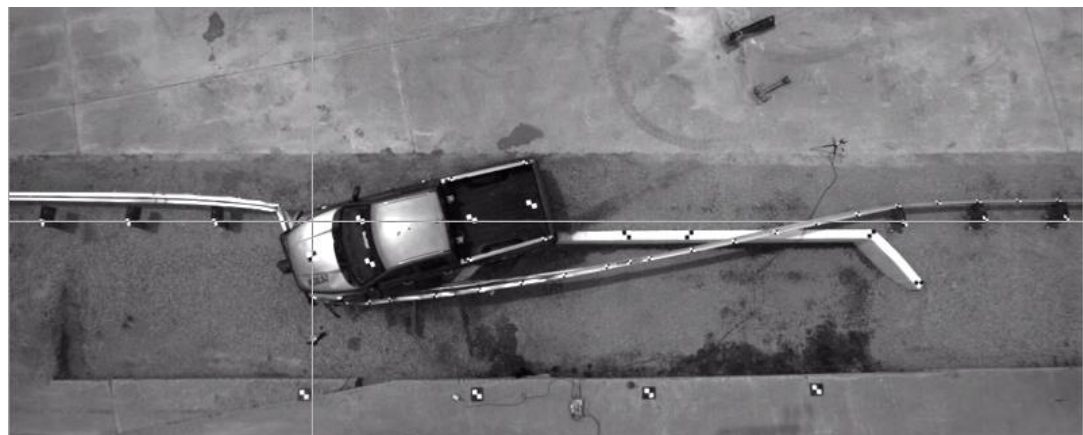
Figure 32. Longitudinal Distance of Fractured Post Relative to 2270P Bumper Corner, Test no. MGSLs-2

The comparison of post fracture and disengagement in test nos. MGSLS-2 vs LSC-1 is shown in Table 2. Review of the data found that the UBSPs in test no. MGSLS-2 broke away when the truck was significantly closer to the post as compared to test no. LSC-1. Comparison of post breakaway was most relevant for the first breakaway post downstream of the unsupported span in each test, as anchor failure occurred in test no. MGSLS-2 prior to breakaway of the second and third posts downstream of the unsupported span. The first breakaway post downstream of the unsupported span in test no. MGSLS-2 disengaged when the truck was 18.7 in. (475 mm) closer as compared to the disengagement of the same post in test no. LSC-1. This may indicate that the UBSP provided additional support to the guardrail prior to fracture and may have led to increased barrier stiffness and rail pocketing. Another factor in the delayed disengagement of the UBSP post

may have been that some of the CRT posts in test no. LSC-1 fractured at the second weakening hole in the CRT post below grade, as well as splitting vertically. The UBSP only has a fracture mechanism at ground line and is made of steel. Thus, it cannot replicate a failure of the post below grade or the vertical splitting observed in test no. LSC-1.

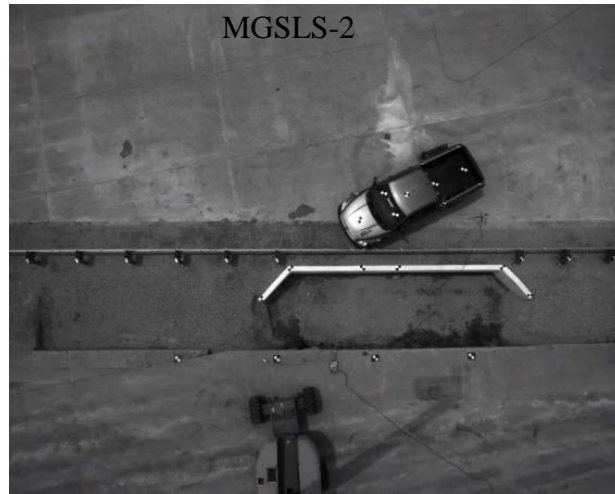
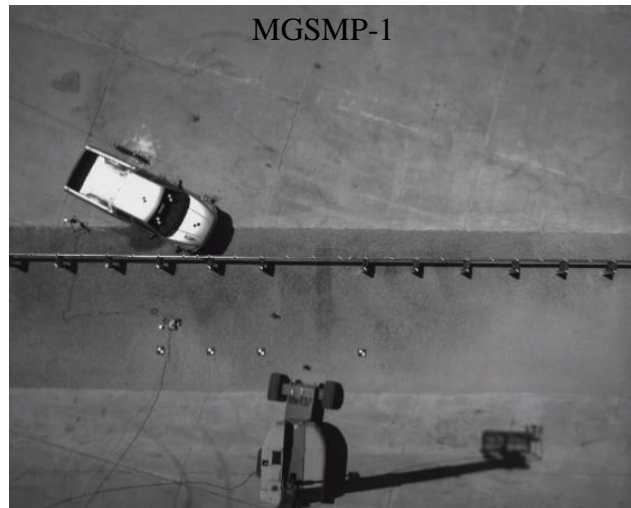
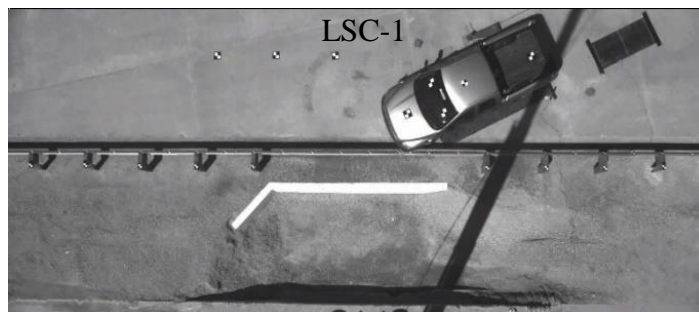
Figure 34. Overhead View at Time = 0.000 sec, Test Nos. MGSLs-2, MGSMP-1, and LSC-1

The maximum pocketing angle for test no. MGSLS-2, as well as comparable test nos. MGSLS-1 and MGSMP-1, were calculated from analysis of overhead video. Sequential images of the overhead video from 0.000 sec to 0.140 sec for test nos. MGSLS-2, LSC-1, and MGSMP-1 are shown in Figures 34 through 37, and the calculated pocketing angles are shown in Figure 38. Note that the calculated pocketing angles shown for test no. MGSLS-2 are only relevant up to the point of the downstream end anchor failure at approximately 140 msec after impact. Review of the data found that test no. MGSLS-2 initially had slightly higher pocketing angles than test nos. LSC-1 and MGSMP-1. By 0.040 sec after impact, test no. MGSMP-1 showed a sharp increase in pocketing angle due to the vehicle approaching the first standard line post downstream of the unsupported span created by the omission of a single post. Test no. MGSLS-2 showed a similar increase in pocketing angle as the vehicle approached the first UBSP downstream of the unsupported span. The pocketing angle for test no. MGSLS-2 continued to increase until anchor failure at approximately 0.140 sec after impact. Test no. MGSLS-2 displayed pocketing angles

that were generally greater than those of test no. LSC-1. This was consistent with the earlier disengagement of the CRT posts in test no. LSC-1 noted previously, and may potentially indicate that rail loading was affected by use of the UBSPs. However, anchor load data was not available from test no. LSC-1. The pocketing angles observed for all three tests were less than or very near

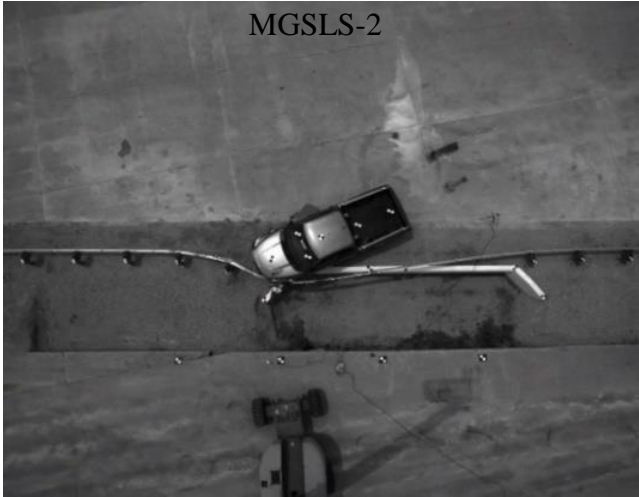
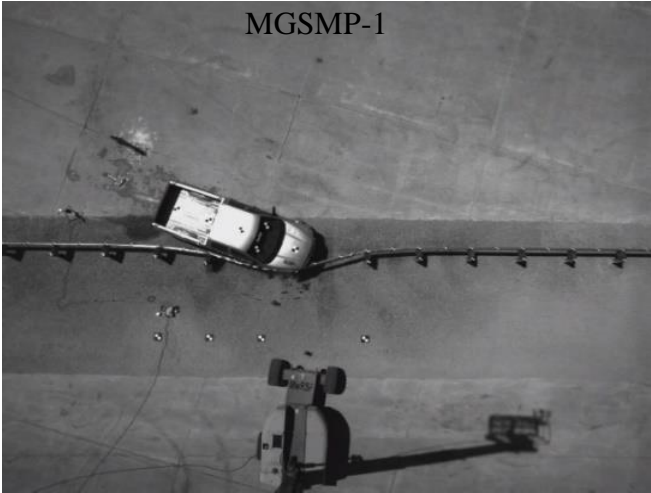
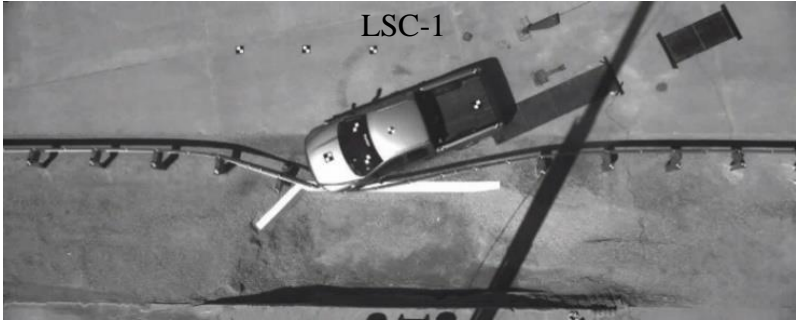
Figure 37. Overhead View at Time = 0.140 sec, Test Nos. MGSL-2, MGSMP-1, and LSC-1

the threshold of 23 degrees that has previously been deemed acceptable. Additionally, the maximum pocketing angles for test nos. MGSLS-2 and MGSMP-1 were very similar prior to anchor failure, but the end anchor in test no. MGSMP-1 did not fail. The pocketing analysis also noted that some kinking of the rail was observed at the first post downstream of the unsupported span in test no. MGSLS-2 which was not observed in test nos. MGSMP-1 and LSC-1. This may indicate that the UBSP provided additional stiffness prior to fracture and potentially affected rail loading as compared the other tested systems. However, the kinking observed was not sufficient to believe to be a direct cause of the failure of the end anchorage.

Thus, the analysis indicated that the rail pocketing observed in test no. MGSLS-2 was more than observed in previous testing of the MGS long-span guardrail and may have affected rail loading, but the magnitude did not appear to be large enough to indicate a serious concern that would lead the researchers to suspect it as the cause of the downstream end anchorage failure. Additionally, while pocketing of the guardrail was similar to previous testing rail loading may have been affected based on the kinking of the rail prior to anchor failure.
