Fractographic Study to Characterise the Interaction Between Intralaminar and Interlaminar Fracture From Embedded Defects Under Compression Loading

Carla Canturri¹, Emile S. Greenhalgh^{†2}, Leif E Asp³, Silvestre T Pinho²,

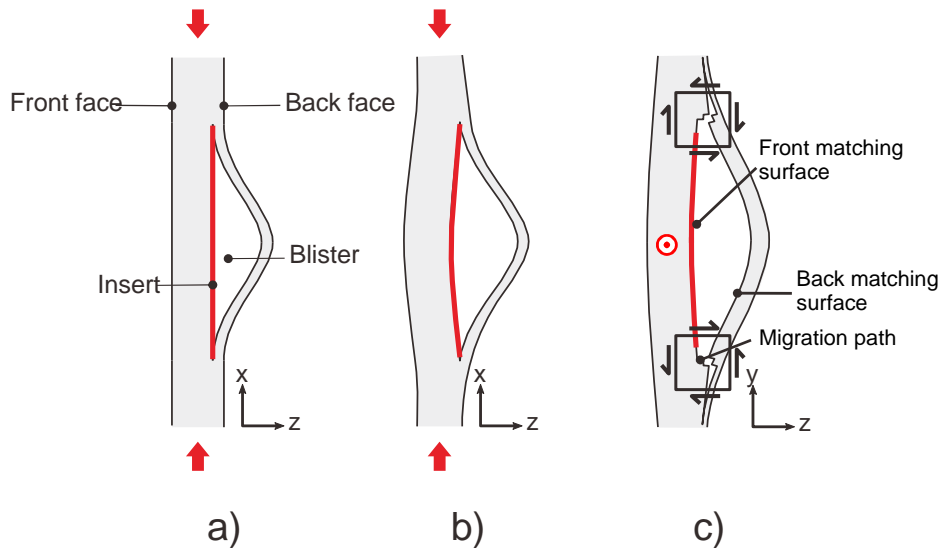
Figure 3 Damage growth mechanism of an embedded delamination with a) local buckling, b) global buckling and c) local-global buckling and delamination migration at the transverse boundary.

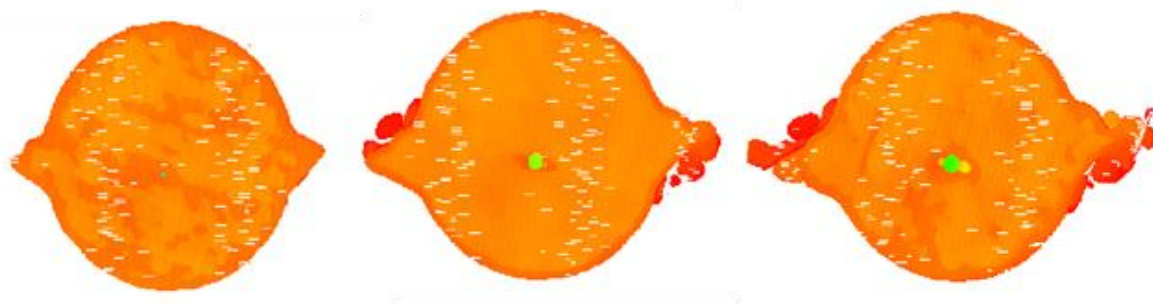
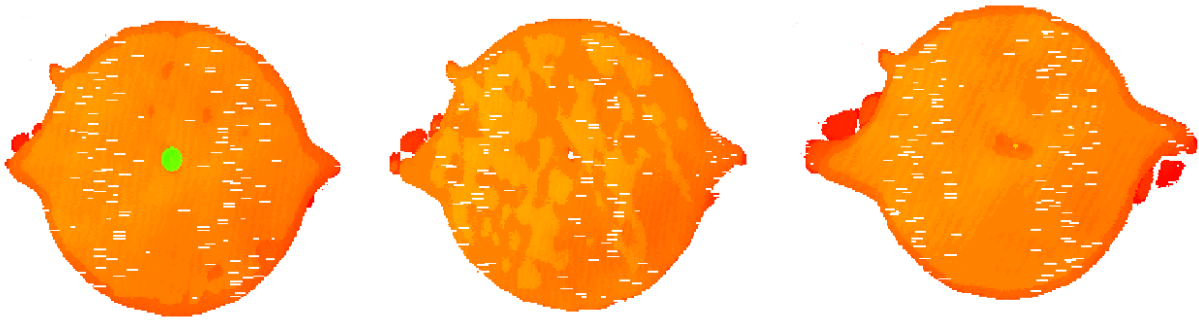
While there are discrepancies between the results for the repeated specimens in terms of buckling load and delamination growth onset, the growth mechanisms are thought to have a higher degree of reproducibility as shown on the C-scans of the repeated specimens H1 and H2 in Figure 4. Based on the fractographic observations, the failure sequence and growth directions for Specimens I, H2, E2, and C are summarized in Figure 10, Figure 14, Figure 17 and Figure 20, respectively. It can be summarised as follows: the region above the pre-inserted defect buckled and formed a blister. Due to the high-bending strains at the insert

Figure 4 Representative time of flight C-scans between interrupted tests of Specimen a) H1 and b) H2 (defect at the +65°/-25° ply interface).

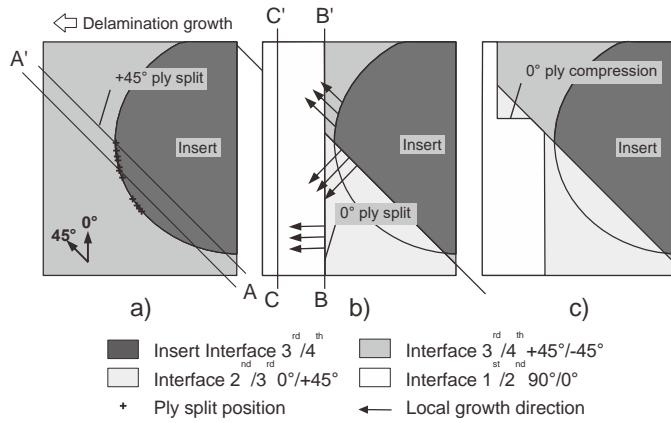
Figure 10 Failure sequence for Specimen I (Baseline) with a stacking sequence of $[90^\circ/0^\circ/+45^\circ/-45^\circ]_{4s}$ with the defect located at the $+45^\circ/-45^\circ$ ply interface.

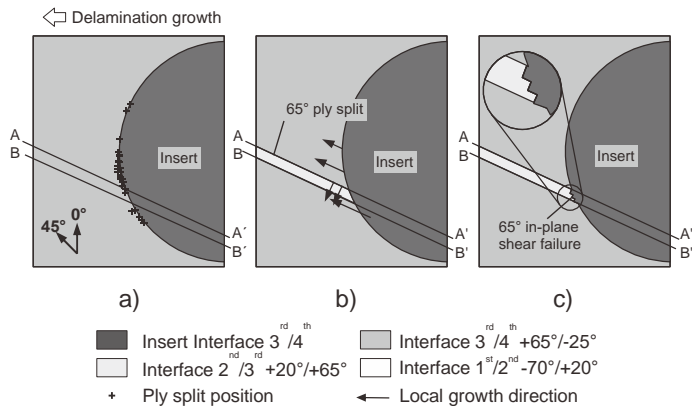
Figure 14 Failure sequence for Specimen H2 with a stacking sequence of $[-70^{\circ}/+20^{\circ}/+65^{\circ}/-25^{\circ}]_{4s}$ and the defect located at the $+65^{\circ}/-25^{\circ}$ ply interface.

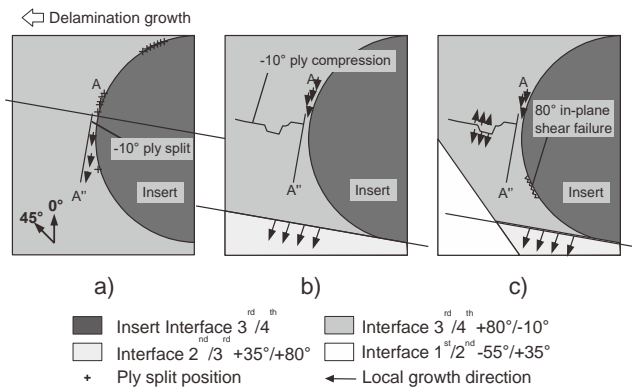
As shown in Figure 17, the growth sequence in Specimen E2 (defect located at the $+80^\circ/-10^\circ$ ply interface) differed from that of the Baseline (defect located at the $+45^\circ/-45^\circ$ ply interface) since there was no significant delamination migration in Specimen E2. Instead the delamination had grown at the original defect plane whilst some ply splitting of the fourth (-10°) ply had developed (Figure 17a and Figure 17b). Consequently, compression failure of the fourth ply (-10°) had extended away from the starter defect, initiating at these ply splits.

Figure 17 Failure sequence Specimen E2 with a stacking sequence of $[-55^\circ/+35^\circ/+80^\circ/-10^\circ]_{4s}$ and the defect located at the $+80^\circ/-10^\circ$ ply interface.

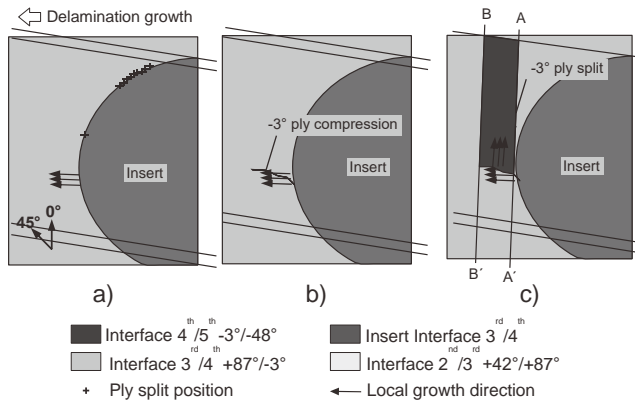
The sequence of events for Specimen C (defect at the +87°/-3° ply interface) is illustrated in Figure 20. . Although ply splits developed in the third ply (+87°), the delamination remained at the original ply interface (Figure 20a). This is similar to the observations of Specimen E2 (Figure 15c). Once the fourth (-3°) ply had been exposed by the delamination, the lack of through-thickness support on this loading ply had promoted micro-buckling, which had propagated away from the starter defect (Figure 20b). Consequently, from this compression failure, delamination had grown between the fourth and fifth plies (Figure 20c). Finally, ply splits had developed in the fourth (-3°) ply (Figure 20c).

Figure 20 Failure sequence Specimen C with a stacking sequence of $[-48^{\circ}/+42^{\circ}/+87^{\circ}/-3^{\circ}]_{4s}$ and the defect located at the $+87^{\circ}/-3^{\circ}$ ply interface.
