# Multi-Source Data Integration to Investigate a Deep-Seated Landslide Affecting a Bridge

Received: 13 June 2019; Accepted: 9 August 2019; Published: 12 August 2019

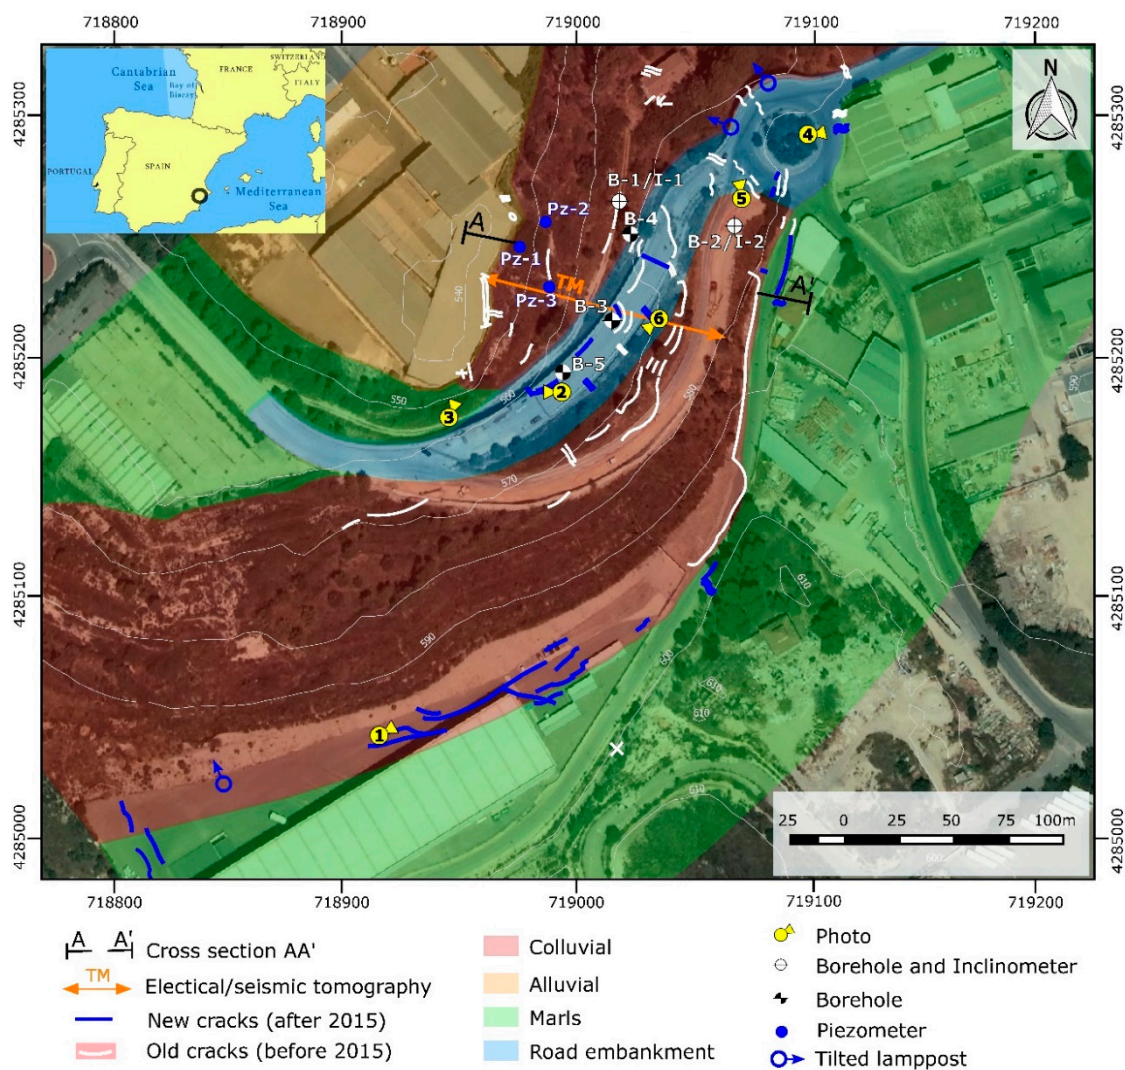
**Figure 1.** Location of the study site and geo-lithological sketch map and location of installed instruments.

The damage inventory that developed during the field campaigns and the location of the crack is shown in Figure 1. A remarkable long tension crack, over 100 m, was observed on the top of the slope, not just located above the bridge, but also spreading towards the southwest. This tension crack affects the outside pavement of the industrial building located south from the bridge on the top of the slope (Figures 3 and 6-1). It is also noteworthy the number of tension cracks on the soil surface some meters above the bridge and below the structure (Figure 6-2). However, fewer cracks were observed at the toe of the slope, although the retaining wall of one of the industrial buildings is clearly cracked and tilted (Figure 6-3). Tension cracks have also been clearly detected north of the bridge, in the concrete fence of some plots and by the roundabout pavement (Figure 6-4,5).

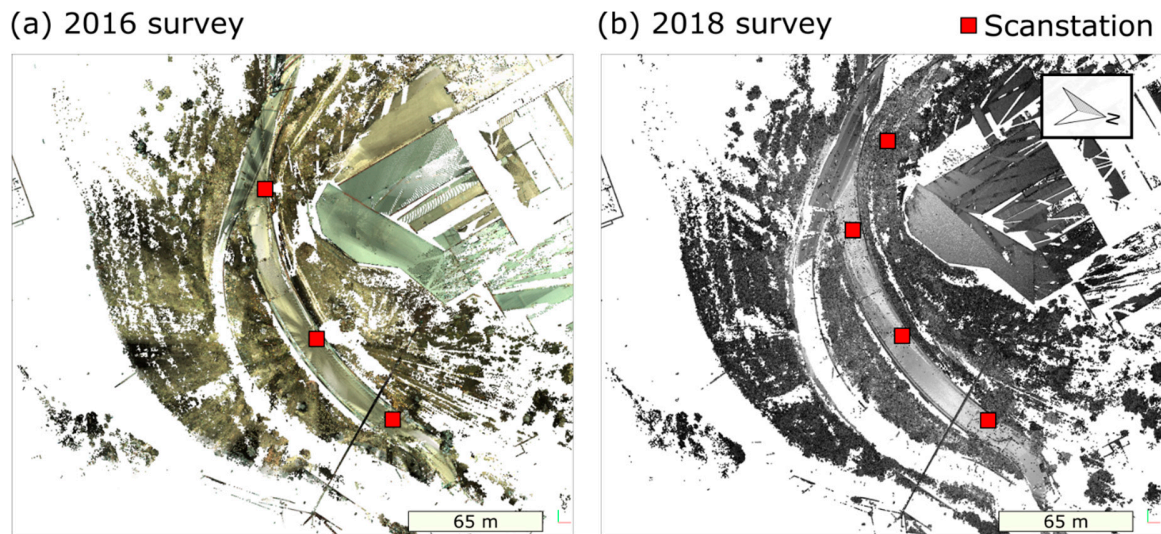
**Figure 2.** Top view of the two three-dimensional (3D) point clouds acquired on (a) 6th May 2016 and (b) 27th April 2018.

A Leica C10 terrestrial laser scanner was used for monitoring the bridge. This scanner has an angular accuracy of  $12''$  and a distance accuracy of 4 mm, being the noise 2 mm at 50 m [40]. Two scans were done for change detection, in 6th May 2016 and 27th April 2018 (Figure 2). In the first campaign, three scan stations were performed at the locations that are shown in Figure 2. In the second

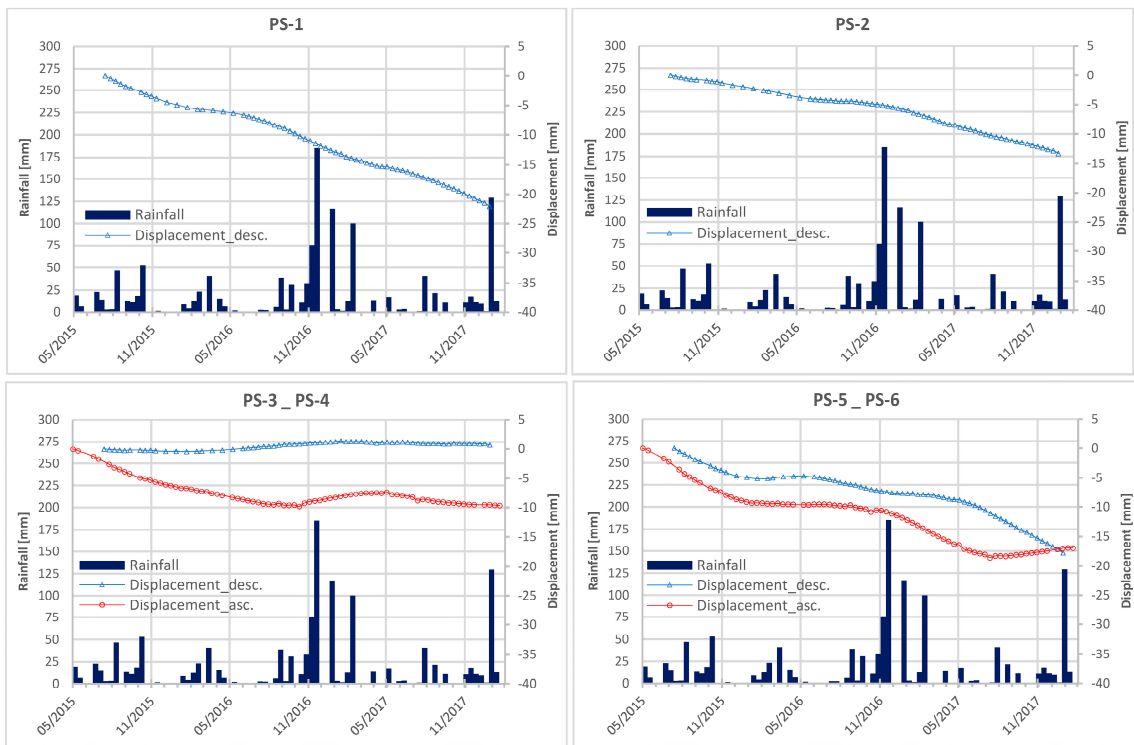
**Figure 8.** Time series of displacement of points located at the head (PS-1), bottom (PS-3 and PS-4), eastward (PS-2) and westward (PS-5 and PS-6) of the slope, see Figure 7. The displacements are measured along the LoS.
