Failure of cargo aileron's actuator

G. Zucca, M. Amura, L. Allegrucci, M. Bernabei

Italian Air Force, Flight Test Centre, Chemistry Department, Military Airport M. De Bernardi, via Pratica di Mare, Pomezia (RM), 00040, Italy

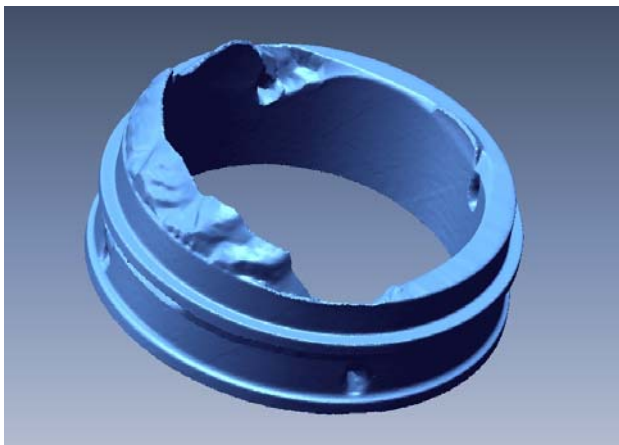
Figure 10: Actuator case, digital geometry.

Actuator case and cap geometry were acquired using a 3D scanner Fig. 10 e Fig. 11, the diameters were measured in 8 points as showed in Fig. 12 e Fig. 13.

The two parts have an average mechanical interference of 25 μm . This was the reason of the tight fit observed during disassembly operations between external case and cap.

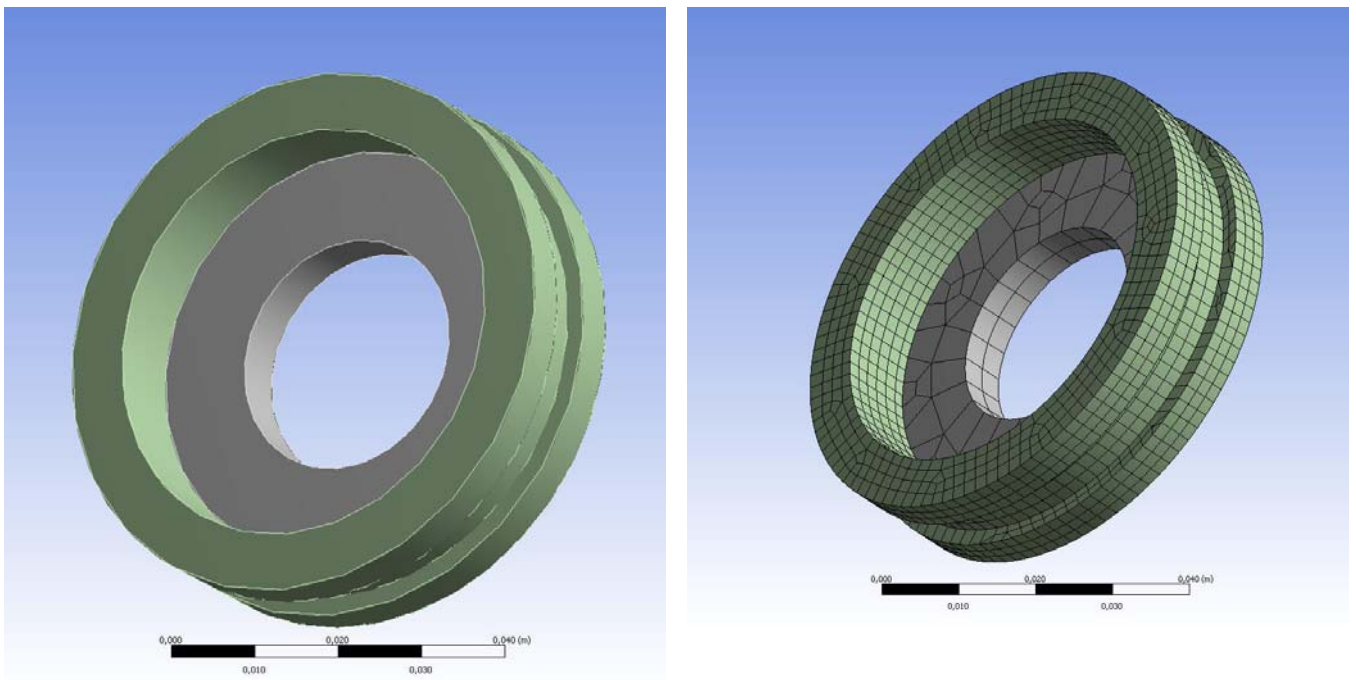
Figure 15: CAD Geometry (left), mathematical model (right).

A FEA model was performed in order to evaluate the effect of forced coupling between the actuator case and the cap. The Geometric 3D model of DBA was reproduced by the design drawings Fig. 15.

4768 hexahedrons [7] elements were applied to provide the mesh for mathematical model Fig. 15. Being impossible to reproduce exactly the geometry of the interference, it was assumed as a conservative hypothesis the perfect fit between the two parts: no gap and no interference.

The hydraulic system oil works oil within a range of 60°C - 90°C, while the pressurized cabin compartment where the DBA is placed is at about 20° C. This implies a thermal variation of $\Delta T = 40 - 70$ ° C that becomes a thermal load to the structure due to the different thermal expansion coefficient of the case assy and the cap. Indeed, the cap is made of copper alloy AMS 4631, while the case assy is AA7049. Therefore an average $\Delta T = 55$ ° C was applied.

Numerical results showed how just the perfect fit was enough to increase the stress value of about 60 MPa. In the real condition of forced coupling (about 25 μm interference) the stress increase would be higher. Stress map Fig. 16 shows how the maximum stress is reached on the outer edge of the case Assy. A parametrical simulation was carried out increasing the gap between the actuator case and the cap. Results showed that the stress became null at about 50 μm of gap (Fig. 17).
