## Ground Failure Investigation over Abandoned Coal Mines: A Case Study

# Ground Failure Investigation over Abandoned Coal Mines: A Case Study

**SYNOPSIS:** The slurry backfill operation for the Rock Springs subsidence control project is briefly described. The extent of ground failure and building damage is presented. The scope of the ensuing geotechnical investigation to indicate any possible cause and effect relationship between the pumped slurry backfill operation and observed damage is described. The general and specific findings regarding the damaged area are discussed. Conclusions from the investigation are presented.

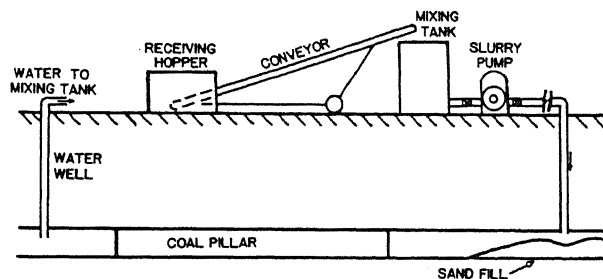
Fig. 1 Slurry Pumping System (Colaizzi et.al., 1985).

The method used to backfill the mine voids in the Rock Springs Subsidence Control Project was the pumped-slurry method of hydraulic backfilling (Colaizzi and Bithell, 1986; Colaizzi, et.al., 1981). In this process, a homogeneous mixture (slurry) of water and granular material is pumped from a remote plant site to the injection hole. The free falling slurry moves through a vertical steel casing to be deposited in subsurface voids (Fig. 1).

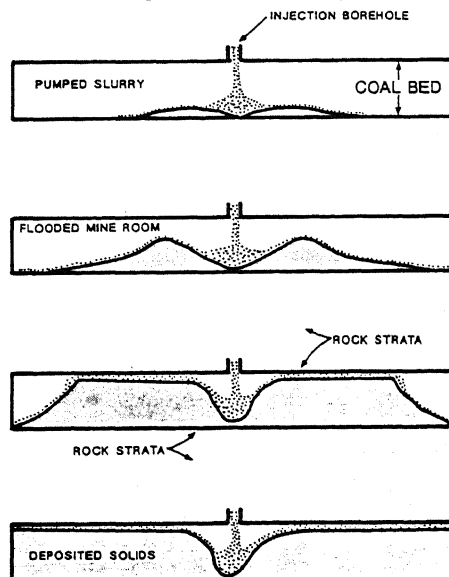
Fig. 2 Section View of Slurry Deposition (Colaizzi and Bithell, 1986).

The degree of void filling is a function of the velocity of the slurry flow at the mine level. As the slurry first enters the mine void from the injection borehole, its velocity is greatly reduced due to the increased cross sectional area of the transporting conduct (Fig. 2). This

rapid drop in velocity causes the solid particles to be deposited to form a doughnut-shaped mound on the mine floor. As the height of the mound approaches the mine roof, the velocity of the slurry increases through the narrowing channels, and the solid particles are transported to the outer limits of the mound. At the boundary of the mound, the velocity decreases abruptly and the solids are deposited on the advancing face of the pile. The process continues until the energy required to maintain the flow of the suspended particles becomes greater than the energy supplied by the available gravity head.
