# Effect of Foundation Deformations on The Damage of a Masonry Villa (Case History)

**SYNOPSIS** Cracks in the masonry walls of a one storey villa due to foundation deformations are investigated in this paper. In spite of the fact that the soil formation in the site was found to be almost uniform, hogging deformation profile took place in the strip foundation due to unequal loading. Analysis of the walls together with their supporting soil, as one integrated system, showed that very small foundation deformation can produce tensile stresses in the wall higher than its tensile strength. Repair of the cracks was proposed and carried out successfully.

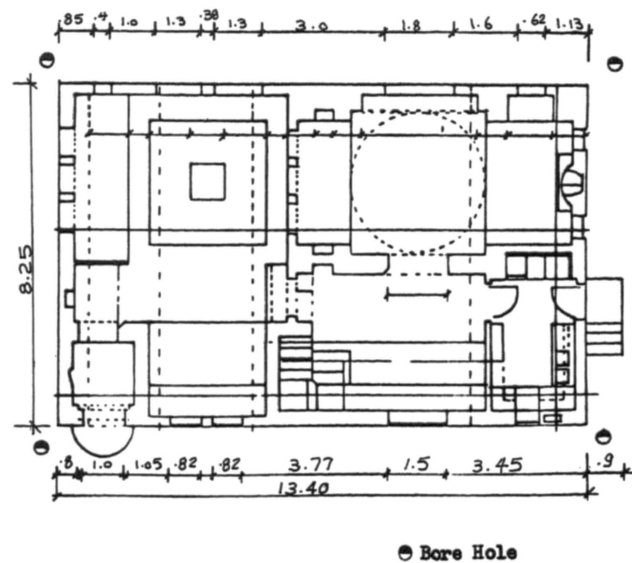
Fig. 1 Plan of The Building

The building was constructed in 1978. Fig (1) shows the plan of the building while fig.(2) and fig.(3) show elevations of the north and south walls respectively. The building consists of masonry walls with thicknesses varying from 250 to 500 mm as shown in plan. The walls are founded on a reinforced concrete continuous strip foundation. There is a mezzanine floor in the south east part of the building while the north east part has no intermediate slab and is covered with a masonry dome. All the west part is an open court as shown in plan.

Using shell and auger drilling equipment , four boreholes were sunk to a depth of 20 m below the existing ground level at the locations shown in fig.(1). The soil strata at the site , as revealed by the site investigations, were found to be almost uniform. A typical soil section is illustrated in fig.(6). Standard penetration tests were carried out in the sand layers at 1.0 m intervals , the results are presented in fig.(7). The two upper sand layers were found to be medium dense whereas the bottom layer is medium dense to dense. As far as the clay layers are concerned , values of the undrained shear strength ( $C_u$ ) and the coefficient of volume compressibility are included in fig.(8).

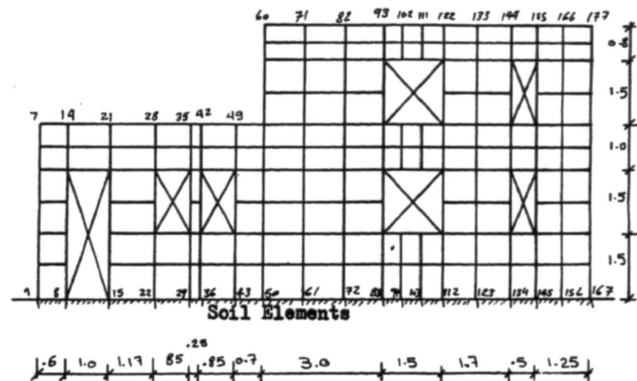
Fig. 11 Finite Element Mesh Used in The Analysis.

The problem was then analysed twice. Both the two analyses were qualitative rather than quantitative in order to furnish an insight into the behavior of the walls. At first a preliminary analysis of the strip foundation, shown in fig.(9), as a beam on elastic support was carried out. The modulus of subgrade reaction was estimated from the soil data. The loading on the strip foundation of the south wall and the resulting profile of deformation underneath it are shown in fig.(10). The deformation profile indicates that although all settlements are downward, there are local hogging profiles underneath the openings caused by the difference in loading. From this settlement profile, one can expect that the connecting masonry beams on top of the openings may be subjected to tensile forces. In order to verify this expectation a more sophisticated analysis for the walls was carried out using the finite element method. Plane stress quadrilateral hybrid elements, developed by Green (1972), were used in the idealization of the walls while half plane surface elements, developed by Macleod et al. (1980), were used in idealizing the soil. Fig.(11) shows the mesh used for the south wall. The results showed that the connecting beams are subjected to tensile stresses much more than the tensile strength of the masonry.
