## Remedial Measures to Seepage and Instability Aspect of a Dam Near Bombay

**SYNOPSIS:** The paper describes the distress caused to a minor earth dam constructed at a high elevation in a mountainous area to conserve water. The distress related to instability of the dam and also due to high percolation underneath the dam coupled with formation of piping. The remedial measures taken to rectify instability and reduce percolation are described in this paper.

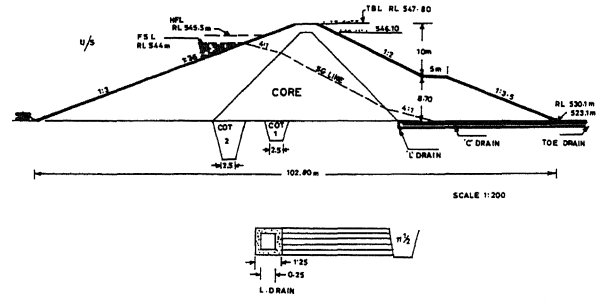
Fig. 2 Subsurface Section Along the Dam Axis

The whole area consisted of highly weathered soil mass followed by highly fractured and jointed basalt. See Fig.2. Such a condition of reservoir may give rise to high degree of subsurface percolation. It was also observed that a big piping had appeared close to the waste weir and was cutting across underneath the dam and was opening up down stream at RL 536. Further examination revealed that 2 to 3 streams which are passing through the reservoir area converge into goose neck and join the main valley. The location of the piping coincides with the course of the stream. It is presumed that the cut off trenches are above the bed of the streams which are filled up with sand and gravel. See Fig.5. It is also observed that considerable distress has taken place on the right flank due to blasting operation during the construction of waste weir. This can lead to heavy percolation through the right flank when the dam would be full.

To understand the causes of heavy seepage it was considered necessary to take around 4 boreholes along the dam axis. See Fig.2. With the help of 4 borehole logs a subsurface profile is developed to indicate the strata containing murrum, highly crushed fragmented rock and intact rock etc. It can be seen from the section that on the right flank murrum deposit is encountered upto RL 536 and at the centre of the dam it is upto RL 527.5. Near borehole 4 the murrum zone ends at RL 539. Below the murrum zone around 8 m. to 10 m. of thick fragmented crushed rock zone is encountered. On the left flank the rock strata encountered is moderately fragmented rock as shown in Fig.2. On the basis of subsurface section coupled with surface observations in the storage area it can be concluded that even after the dam is constructed almost all the water can percolate out at a high rate through the subsurface underneath the dam. The average thickness of crushed rock and murrum overburden would be around 18 m. Approximate computations show that the coefficient permeability K value would be  $2.2 \times 10^{-2}$  cm/sec. for average strata. However, the coefficient of permeability for fractured zone would be  $4 \times 10^{-1}$  cm/sec.
