## **CASE HISTORIES OF DAMAGE OF FOUNDATIONS NEAR SLIDING SLOPES**

**Constantine A. Stamatopoulos**

### **ABSTRACT**

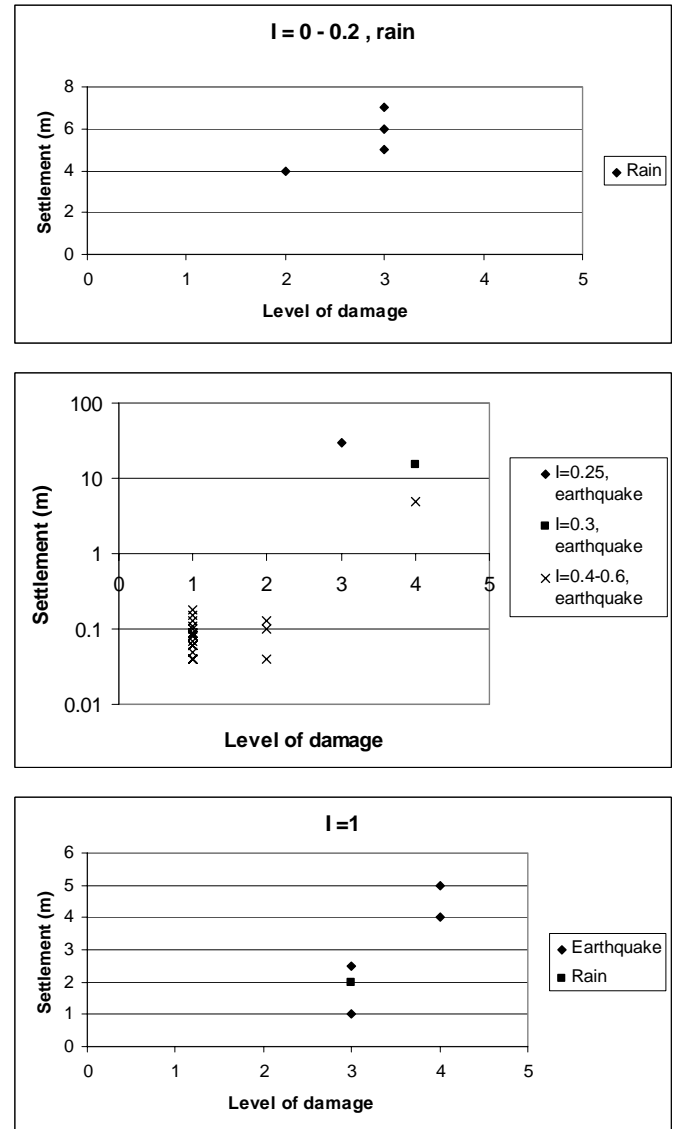
Tables 1 and 3 present the level of damage in terms of the critical parameters that were described above for all the historic cases that were collected. The results are presented graphically in Fig. 13. Damage level is given in terms of the factor I, the settlement, and the cause of slide (heavy rain or earthquake). Results are separated for factors I: (a) smaller than 0.2, (b) between 0.2 and 1 (actually according to the collected data between 0.25 and 0.6) and (c) equal to one.

It can be observed that the damage of buildings is different when the factor I takes different values:

The above hold regardless of the cause of the slide: heavy rain or earthquake.

Fig. 13. Statistical analyses: Damage level in terms of the factor I, the settlement and the type of slide.
