Bloomfield Road Stormwater Storage Tanks Grouting Works, Blackpool, UK

Seventh
International Conference on
**Case Histories in
Geotechnical Engineering**

**BLOOMFIELD ROAD STORMWATER STORAGE TANKS GROUTING WORKS,
BLACKPOOL, UK**

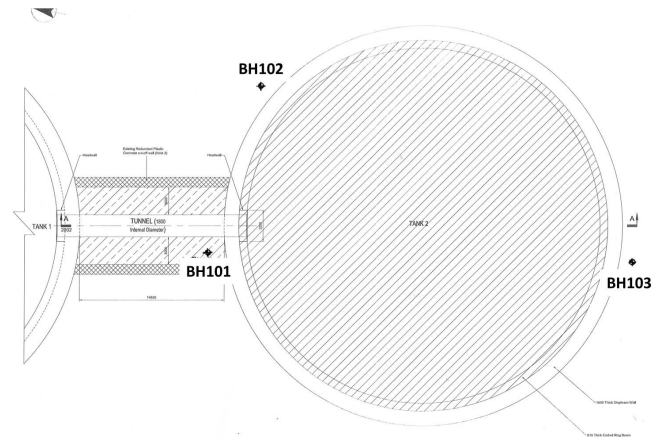
Fig. 6 – Advance Ground Investigation Borehole Location Plan

Figure 6 illustrates the location of the three boreholes. Borehole BH101 was located to investigate potential change in ground conditions close to the interconnecting tunnel. Boreholes BH101 and 102 were located where highest volumes of groundwater inflows had been observed within the tank. Borehole BH103 was targeted in an area of no observed internal groundwater ingress to act a control during subsequent interpretation of results.

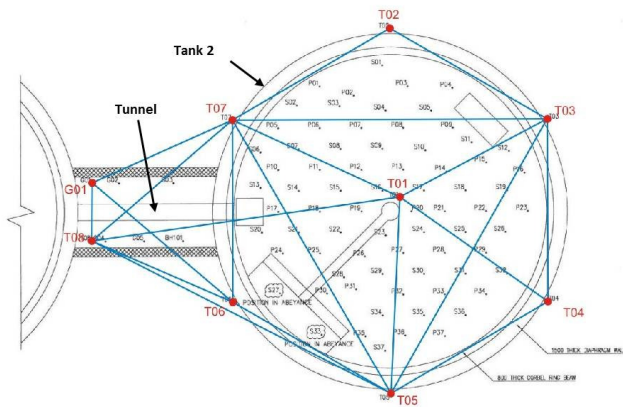
Fig. 8 – CHT borehole location and survey lines

Investigations to establish the mudstone/halite interface included six boreholes (T02 to T07 Fig. 8) to 75m depth around the perimeter of Tank 2 and one borehole (T01 Fig. 8) to 38m deep within the centre of the tank. The central borehole was drilled from the base of the tank at approximately 40m below ground level. The boreholes were fitted for subsequent CHT surveys to investigate potential voiding.

Results from the CHT survey indicated high chloride groundwater flow through the mudstone. It was concluded that significant halite voiding was not present (Fig. 9).

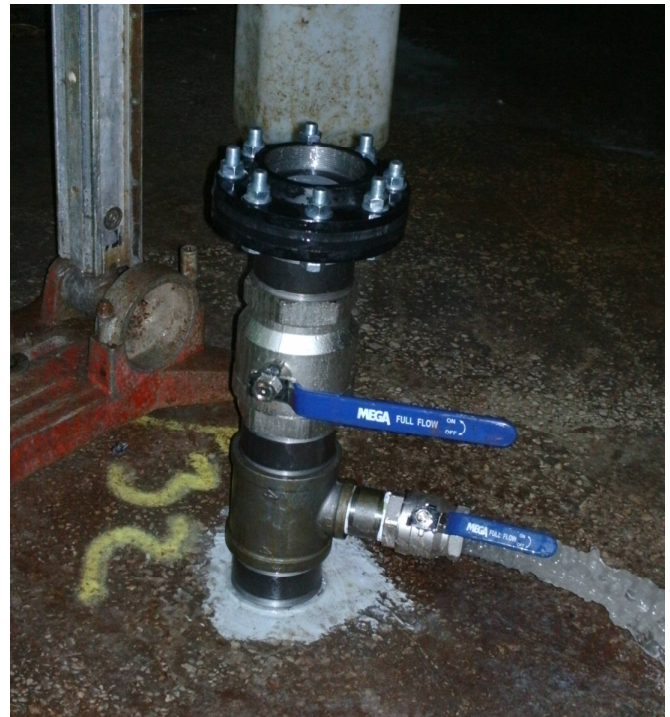
Fig. 12 – ‘Stuffing box’ installation

Grouting operations within the tank were planned through 37 primary and secondary holes at approximately 3m centres (Fig. 8). Initial preparation required installation of a ‘stuffing box’ (Fig. 12) over each borehole position to allow drilling under the challenging anticipated 3 to 4bar groundwater pressures.

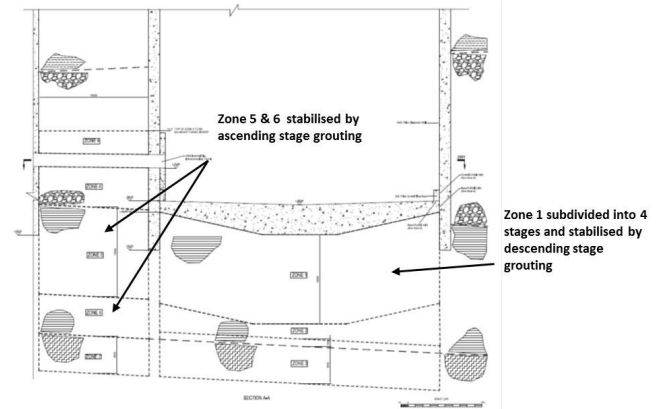
Fig. 14 – Investigation and treatment zone delineation drawing.

Descending stage drilling and grouting commenced in the primary positions. Drilling and grouting was completed in advance of the next stage to ensure progressive improvement to stability (Fig. 14). Interpretation of ground investigation works undertaken concurrently allowed final treatment borehole depths to be scheduled to ensure penetration into the underlying Halite was avoided (see above and Fig. 10).

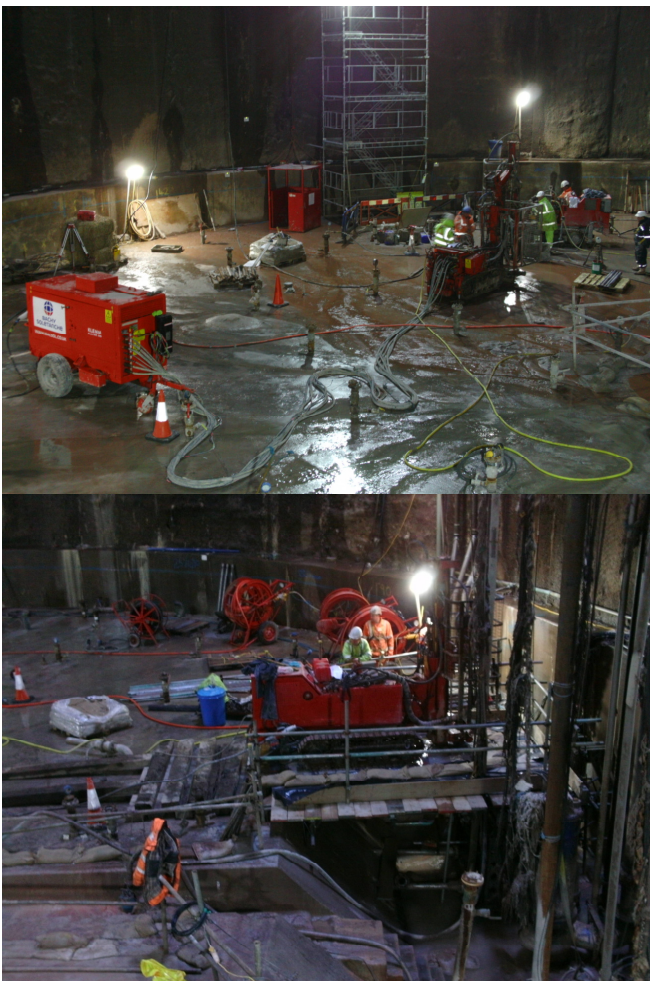
Fig. 13 – Site operations within the tank.

Initial drilling extended 500mm below the tank base slab to allow primary contact grouting between the base slab and formation mudstone. During these works high groundwater pressures were only experienced close to the observed groundwater ingress locations; limited pressure was encountered elsewhere. Voids up to 700mm depth were encountered directly below the base slab in locations around the sump where the predominant groundwater and fines ingress was observed. This validated assumptions associated with assessment of this being the primary threat to the structure. Grouting operations demonstrated extensive connectivity between borehole positions with a number of connections being identified across the tank. Figure 13 illustrates typical drilling and grouting operations within the tank.
