International Conference on Case Histories in Geotechnical Engineering (2008) - Sixth International Conference on Case Histories in Geotechnical Engineering

Repair of a Failed Slope Using Geogrid Reinforcement

Bureau of Road Research and Development, Department of Highways, Thailand

REPAIR OF A FAILED SLOPE USING GEOGRID REINFORCEMENT

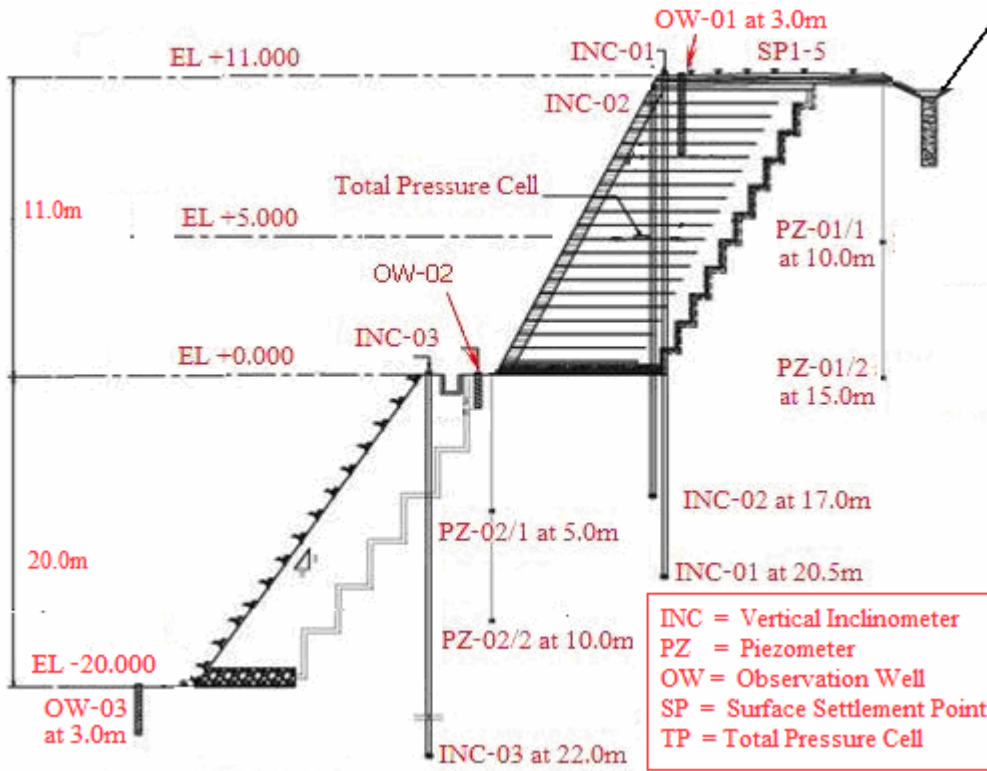
Figure 3: Cross Section of Instruments Installed at Test Site

In order to understand factors causing the failure, the Bureau of Road Research and Development hired a company to install geotechnical instruments at the site. The instruments are inclinometer, pneumatic piezometer, surface settlement plates, total pressure cell and observation well. The number and purpose of each instrument are shown in Table 1 and the layout of instrumentation is shown in Figure 3. In addition, the soil samples were collected and tested in the laboratory to determine some engineering properties
