International Conference on Case Histories in Geotechnical Engineering (2008) - Sixth International Conference on Case Histories in Geotechnical Engineering

Need for Prior Geotechnical Engineering Studies for Foundation Design: Cases of Collapsed Buildings in Port Harcourt and Environs, Nigeria

NEED FOR PRIOR GEOTECHNICAL ENGINEERING STUDIES FOR FOUNDATION DESIGN: CASES OF COLLAPSED BUILDINGS IN PORT HARCOURT AND ENVIRONS, NIGERIA

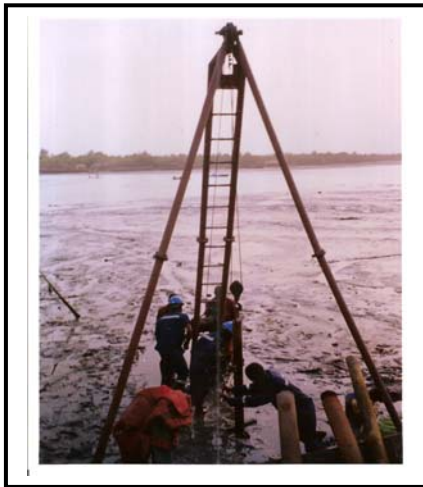
Subsurface Conditions. The Subsurface conditions at the project site were studied by sounding in the form of Standard Penetration Testing (SPT), with the aid of Shell-Percussion Rig (Fig.3) while retrieving soil samples at specific depth intervals of 1.50 meters for purposes of visual examination of soil samples, laboratory testing and classifications, as the case may be.

Fig. 3. Percussion Rig used adjacent to the Building Sites.
