Foundation Strengthening and Protective Measures for Sri Sangameshwar Temple at Kudal Sangam, Karnataka

Devendra Sharma
Central Building Research Institute, Roorkee, India

SYNOPSIS : Sri Sangameshwara temple situated at the confluence of two rivers developed noticeable tilt. Also the temple site be inundated by the back waters of the dam during floods. An elaborate plan of dismantling the temple and reconstructing it by the same stone pieces and statuary could be carried through partially only and the sanctum sanctorum portion housing the 'Lingam' had to be retained. Now the entire temple is to be reconstructed as and where it was. The temple was founded on a boulder plateform with heterogeneous river deposits below it. Honouring the constraints of uninterrupted daily worship rituals in the temple and the underside of the pedestal supporting 'Lingam' not to be disturbed, strengthening by providing a double row of piles around the existing structure and a protective wall around the site were recommended. The choice and design aspects of these measures are discussed.

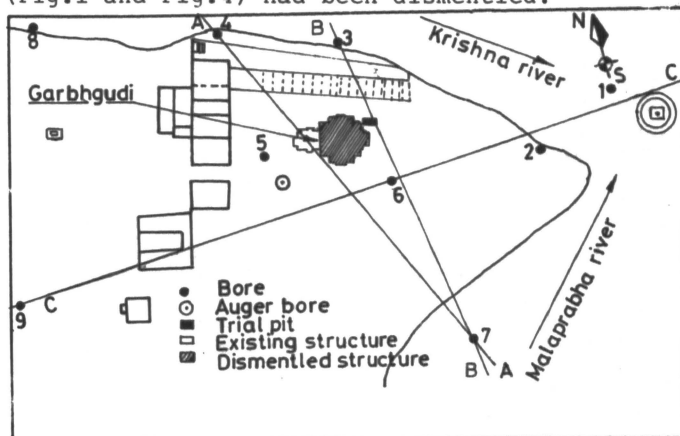
FIG.1 Sri Sangameshwara temple - key plan

Sri Sangameshwara temple is situated at the confluence of the rivers Krishna and Malaprabha in district Bijapur of the Karnataka State of India. The site is known to be an important seat of the shavite sect of the Hindus and associated with saint Basvanna whose works are ascribed to 12th century A.D. The temple is closer to the river Krishna on its north (Fig.1) and this existing portion (Fig.2 and Fig.3) is the sanctum sanctorum known as 'Garbhgudi' housing the 'Lingam' on the pedestal. The remaining major front portion (Fig.1 and Fig.4) had been dismantled.

endanger the temple site, has an area of 6400 sq.km. The area around the confluence is generally 'black cotton soil', expansive clays, covered country. The basement rock as revealed by mine boreholes at the site (Fig.1) was granite and its variants. The ground levels varied from 482m to 492m and hard rock encountered from 470m to 480m and an overburden of 1.5m to 21.0m thick (Report, 1987). the present floor level at the temple is around 493m. The likely depth of the basement rock indicated by sections AA, BB and CC through the boreholes (Fig.1) is at an elevation from 475m to 470m. These boreholes showed no general sequence of deposit layers which varied from soil to boulders and mixed heterogeneous

materials. The temple seems to be located over a depression in the basement rock and the borehole B6 (Fig.1) showed the lowest bedrock level at 470.31. Both the site and the bedrock below had an overall general slope towards the north and northeast. The closer proximity of the river on the north side and general ground to north are important to note. The same slope would have existed prior to the temple construction. According to the classical Hindu temple architecture slope of the site is an important consideration for the choice of the site (Sharma, 1988) and a site sloping towards, north, north east or east is considered auspicious (Mansar, 1951; Nambodriped, 1987, Kulkarni, 1985). Specially northward slope is more important for Shaiivite temples. Several Indian classics on architecture support this practice.

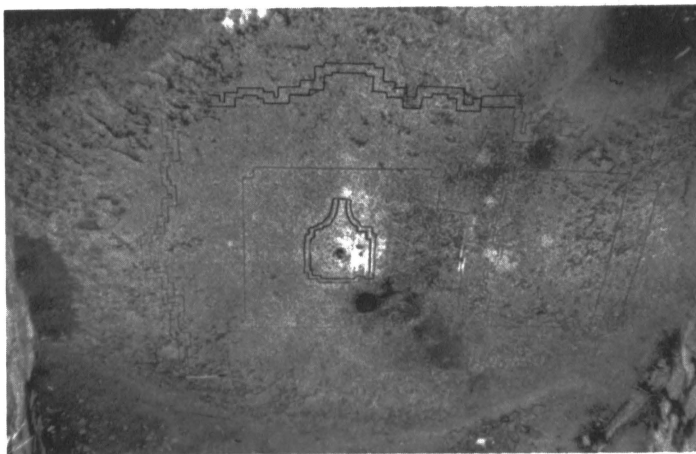
FIG.6 Original plan carved on rock

The temple is several centuries old and no documented details except an original temple plan carved on a rock outcrop (Fig.6) at a place few kilometers away from the temple could be available. This plan is at the temple plinth level and if it is the complete layout, the original temple had only a smaller structure leading to the entrance of the sanctum sanctorum. Now diementled front portion within a square of about 16m sides (Fig.4) must be a later addition. A part of the originally constructed front is still retained (Fig.2). The sanctum sanctorum structure at its base is within 7.5m x 7.5m (Fig.4) and with a total height of 16m upto temple top above the present floor level. The granite stone masonry with exquisite carvings Fig.7 has a wall thickness of about 1m and is 5.6m high. The remaining tapering top structure is plastered brick work with moulding (Fig.2 and Fig.3). The estimated weight of the superstructure is 1130t. The masonry on outside showed signs of weathering, obliteration of stone carvings, opening of joints and dislocation of stones (Fig.7). The brick top was also reported to have cracks in the past and repaired.
