## EXPERIENCES IN LARGE SLOPE STABILITY PROBLEMS UNDER COMPLEX GEOLOGY

**Camilo Marulanda**  
INGETEC S.A.  
Bogotá, Colombia

**Alberto Marulanda and Camilo Phillips**  
INGETEC S.A.  
Bogotá, Colombia

## CASE HISTORIES

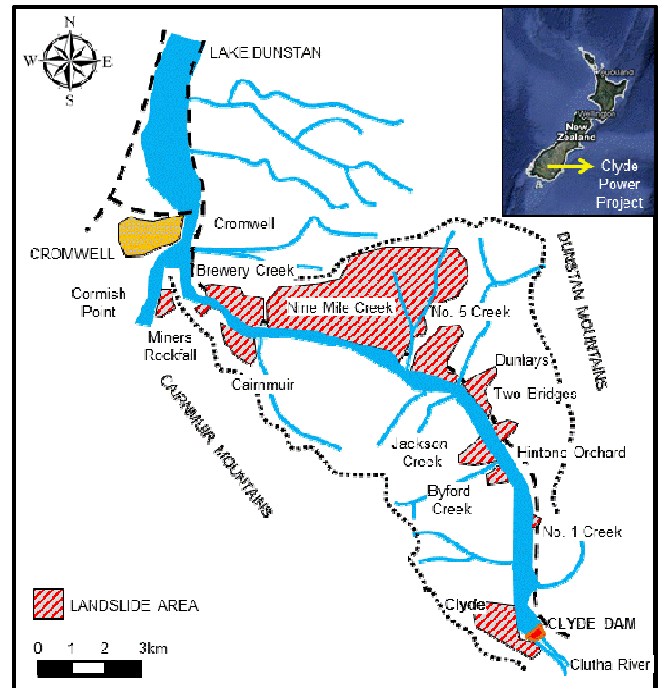
Fig. 12. Cromwell Gorge landslide location [After: Gillon et al., (1991)]

The hydroelectric project of Clyde Dam is located in the southwest of New Zealand. Clyde Dam has an elevation of 102 m and a capacity of 432 Mw. With the construction of the dam a 62 m deep and 15 km long lake was created. Several old landslides of big magnitude existed at the Cromwell Gorge (where Clyde Project is located) which were triggered during the impoundment of Dunstan Lake (See Figure 12). The volume of these landslides ranged between 1 and 1000 Mm<sup>3</sup>.

Three types of instabilities were identified. The first type included landslides with planar failure surface along foliation planes or shear zones as the main mechanisms, including also

movements across the shear zones intersecting foliation planes. The second type included wedge failures, given the conjunction of joint planes, foliation and shear surfaces, respectively. The third type consisted in failures by buckling generally located in the upper parts of the slopes and controlled by high angles of parallel planes of the fractured and relaxed rock.
