# Performance of Lightweight Waste-Impoundment Dikes

**SYNOPSIS:** The containment dikes of two sludge disposal lagoons were founded on low strength, highly compressible wetland soils in Madison, Wisconsin. These lagoons, constructed in 1942 and 1967 respectively, encompass 130 acres of digested sludge produced at the sewage treatment plant. The dikes have experienced two previous failures in 1970 and 1973. A dike rehabilitation program was initiated in 1976 to prevent additional failures. New dikes were built using wood chips as a lightweight fill. Non-woven synthetic filter fabric was used to prevent soil intrusion into the chips and to provide resistance to lateral spreading. An investigation was initiated in 1984 to assess the current and long term stability and settlement of the dikes, to determine the fate of the wood chip fill, and to develop recommendations for ways to stabilize the dikes, if necessary. This paper presents the results of the stability and settlement analyses, and the attendant interpretations. The investigation indicated better than marginal stability, predicted minor loss of freeboard between 1987 and the year 2000, and found only minor changes in the woo

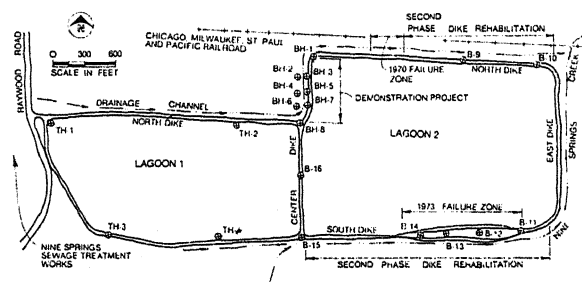
Figure 1. General Plan of the Dikes (from Schneider and Roth, 1976).

Dikes around Lagoon 1 have been relatively stable although they require periodic maintenance to compensate for settlement. Dikes surrounding Lagoon 2, however, require continual maintenance and have failed twice since construction. The two areas of embankment failure are shown on Figure 1. Both failures were similar in nature beginning with relatively rapid subsidence of portions of the embankment. As the dikes settled, imported fill was placed to try to maintain freeboard and prevent discharge of supernatant into the

adjacent surface waters. The dikes generally continued to settle rapidly, and mud waves formed on both inboard and outboard sides. The failure zones spread longitudinally along the dikes as repair filling proceeded. The failure zone at the north dike eventually extended approximately 300 ft; the failure zone at the south dike extended approximately 1,300 ft.

At the time the north dike failed, sludge and supernatant escaped into the drainage channel. After this failure, more fill was placed and the failure zone eventually stabilized. A similar failure occurred in 1973 in the south dike. The dike crest settled below lagoon level, but the associated mud waves rose high enough to prevent discharge of supernatant.

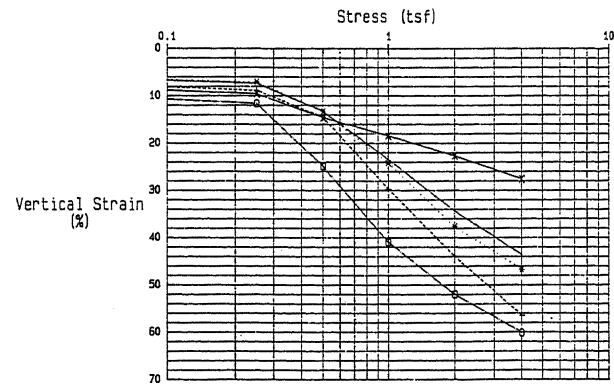
Figure 3. Compression Curves of Wetland Deposits

The marl had an organic content of about 28% and exhibited a compression behavior very similar to that of the peat samples (organic content 23% to 89%). The silty clay had a markedly lower organic content (about 5%) and exhibited much less compressibility compared to the others as shown in Figure 3. This figure also implies that the soils encountered had been compressed under a stress of about 1,000 lb/ft<sup>2</sup> or less. The one-dimensional laboratory compression versus time curves were represented using an equation first proposed by Gibson and Lo (1961) and applied to peats and organic soils by Edil and Dhowian (1979). This equation has been found to be quite useful in representing the compression of peats from numerous sites and has the following form:

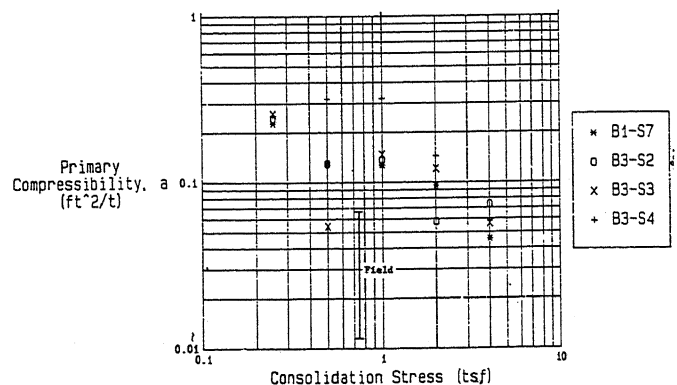
Figure 4. Primary Compressibility versus Consolidation Stress

The laboratory compression curves (vertical strain versus time) under different increments of stress have been evaluated using the compression equation given above to obtain the parameters resulting in the best possible fit of the equation to the measured data. Figures 4 and 5 provide a plot of parameters  $a$  and  $b$  as a function of the stress level used in the laboratory tests. These curves show trends noted before for similar soils from other sites (Edil and Mochtar, 1984). There is a decrease of compressibility with increasing stress. Figure 6 shows the rate factor for secondary compression ( $\lambda/b$ ) as a function of the average strain rate ( $\dot{\epsilon}$ ). Average strain rate is defined as the final measured strain divided by the lapsed time under a given increment of stress applied.
