(2013) - Seventh International Conference on
Case Histories in Geotechnical Engineering

Bank Instability Problems Associated With the Riverside Construction

BANK INSTABILITY PROBLEMS ASSOCIATED WITH THE RIVERSIDE CONSTRUCTION

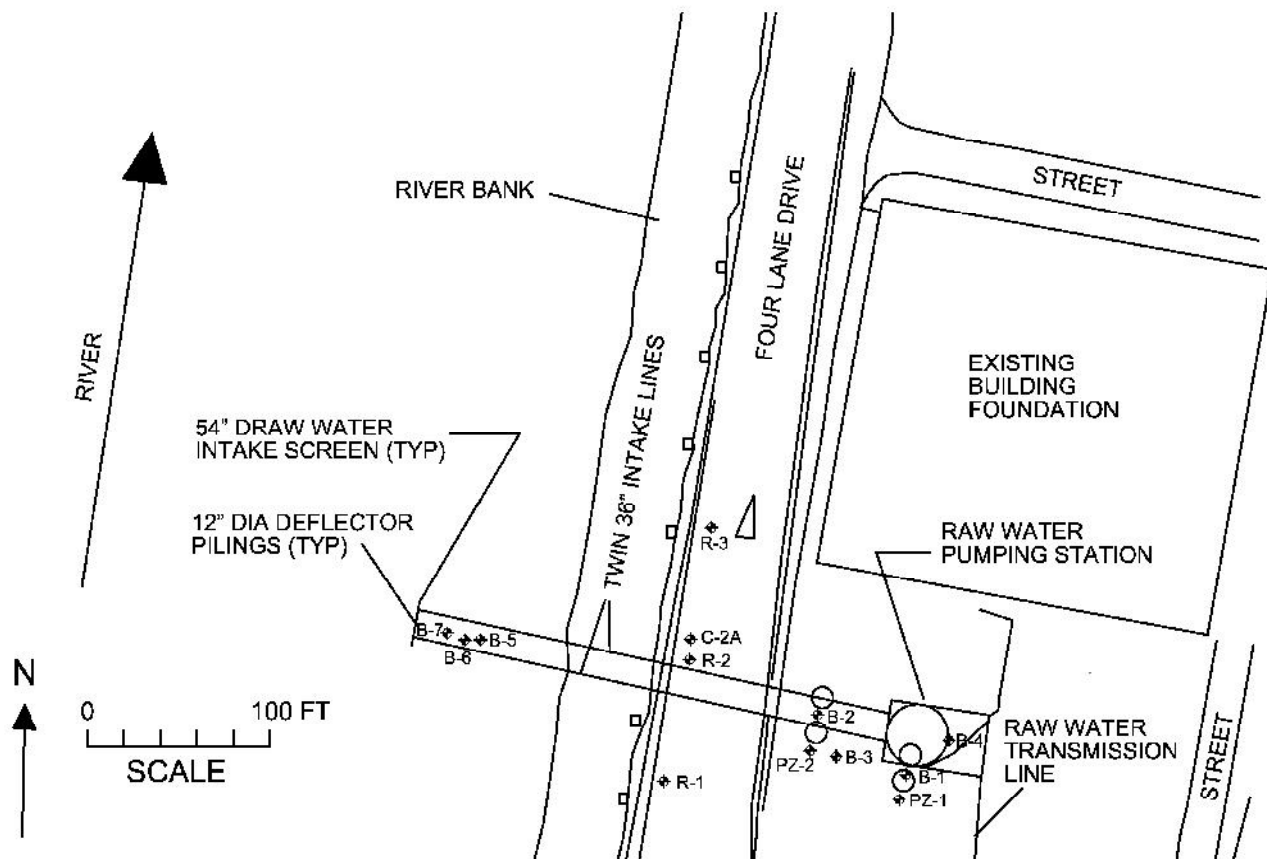
Fig. 1. Site plan of river intake area

As part of the geotechnical design investigation, a total of 8 borings were drilled: 3 around the Pump Station Building (B-1, B-4, and PZ-1), 3 immediately west of the wet well shaft and east of the highway (B-2, B-3, and PZ-2), and 3 in the river near the intake structure (B-5, B-6, and B-7) (see Fig. 1). No design borings were drilled in or immediately above the riverbank slope.

Between November 19 and 20, 2004, three additional auger borings (R-1, R-2, and R-3) were drilled in the roadway on the west side (see Fig. 1). The borings were located within about 20 ft of the crest of the slope on the north and south sides of the alignment. The holes were drilled approximately 9 months after the February 2003 landslide. The borings were advanced using a hollow stem auger and were drilled to refusal. Split spoon soil samples were taken every 2.5 ft in the upper 20 ft of the hole and then at 5 ft intervals to refusal. No rock cores were taken in the post-construction boreholes.
