Dutch Dike Breach, Wilnis 2003

DUTCH DIKE BREACH, WILNIS 2003

S. Van Baars

University of Technology Delft
Delft, The Netherlands

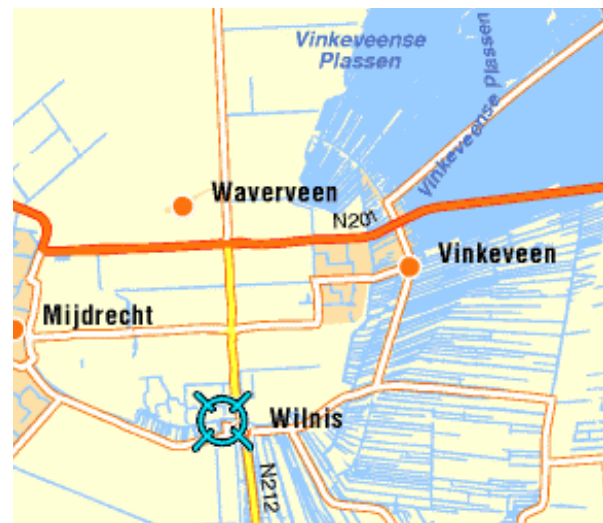
Fig. 3. Wilnis connected with the lake

The village Wilnis is part of the community "Ronde Venen" (Round Peats). It is about 30 km Southeast of Amsterdam. There is a ring canal which goes from the lake near Vinkeveen, through Wilnis, towards the city Mijdrecht (Figure 3). The old part of Wilnis is South of

the ring canal. The new housing quarter, named "Veenzijde" (Peat-side) is the square of land North of the ring canal.
