## Landslide Stabilization Along The Ohio River Using Cantilevered Stub Piers

## LANDSLIDE STABILIZATION ALONG THE OHIO RIVER USING CANTILEVERED STUB PIERS

Paper No. 3.34a

Ohio Department of Transportation  
Hamilton-50-6.50 Landslide  
Addyston, Hamilton County, Ohio

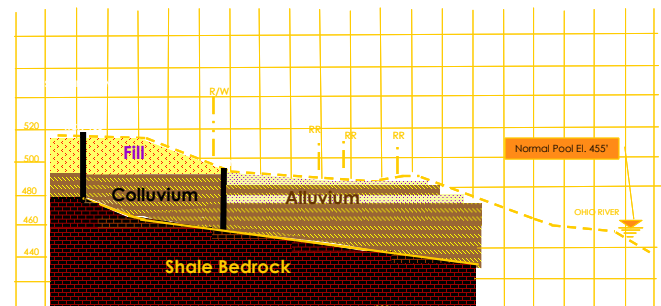
Bedrock lies between 31 and 50 feet deep. Typically, gray shale and limestone occurs. However, about 3 feet of brown weathered shale with limestone occurs in some locations above the gray shale. The horizontally-bedded shale and limestone belongs to the Kope Formation (Ordovician System) and includes shale that rates as very soft to soft in terms of bedrock hardness. There are numerous documented landslides in this local geologic setting. Shale comprises about 90% of the Kope’s mass. Very hard limestone makes up the remainder, occurring in layers up to about 1.5 inches thick. Figure 3 provides a general subsurface profile illustration.

Fig. 3: Typical subsurface profile.

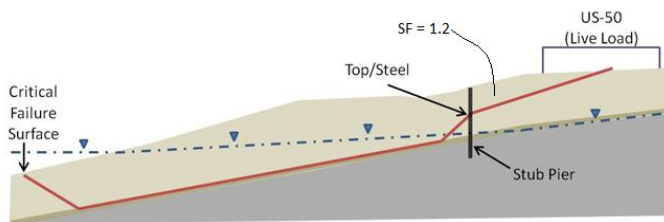
From an analytical point, the short-term solution criterion was quantified by slope stability analyses. Laboratory tests were conducted and soil parameters were then adjusted slightly for the failed slope condition (safety factor of 1.0) and observed shear plane depths. Then, the shear plane was forced upward to the planned top-of-steel elevation of the stub piers. This process resulted in a theoretical safety factor increase from the original 1.0 to about 1.2 (see Figure 4). ODOT agreed with this potential improvement, as a short-term solution.

Fig. 4: Slope stability schematic.

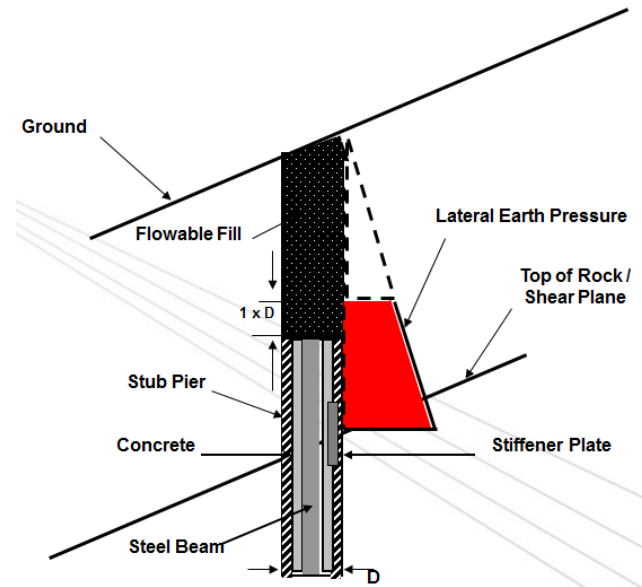
Stub pier design details were then developed. The lateral earth pressure was estimated assuming triangular earth pressure distribution from the ground level to the shear plane. This resulted in a trapezoidal-shaped earth pressure diagram acting on the piers. For potential arching effects above the steel, it was assumed that the contributing pressure extended to one pier diameter above the top-of-steel. This estimated earth pressure was also checked using slope stability analysis to compute the resisting pressure required to generate a theoretical safety factor of 1.2. Refer to Figure 5 for schematics of the assumed earth pressure diagram.

Fig. 5: Stub pier schematic.

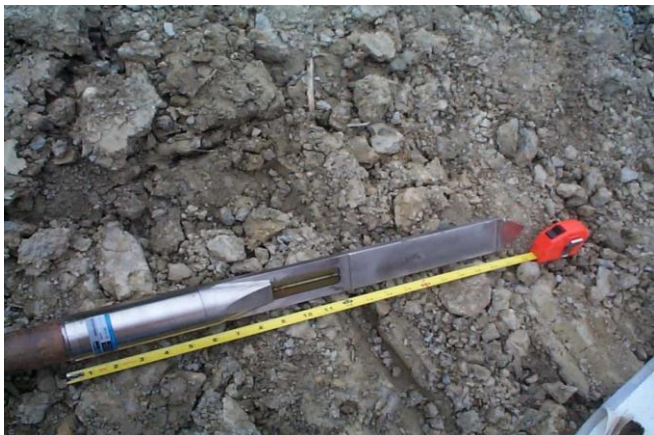
4. Three Push-In Earth Pressure Cells (Geokon Model 4830; see Figure 6) were installed within boreholes located about 8 to 10 feet upslope of selected Stub Piers. These devices were located about 40 to 45 ft. below grade and were installed with the intent of being just above the bedrock surface (close to the interpreted shear plane). These devices measure total horizontal pressure in the soil.

Fig. 6: Push-in earth pressure cell.

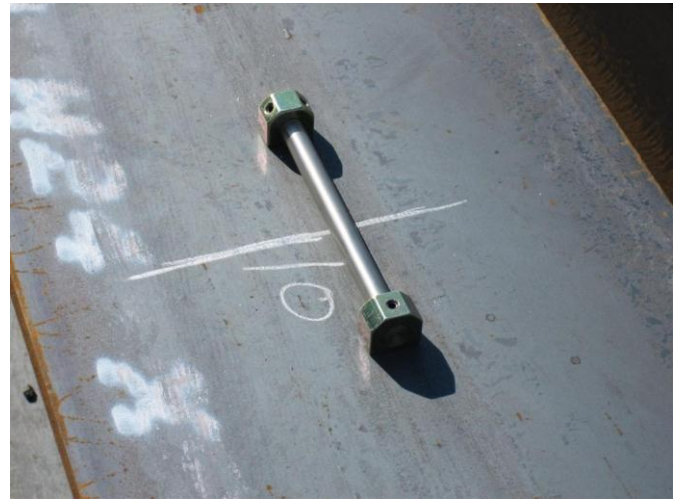
5. At two piers, six vibrating wire strain gages were installed per pier (four on the tension side and two on the compression side). The strain gages (Geocon Model 4000 Strain Gages, weldable mounting blocks, plucking coil and thermistor) were welded directly to the steel beam; see

Figure 7. A thermistor is integrated into the strain gages to account for temperature induced strain. Individual pieces of angle iron were welded over the strain gages to prevent damage during concrete placement.

Fig. 7: Strain gage.

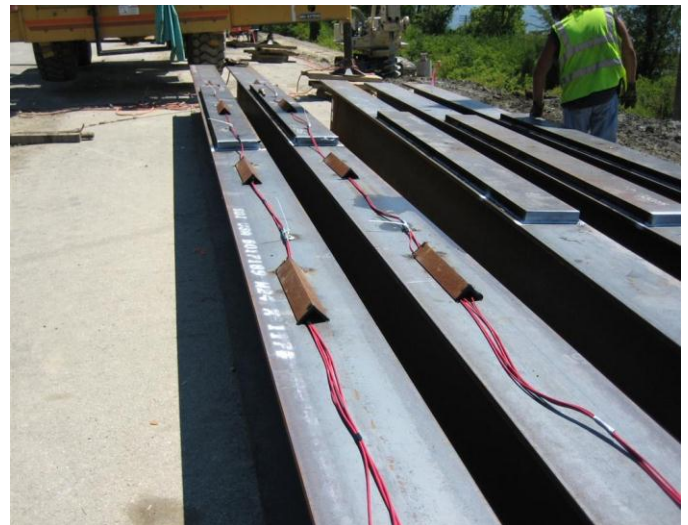
The strain gage cables were extended up the two respective Stub Piers to the ground surface. These cables, as well as the earth pressure cell cables, were routed laterally to a terminal box, which was installed on a post embedded within the top of a nearby Stub Pier. Figures 8 and 9 show the cables, protective steel angle iron over the strain gages, and fully instrumented pile before installation. Figure 10 shows installation of an instrumented steel beam.

Fig. 8: Strain gage and cable assembly.

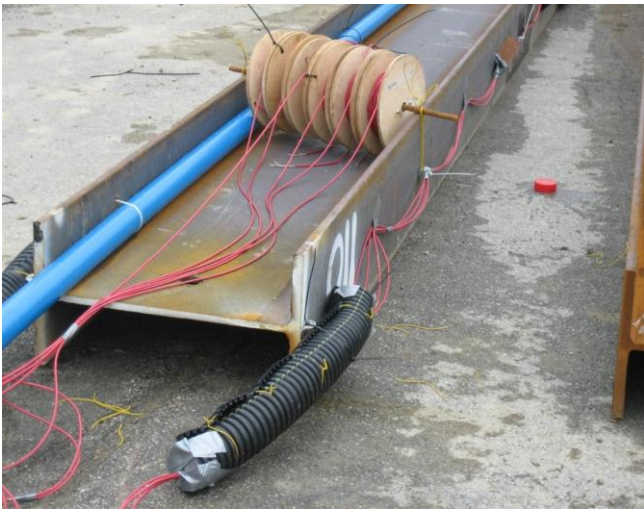
Fig. 9: Pile instrumented with strain gages, cables, and inclinometer casing.

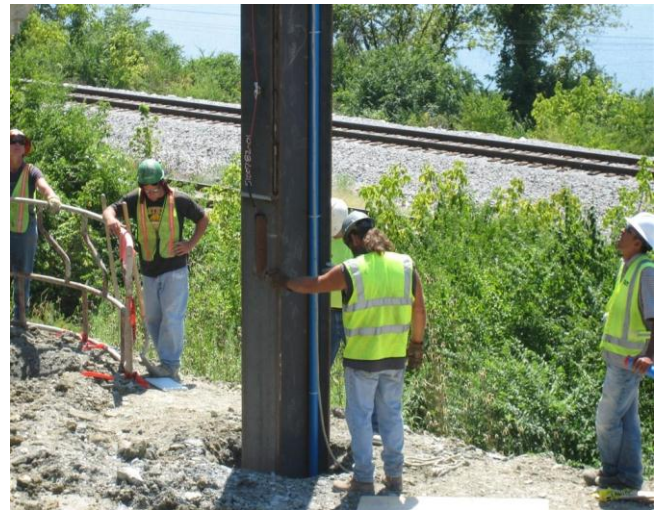
Fig. 10: Setting instrumented steel beam into shaft excavation.
