Repair of the Church of La Purisima Concepcion of Huelva (Spain) with Jet-Grouting, for Damages Caused by the Construction of Diaphragm Walls in its Proximity

REPAIR OF THE CHURCH OF LA PURISIMA CONCEPCION OF HUELVA (SPAIN) WITH JET-GROUTING, FOR DAMAGES CAUSED BY THE CONSTRUCTION OF DIAPHRAGM WALLS IN ITS PROXIMITY

ABSTRACT

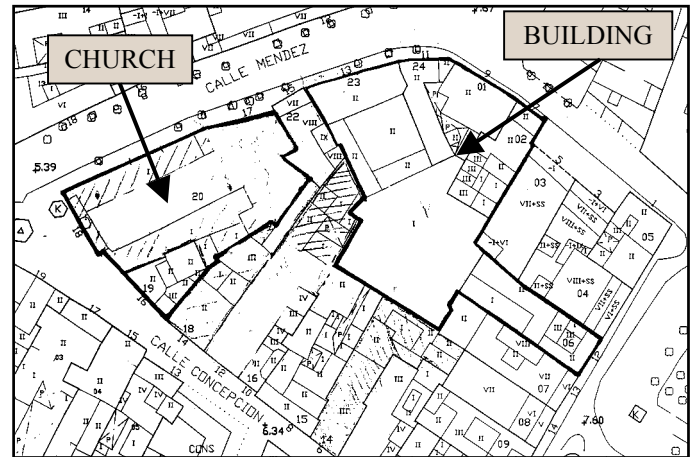
Fig.4. Situation

Because of the movements of the walls there had been differential settlements in the supports of the church, and the parochial buildings, and many cracks appeared in the walls.

The damages caused by the movements of the walls by failures of the provisional struts have been increased by the modifications of the water table, and the changes in the soil parameters.
