## Ellis Island: Vibration Effects on Historic Buildings Caused by Pile Driving

## ELLIS ISLAND: VIBRATION EFFECTS ON HISTORIC BUILDINGS CAUSED BY PILE DRIVING

Sixto Fernandez, MSc.

Schnabel Engineering

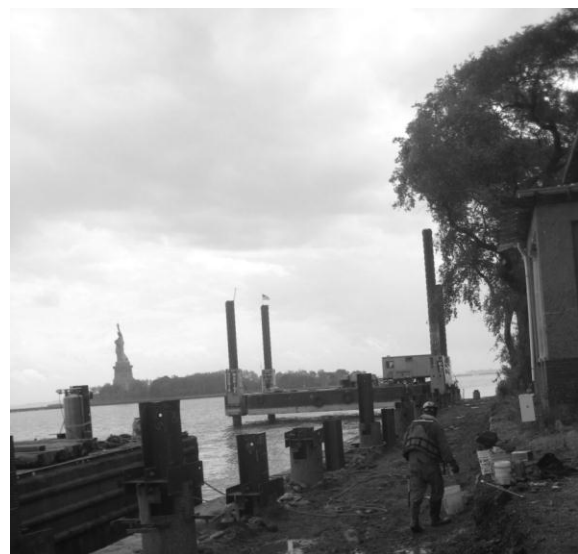
The soldier piles were steel H piles HP 14x89, 300 kip capacity in compression driven to rock. The lateral loads are taken by ground anchors. The piles are located parallel to the seawall as close as 20 ft from the buildings in some areas (Figure 4). The majority of the piles were driven along the South end of the Island. A total of about 120 piles were driven around the South end, East of the South side of the South Island and the ferry slip. Pre-drilling of the first 30 to 35 ft was used to reduce the vibration energy transmitted to the historic buildings.

The piles were driven from a barge with an air hammer. The hammer was a Vulcan-Bull 510 with a theoretical energy of 39,000 lb-ft. Figure 4 illustrates a typical driven piles arrangement and shows a typical location of the seismograph's boxes. These piles were located at the East side of the South Island, where the distances from the piles to the historic buildings are larger than those at the South end.

Fig 4. Typical driven piles and seismograph locations with respect to the buildings.

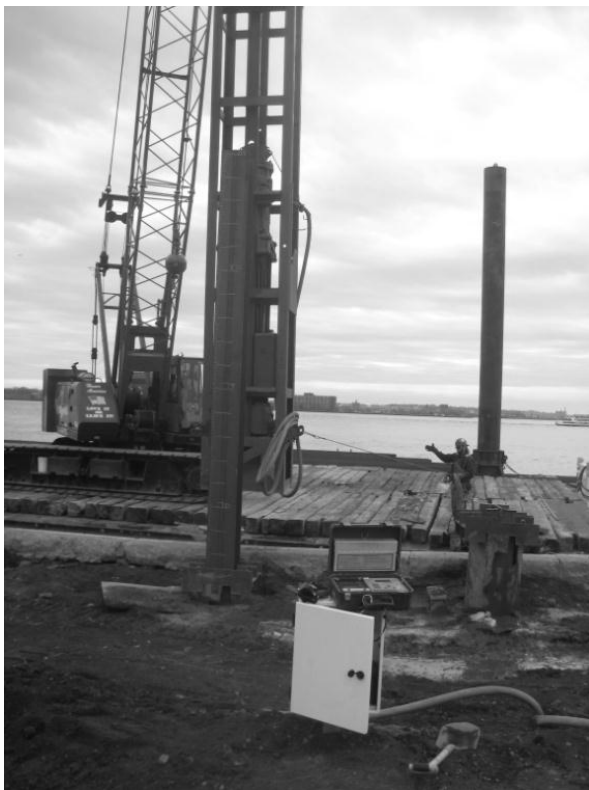
The vibration monitoring was done with four (4) seismographs, simultaneously recording vibrations and covering a radius of about 200 ft of pile driving activities. The seismographs were enclosed in a metallic box containing a Blastmate seismograph (Figure 5), one battery and one sensor that activated a light on top of the box when the PPV exceeded the threshold. The geophone was located at the same location of the box, buried in the ground at about 1 ft deep from the ground surface.

Fig 5. Vibration monitoring enclosing box with Blastmate seismograph.

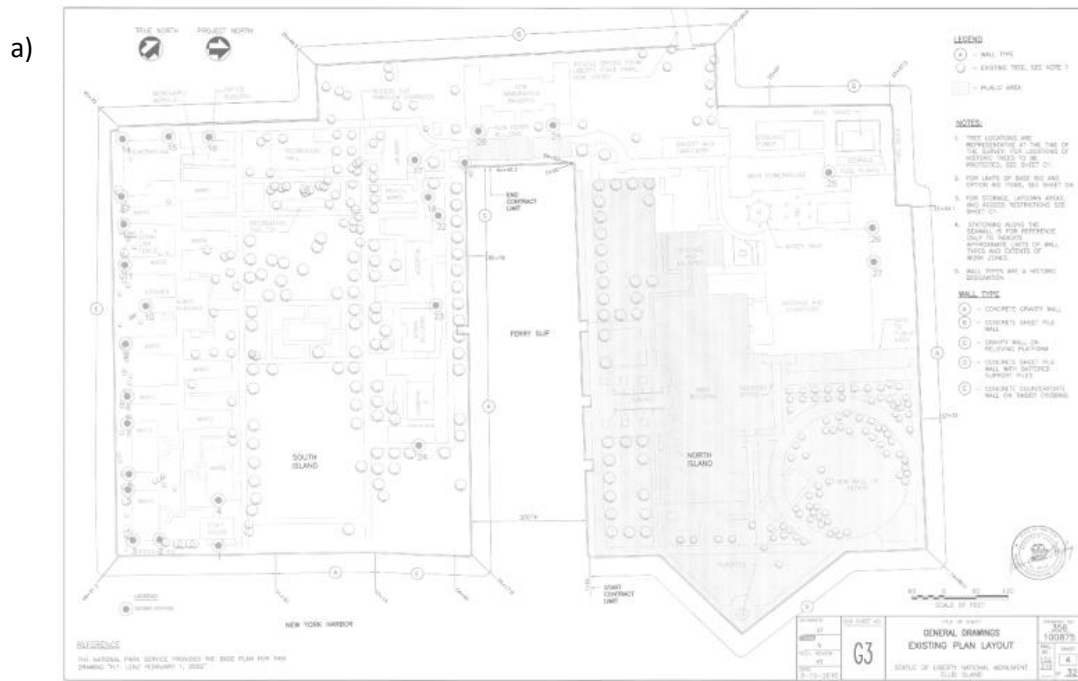
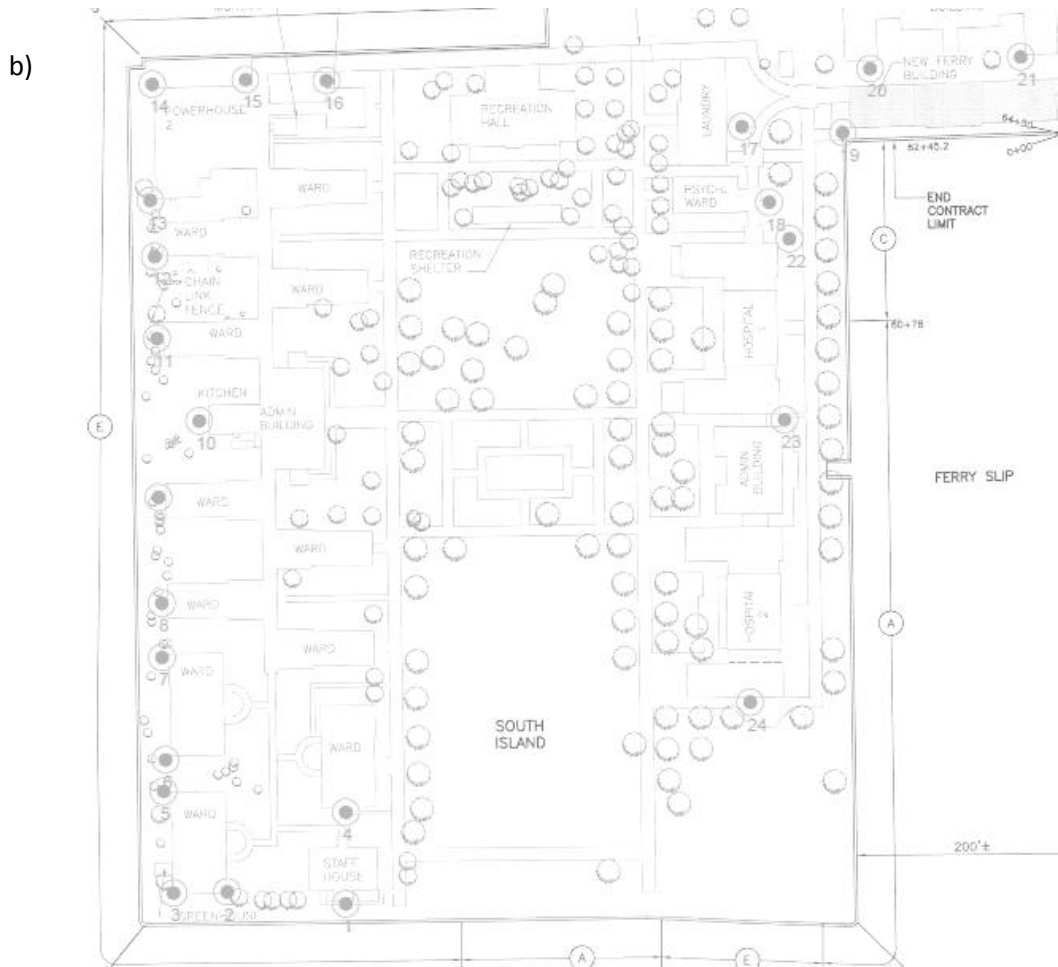
The location of the seismographs varied depending on the area that the contractor was driving piles. The concept of moveable stations permitted monitoring of vibrations for a radius of about 200 ft of pile driving at all times. An approximate location of all the used monitoring stations is shown in Figure 6.

Fig 6. Vibration monitoring stations; a) General plan; b) South Island
