Monitoring and Stabilisation of the Giants Seat Landslip, U.K.

David E. Jones
Bechtel Ltd., Warrington, Cheshire, UK

MONITORING AND STABILISATION OF THE GIANTS SEAT LANDSLIP, U.K.

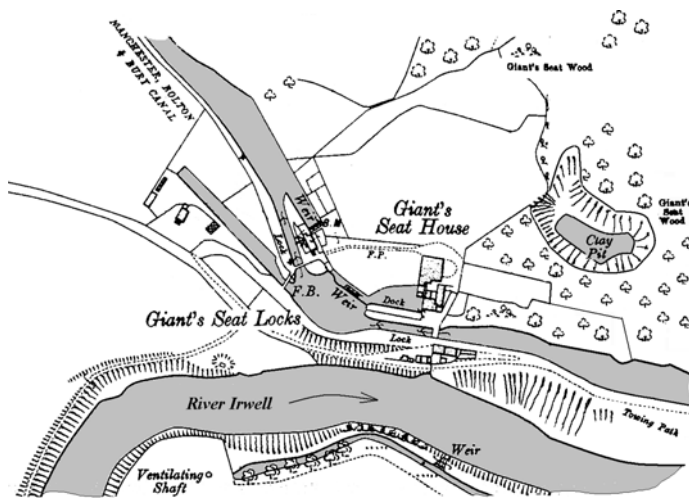
Fig.3. Site map in 1907 showing the MBB canal (site within circle)

Also seen on the 1907 map is a Clay Pit. Such pits can commonly be found close to the canal system associated with puddle clay sealing of the canals. However, in this case, based upon the chronology of maps the clay pit significantly postdates the canal. A pipe, perhaps overflow, ran from the water filled former clay pit to the north side of the canal. On later maps the clay pit is identified as a pond.
