The World Trade Center “Bathtub”, a Case History

George J. Tamaro

Mueser Rutledge Consulting Engineers, New York, New York

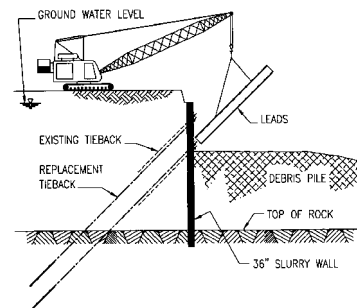
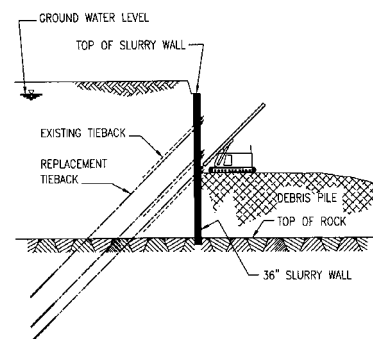
Fig. 9 Tieback Installation

The abandoned “original” tieback tendons were inspected and found to be unsuitable for reuse. Replacement anchors, intended to be “permanently corrosion protected” are now installed. The anchors consist of eighteen 15mm (0.6 inch) diameter strand and are tested to 360 tonnes (400 tons) and locked off at 270 tonnes (300 tons). Because of staging problems, the uncertainties about the support of the wall by debris and concerns about sudden loading of the wall as a result of the collapse of the lower level floors, tieback capacity of the upper tiers of anchors was set sufficiently high so that the anchors would not fail prior to development of the ultimate moment capacity of the wall. Load cells located at Liberty Street indicated a drop in load with time. This is attributed to the effect of higher lock off loads than necessary, the movement of the wall away from the excavation and the installation of lower tier anchors. Tieback work was performed from inside the excavation using crawler-mounted drills set on timber mats or low headroom rigs at interior areas where remaining slabs could be used as a temporary work platform. Tiebacks were also installed from outside the excavation using “floating leads” extending over the wall. The floating leads were used where the interior working surface was unsafe (Fig. 9). A massive crane was used to support the 23 tonne (25 ton) leads during drilling operations. (Excavation equipment fell several floors through the debris on two occasions.)

The current design generally requires one less tier of anchors at each wall section than was used in the original construction. At several tiers, the replacement tieback anchors will be placed either directly above or below abandoned anchors; at other tiers, the replacement anchors will be a distance from abandoned original anchors.

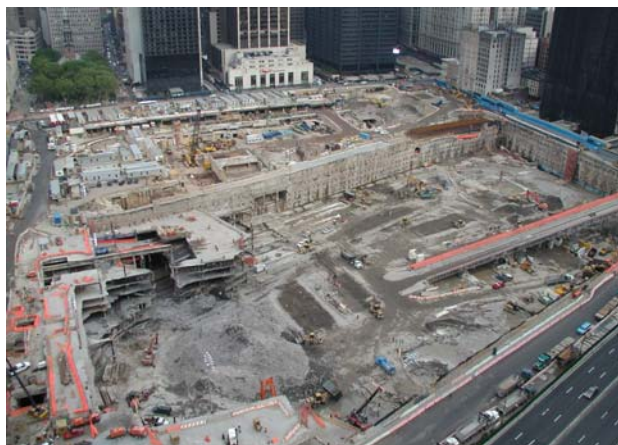
Fig. 11 Site Photo from May 2002.

The anchors at the Liberty Street wall were completed first (Fig. 10). Anchor installation on West and Greenwich Streets proceeded from south to north as workspace became available. Tiebacks were also installed on a segment of the Vesey Street wall where falling debris had punched through WTC 6 and three levels of basement floor slabs. The recovery effort was completed on May 30, 2002, within an eight and one half-month period working 24 hours a day, seven days a week (Fig. 11). At that date approximately 950 temporary anchors were installed to provide lateral support to sections of slurry wall left unsupported as a result of damage to the below grade slab structure. An additional 120 anchors may be needed if and when the remnant basement structures at the north end of the site (Fig. 12) is removed to accommodate development of the site. Eventually all anchors are to be de-tensioned and sealed before they corrode and lose capacity.

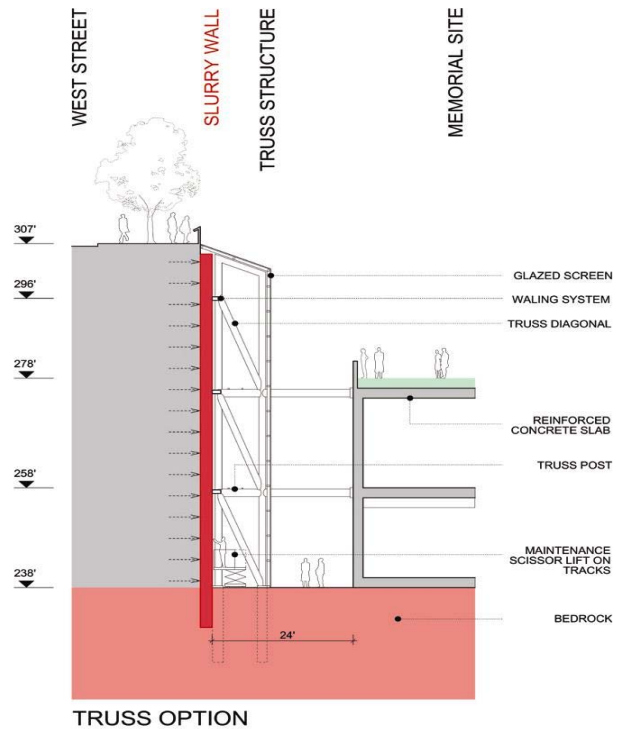
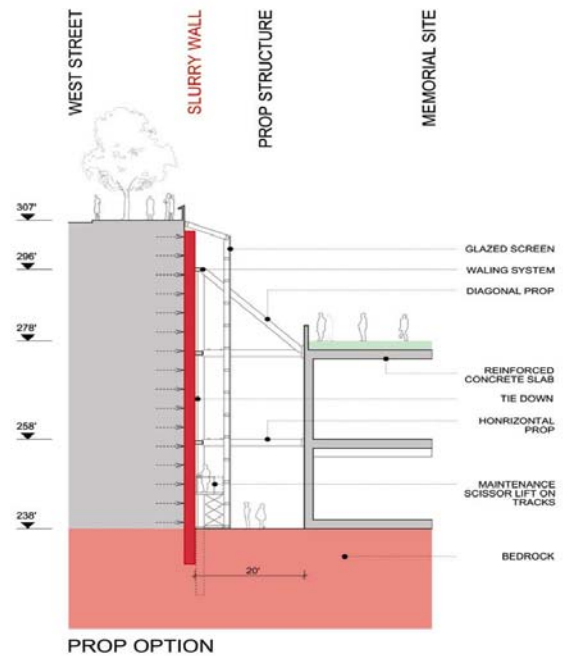
Fig. 19 Proposed re-support of slurry wall where wall is to remain visible

Permanent lateral support of the diaphragm walls will be obtained from future floor slabs. Where floor slabs are not

present, a system of permanent struts, buttresses and/or trusses will be installed so that the temporary anchors may be detensioned and sealed. These supports will have to be capable of supporting individual 6.7meter (22 feet) panels in a configuration closely conforming to the original wall support design. (Fig. 19)
