Settlement of a Light Rail Pier Supported on Large Diameter Bored Piles Remediated by Jet Grouting

SETTLEMENT OF A LIGHT RAIL PIER SUPPORTED ON LARGE DIAMETER BORED PILES REMEDIATED BY JET GROUTING

A support Pier (Pier 161) for a Light Rail line being constructed for the Metro Manila Light Rail Project encountered large settlements after the installation of the Precast Deck Girders. This pier supports bridge crossing across the *San Juan* River with a total span of sixty (60) meters. This Pier is supported on six (6) 1500 mm diameter bored piles designed to extend down to 17 meters or socketed into bedrock at least 2.0 meters based on design requirements. The structure started to settle during the erection of the superstructure when the dead load reached about 700 metric tons. Total settlement was about 42 mm when the erection was halted at a dead load of about 1600 metric tons.

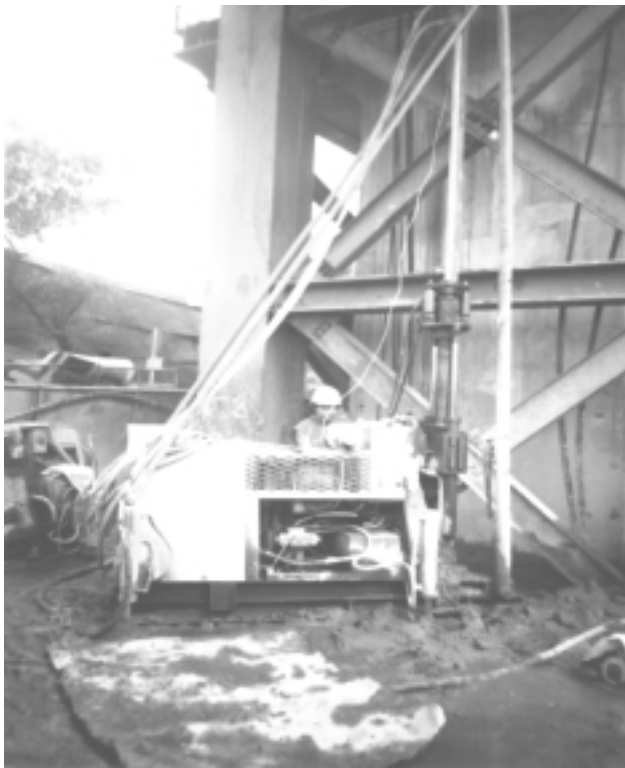
A set up of the equipment underneath the Girders is shown in Fig. 6 and 7. The equipment is a Double tube Jet Grouting System with Grout injected through a side jet protected by a compressed air shroud.

Fig. 6. Jet Grouting Machine set up under Pier

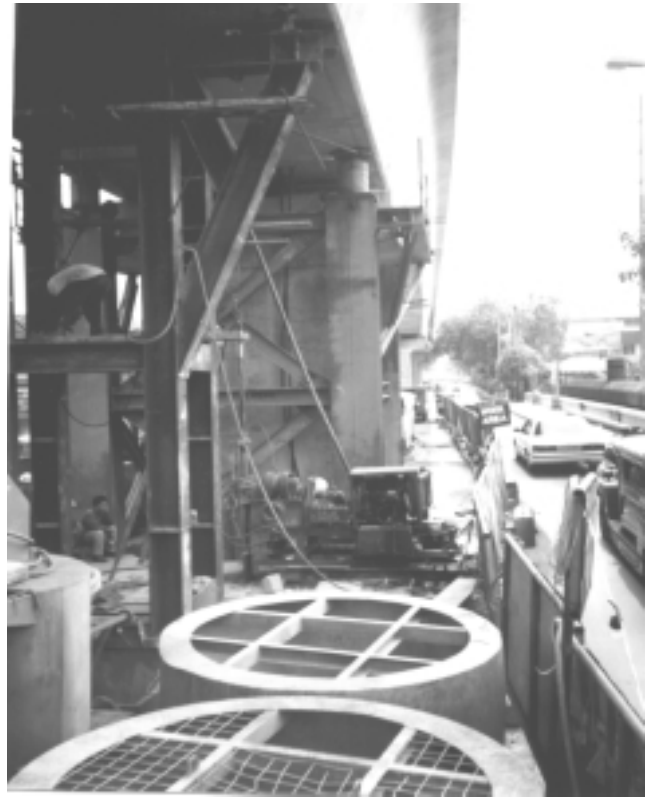
Fig. 7. Jet Grouting Equipment Layout

In addition, each of the Jet Grouted Piles were reinforced at the center by 25mm \varnothing rebars which were inserted by redrilling the Jet Grouted Piles (JGP) after it has sufficiently cured, and extending this 2.0 meters beyond the Soil/Bedrock interface into competent Bedrock. The drilled holes and dowel bars were subsequently regouted effectively doweling each JGP into the Bedrock.
