## Failure Investigation of a Fill Slope in Putrajaya, Malaysia

## FAILURE INVESTIGATION OF A FILL SLOPE IN PUTRAJAYA, MALAYSIA

### ABSTRACT

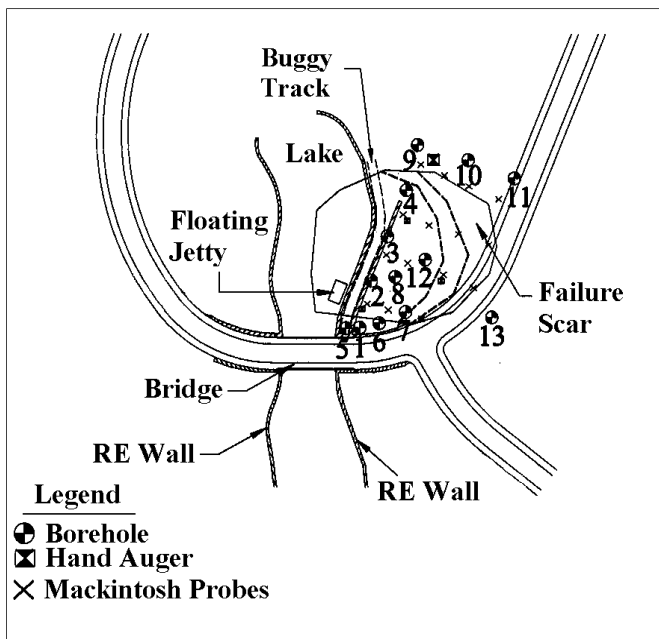
Fig. 6. Location of the site investigation works

After the failure, 13 new boreholes (BH1 to BH13), 15 Mackintosh probes (MP1 to MP15) and 3 hand augers (HA1 to HA3) were carried out by the soil subcontractor to determine the soil profile of the failed area. The generalized soil profile obtained from the boreholes shows that the subsoil consists of medium stiff to stiff silty clay or clayey silt. The locations of the site investigation works are shown in Fig. 6.
