(2004) - Fifth International Conference on Case  
Histories in Geotechnical Engineering

## RECENT EARTHQUAKES IN JAPAN

### ABSTRACT

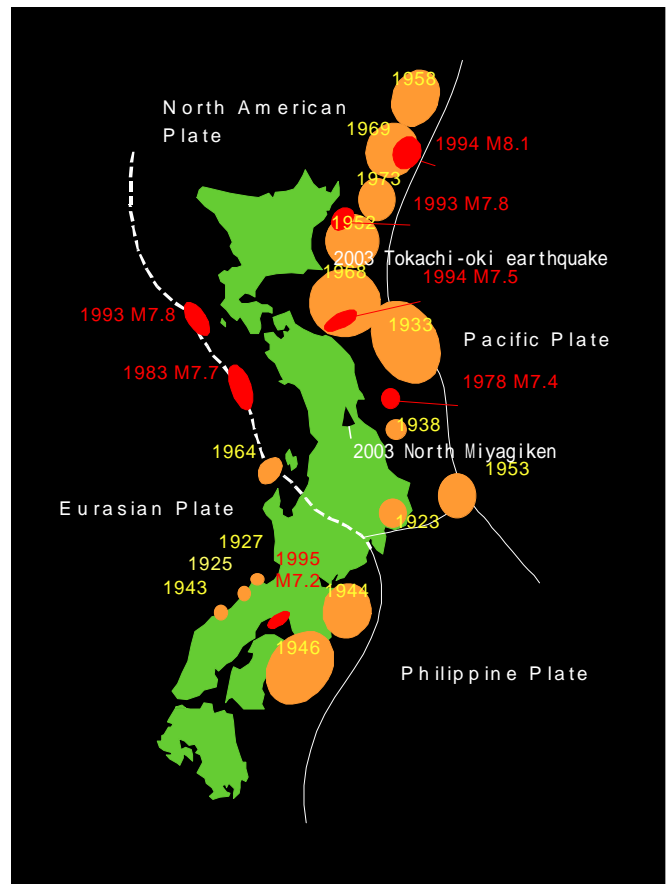
Fig. 1 Earthquakes around Japan, and epicenters of 2003 North Miyagiken (M=6.2) and Tokachi-oki (M=8.0) earthquakes

Figure 1 shows the epicentral area of 2003 North Miyagiken earthquake, located at a pacific side of Northern Japan near Sendai city. Focal depths of the earthquakes were about 10km. The main shock occurred at 7:13. Earthquake motions recorded at Ishinomaki site, located about 10 km east of the epicenter, through K-net station is shown in Fig. 2, together with an earthquake motion recorded at May 26, 2003 earthquake (M=7.0). The failed river embankment at the Naruse river was located about 10km west of the epicenter.

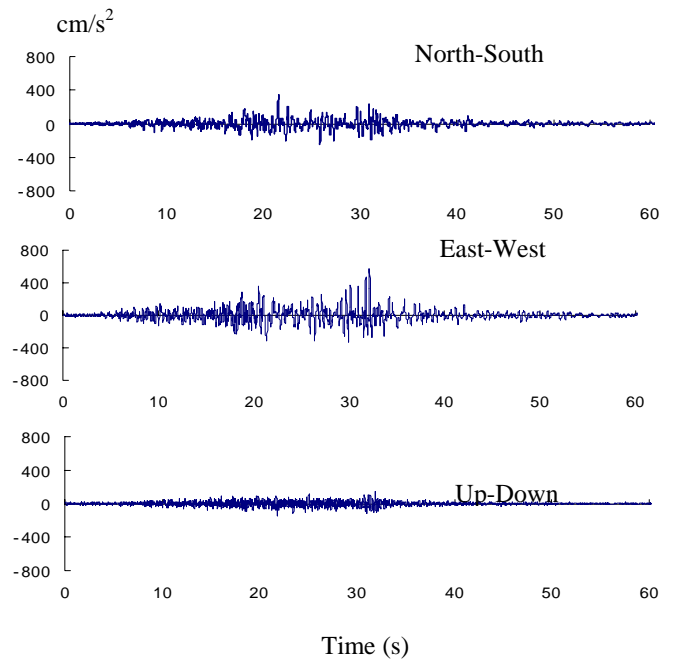
Fig. 9 Earthquake ground motions recorded at Kushiro port during 2003 Tokachi-oki earthquake (After Port and Airport Research Institute)

Figure 9 shows earthquake motions record at the Kushiro port. The peak ground surface acceleration was about 0.5g.
