Failure Investigation and Restoration of Two Cellular Sheetpile Structures

FAILURE INVESTIGATION AND RESTORATION OF TWO CELLULAR SHEETPILE STRUCTURES

Frank M. Clemente, Jr., Ph.D., P.E.

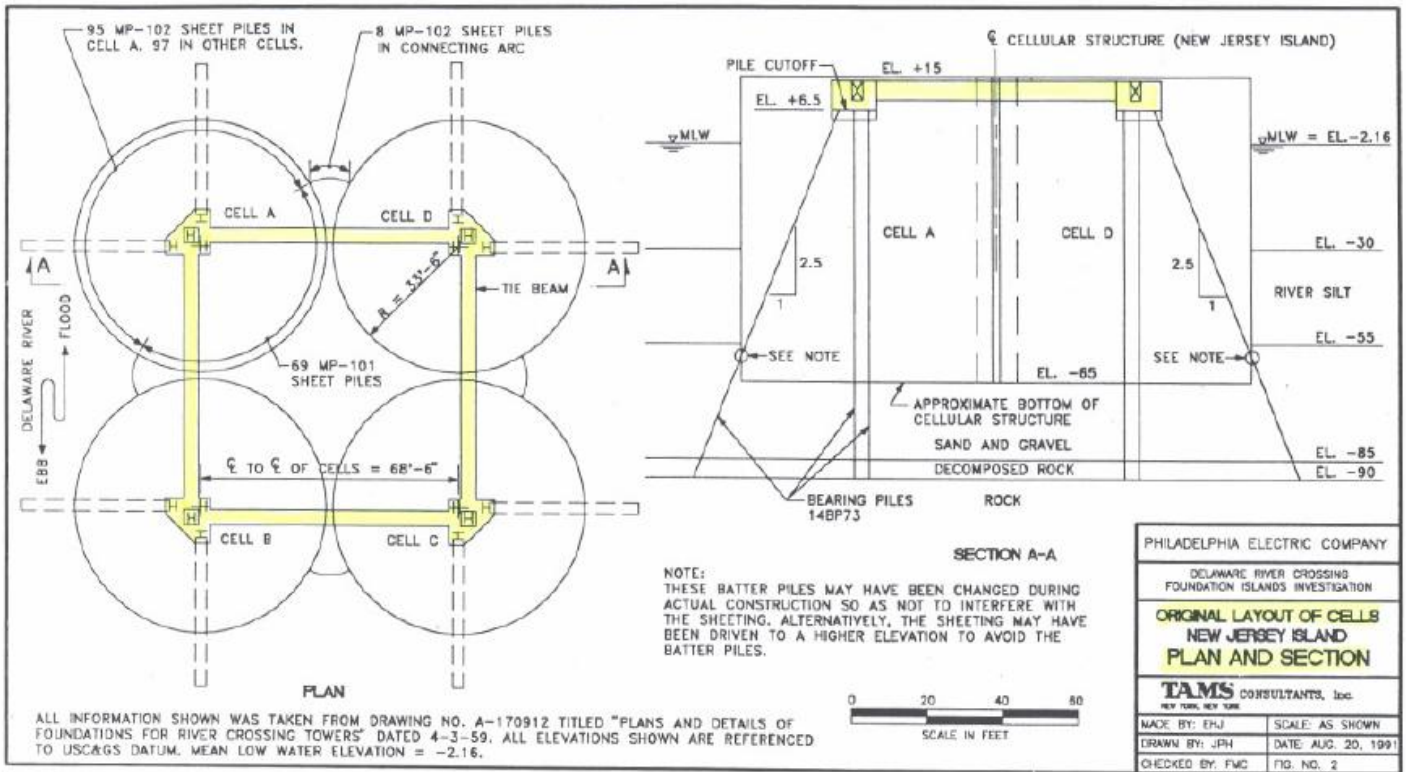
Fig. 2: Plan and Elevation of New Jersey Island

Existing drawings were obtained from PECO and US government agencies. The drawings were used to prepare a geologic profile of the New Jersey Island (Fig. 4) and to define the original configuration of the cells (Fig. 2).

Corrosion Probe, Inc. performed ultrasonic thickness testing of the sheetpiles and evaluated the condition of the cathodic protection system. The cathodic protection system on the New Jersey Island was not operational. An overload trip feature probably deactivated the system when the cables from the H-pile groups to the anodes in the two failed cells were ruptured due to the large displacements of the cell fill. Potential measurements indicate that all structures on the New Jersey Island, including the sheetpiles, H-piles, pile caps and electrical grounds were electrically continuous. This appears to corroborate calculations and oral recollections which indicated that the batter H-piles on that island intersected the sheetpile cells, as shown on Fig. 2. The cathodic protection system on the Pennsylvania Island was operational and in service.

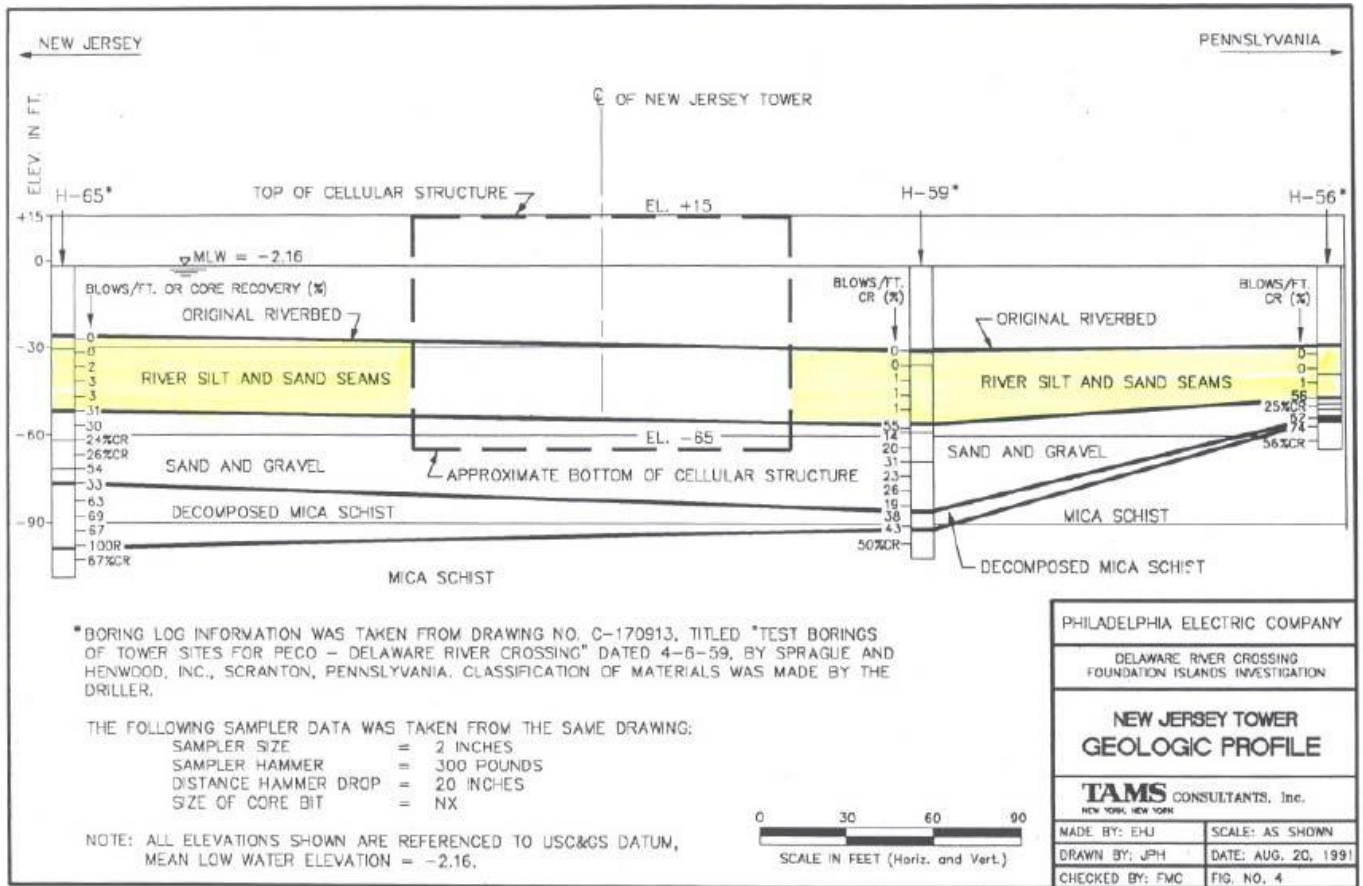
Fig. 4: Idealized Soil and Rock Profile

subsurface profile in the vicinity of the New Jersey Island is shown in Fig. 4.

The soil profile in Fig. 4 shows that the sheetpiles were driven through the soft riverbed silt into an underlying sand and gravel layer. This layer is medium dense to dense and could have caused substantial resistance to penetration of the driven sheetpiles. In overcoming this resistance the sheetpiles, being long flexible members, were vulnerable to damage by tearing of the webs or deformation of the interlocks.
