## Study of Ground Movement in a Mining Area

## STUDY OF GROUND MOVEMENT IN A MINING AREA

### ABSTRACT

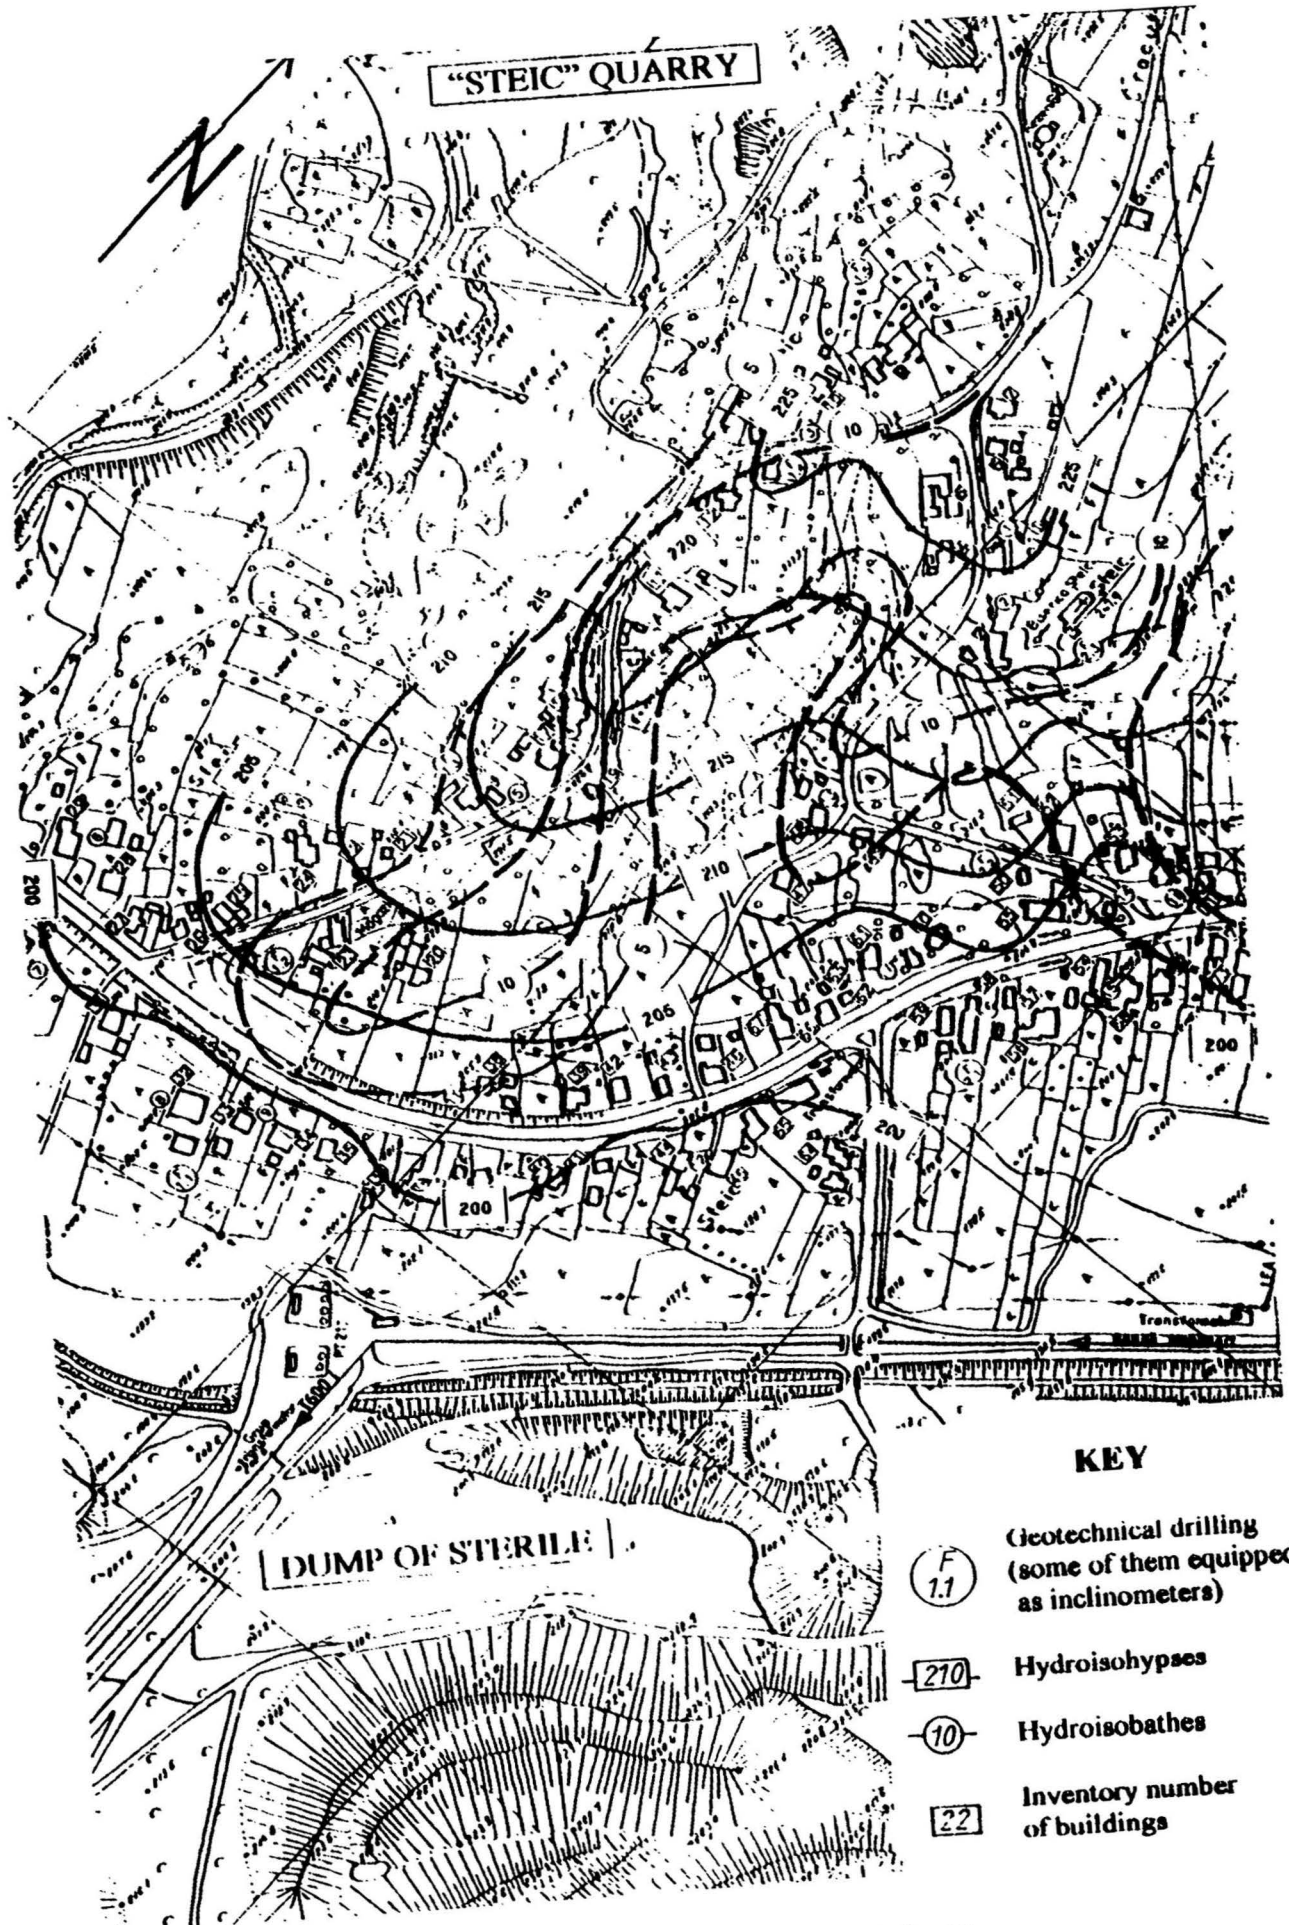
Fig. 1 Partial top view of investigated zone

of Romania, at about 300 km West from the capital city Bucharest. The village is located on northern bank of river Motru valley. The natural ground elevation varies among +200 m (above black Sea level), in the river Motru alluvial plane where the dump is erected, and about + 230 m at the hill top. Due to the space reasons Fig. 1 presents only a part of investigated area.

The southern margin of the quarry is situated at more than 200 m from the nearest house, but in general, excavation begin to develop at an average distance of over 400m from the village limit. As we noted before, the dump is situated in the southern part of studied zone, on the alluvial plain of the river Motru. The minimal distance between the northern dump slope foot and the southern constructed area limit is about 120 m. (200 m in Fig. 1).

On September 10, 1996 we measured the piezometrical level of ground water in 29 domestic wells spread out on the village area. A part of this "water points" is presented in Fig. 1. Considering this investigation we were able to mark the lines of equal elevations of ground water level (hydroisohipses) and the lines of equal depths of ground water surface (hydroisobathes). Ground water surface is situated at depth, varying between less than 5 m (usually 2m) at the slope foot (southern side of build area) and more than 10 m to the hill top (northern side of the village). The general flow direction of ground water is from North to South being characterised by an average hydraulic gradient of 0.08. We

Studying the general stability of the slope on which the village is located four calculus profiles were considered. In Fig.1 the positions of the first two sections are presented while in Fig. 4 and 5 respectively, the corresponding calculus profiles are shown. (Chirică et al. , 1996).

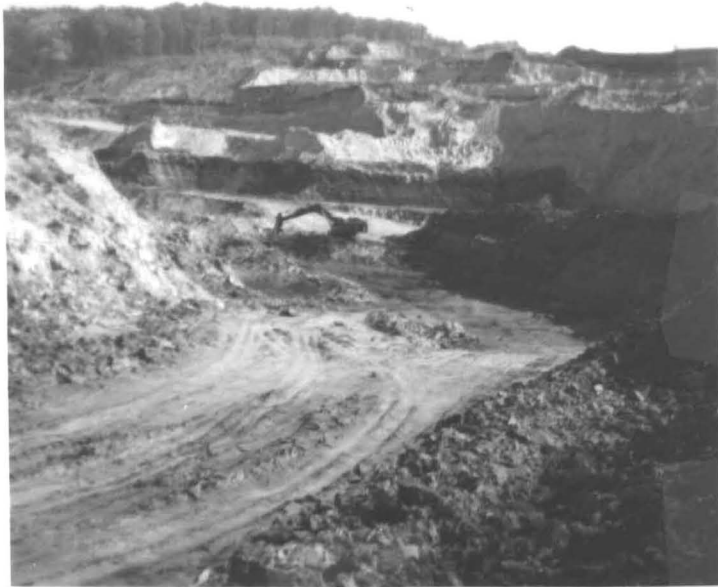
However we considered that the presented map is conclusive enough, being representative for the entire studied zone. The quarry (Photo 1.) is placed on a plateau situated at the hill top.

Photo 1 Steic quarry. General view
